**CALSPAN ON-SITE SIDE IMPACT INFLATABLE OCCUPANT
PROTECTION SYSTEM CRASH INVESTIGATION**
SCI CASE NO.: CA09041

VEHICLE: 2007 KIA RIO

LOCATION: NORTH CAROLINA

CRASH DATE: MAY 2009

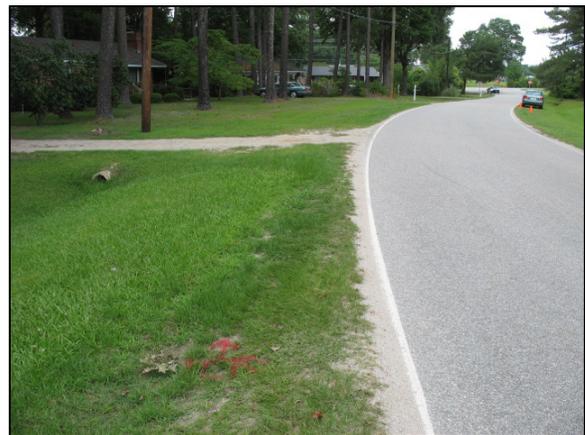
The 16-year-old driver had obtained her driver’s license two months prior to the crash and stated in the interview that on the day of the crash she was in a hurry to get the 17-year-old front right passenger home on time. She was restrained and was operating the Kia northbound on a straight section of the two-lane roadway at a reported speed of 105 km/h (65 mph). The driver reported that a slower non-contact vehicle was traveling in front of the Kia. As the Kia entered the right curve, the driver initiated a passing maneuver and crossed the double-yellow centerline. Subsequent to passing the slower vehicle, the Kia departed the roadway to the left and entered the grass roadside (**Figure 3**). The driver initiated a right steering input in an attempt to return to the roadway and she applied

Figure 3: Location at which the Kia departed the roadway.

the brakes. The rear tires of the vehicle broke traction and the Kia entered a clockwise yaw. The Kia rotated approximately 85 degrees clockwise as it traveled along the west roadside area. The Kia continued its trajectory and yaw to the point of impact with the utility pole (**Figure 4**). The yaw marks attributed to the left side tires measured 72 m (236.2 ft) in length.

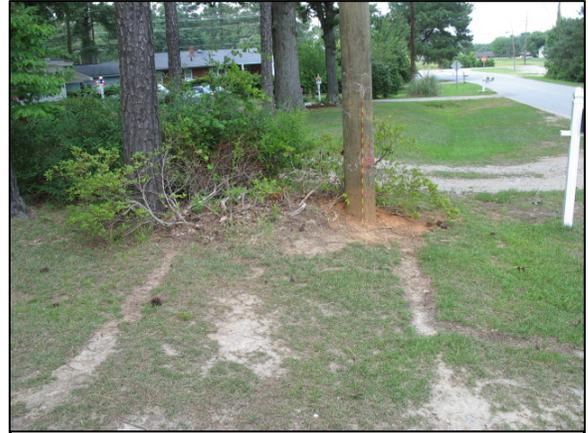
The left A-pillar area of the Kia impacted the utility pole. The impact did not fracture the pole. The barrier algorithm of the WINSMASH program was used to calculate a total delta-V of 49 km/h (30.5 mph). The lateral and longitudinal delta-V components were -9 km/h (-5.5 mph) and 48 km/h (29.8 mph), respectively. The Kia remained engaged with the pole and rotated approximately 15 degrees clockwise around the pole before coming to final rest facing east on the west roadside.

Figure 4: Area of impact with the utility pole.

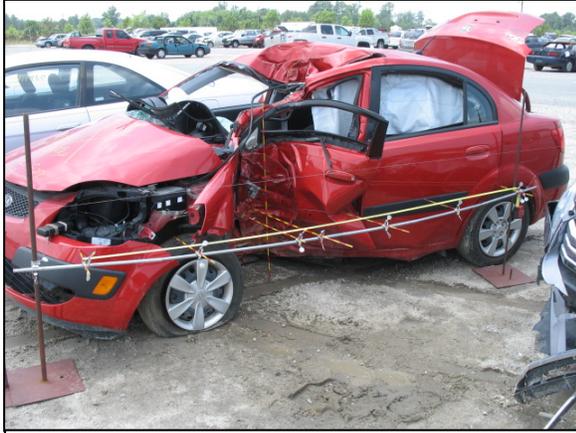
The left side of the Kia sustained severe damage as a result of this crash. The impact to the tree occurred to the forward aspect of the front left door. The direct contact damage began 151 cm (59.4 in) forward of the left rear axle and extended forward 51 cm (20.1 in) to the left A-pillar area. Lateral crush was present to the left doors, B-pillar, A-pillar and left fender. The left front and rear door hinges were intact and remained attached to the A- and B-pillars, respectively. Both left side doors remained closed during the crash. The combined direct and induced damage (Field L) began 14 cm (5.5 in) forward of the left rear axle and extended forward 258 cm (101.6 in). The residual crush profile was measured at the lower door level and was as follows: C1 = 0 cm, C2 = 9 cm (3.5 in), C3 = 18 cm (7.1 in), C4 = 68 cm (26.8 in), C5 = 26 cm (10.2 in), C6 = 6 cm (2.4 in). The maximum crush was located 157 cm (61.8 in) forward of the left rear axle and measured 78 cm (30.7 in). The Collision Deformation Classification (CDC) assigned for this impact was 09LPAW5. **Figures 5 and 6** depict the left side damage sustained by the Kia.

Figure 5: Overall view of the left side damage to the Kia.

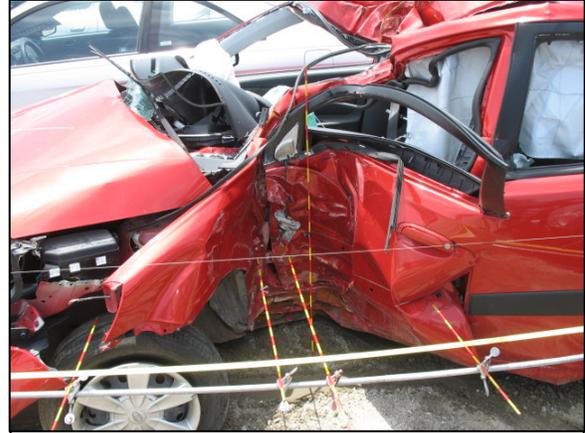
Figure 6: Lateral view of the pole impact damage.

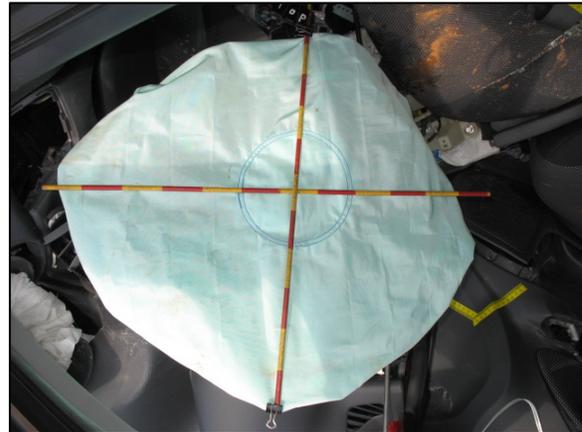
The Kia was equipped with a Certified Advanced 208-Compliant (CAC) frontal air bag system. The driver's air bag was concealed within the center hub of the three-spoke steering wheel by three asymmetrical cover flaps. The top flap was 6 cm (2.4 in) in height and 15 cm (5.9 in) in width at the horizontal tear seam. The two lower flaps were symmetrical measuring 7 cm (2.8 in) in width at the tear seam and 10 cm (3.9 in) in height. The air bag (**Figure 7**) measured 60 cm (23.6 in) in diameter in its deflated state. The air bag was vented by two vent ports at the 11/1 o'clock positions on the rear aspect of the air bag. The air bag was tethered by two straps. There were no occupant contact points on the air bag, but a large amount of dirt and dust had accumulated on the air bag post-crash due to its exposure to the elements.

Figure 7: Deployed driver's frontal air bag.

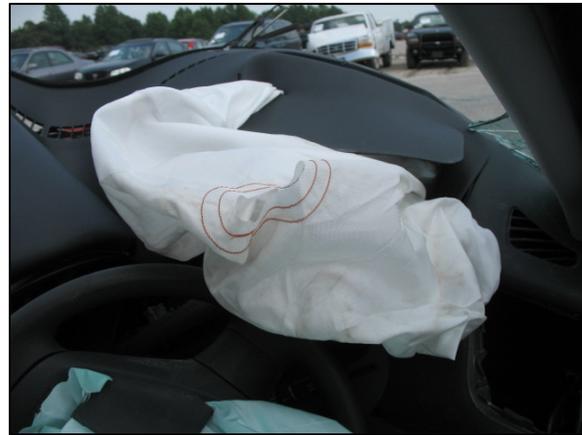
The front right air bag was concealed within the top aspect of the right instrument panel. At the time of the crash, the front right seat was occupied. The occupant's weight was detected by the weight sensor in the front right seat. The CAC front right air bag deployed. The cover flap measured 23 cm (9.1 in) in width and 10 cm (3.9 in) in height. The air bag was vented by a single port at the twelve o'clock position. Due to the lateral intrusion of the steering assembly, the steering wheel rim was in-close proximity to the front right air bag. **Figure 8** depicts the front right air bag.

Figure 8: Deployed front right air bag.

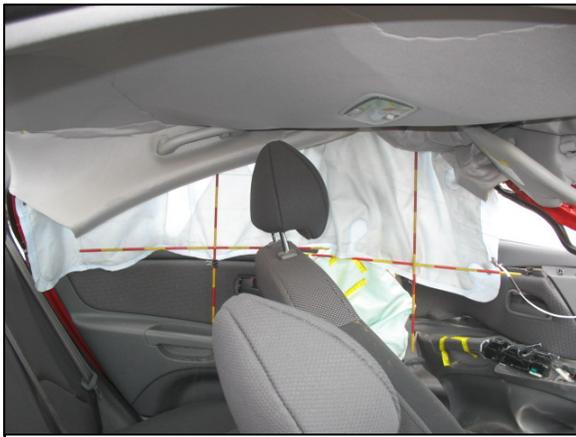
The left IC measured 136 cm (53.5 in) in length. At the front left seating position, the air bag measured 44 cm (17.3 in) in height, and 40 cm (15.7 in) in height at the rear left seating position. The air bag was tethered to the A-pillar by a 44 cm (17.3 in) long strap. Vertically, the curtain air bag extended below the belt line at each outboard position. The IC provided head protection

from the roof side rail to the belt line and from the C-pillar to a location 42 cm (16.5 in) forward of the B-pillar. There was a gap between the front edge of the curtain air bag and the A-pillar. This gap could not be accurately measured due to the damage to the left front door and A-pillar. **Figure 9** depicts the left curtain air bag.

Figure 9: Left curtain air bag.

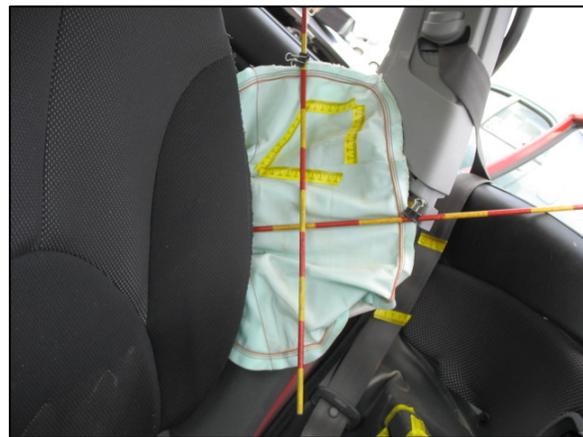
The left side impact air bag deployed from a panel in the outboard aspect of the front left seat back. The membrane measured 22 cm (8.7 in) in width and 36 cm (14.2 in) in height. It contained no vent ports or tethers. There was a scuff mark located on the inboard side of the air bag 5 to 14 cm (2 to 5.5 in) below the top of the bag and 10 to 19 cm (3.9 to 7.5 in) aft of the forward edge. **Figure 10** depicts the front left side air bag.

Figure 10: Left side impact air bag.
