**CALSPAN ON-SITE ROLLOVER CRASH INVESTIGATION**

**SCI CASE NO.: CA09047**

**VEHICLE: 2007 HONDA CR-V**

**CRASH DATE: JULY 2009**

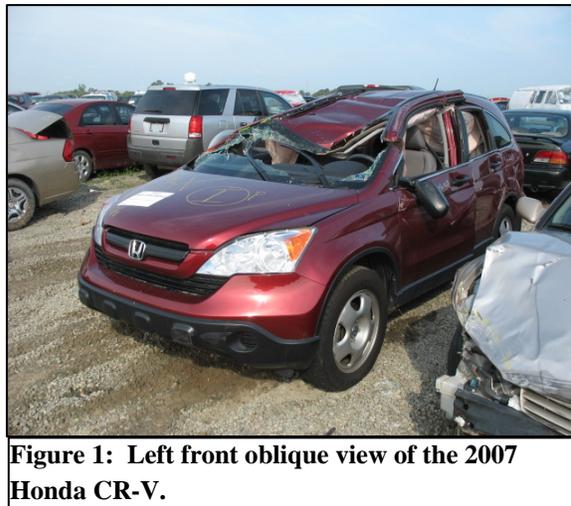
**Figure 1: Left front oblique view of the 2007 Honda CR-V.**

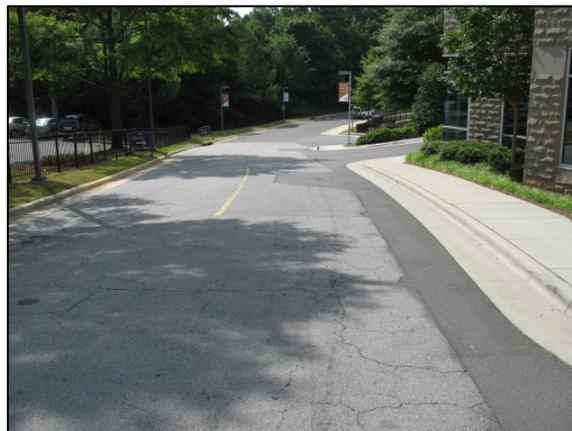
This crash occurred during daylight hours of July 2009 at the 3-leg intersection of two 2-lane roadways (**Figure 2**). The weather conditions were dry and clear. The traffic lanes were surfaced with asphalt. The southbound approach to the intersection had a negative grade of -4.9 percent transitioning to -3.2 percent nearing the intersection. This roadway configuration was an “S” curve beginning to the left and transitioning to the right as the roadway approached the intersection. The eastbound approach to the intersection had a level grade and a shallow right curve. The eastbound travel was controlled by a

**Figure 2: Pre-crash trajectory view of the Honda CR-V.**

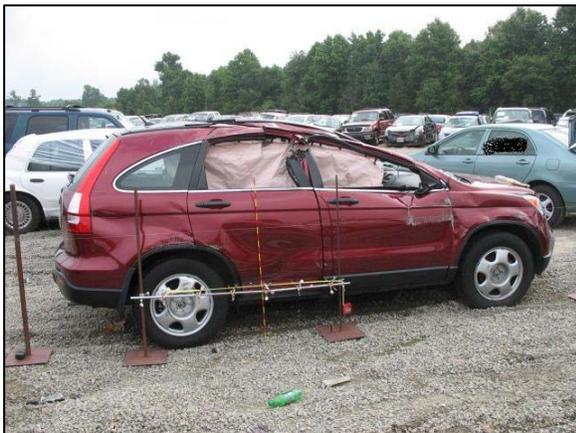
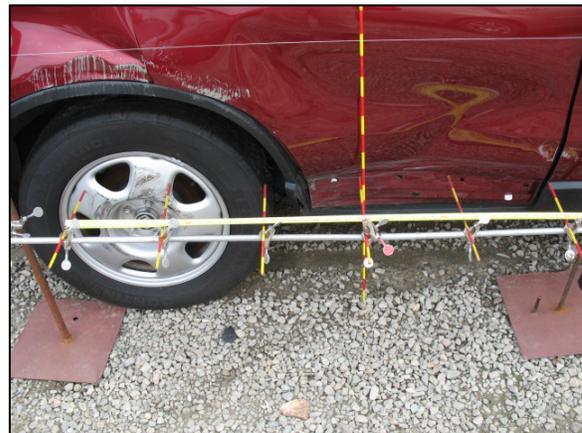
The right, top and left planes of the Honda CR-V were damaged in this multiple event crash. The initial impact involved moderate-severity damage to the right side of the Honda. The doors remained closed during the crash and were operational post-crash. The direct contact damage began on the right side 156 cm (61.4 in) rearward of the right front axle and extended rearward 121 cm (47.6 in) to just aft of the right rear wheel well. The combined direct and induced damage (Field L) began and ended in the same locations. Lateral crush was present to the right rear door, C-pillar and quarter panel. Vertically, the direct damage extended from the sill level to the mid-door level. The residual crush profile was measured at the lower door level and was as follows: C1 = 0 cm, C2 = 3 cm (1.2 in), C3 = 6 cm (2.4 in), C4 = 7 cm (2.8 in), C5 = 6 cm (2.4 in), C6 = 0 cm. The maximum crush was located at C4, 205 cm (80.7 in) rearward of the right front axle. The elevation of the maximum crush was 44 cm (17.3 in), consistent with the front bumper height of the Honda Odyssey. The Door Sill Differential (DSD) measured 3 cm (1.2 in) at the right rear door. The Collision Deformation Classification (CDC) assigned for this impact was 02RZEW1. The right side impact damage is depicted in **Figures 3 and 4**.

**Figure 3: Right side impact damage to the Honda CR-V.**

**Figure 4: Close-up view of the right side crush profile and DSD of the Honda CR-V.**

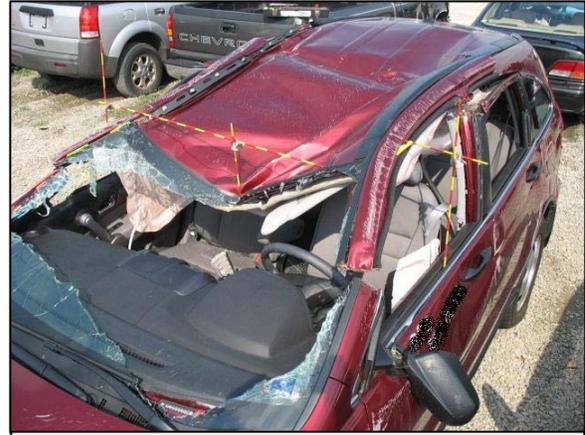
As a result of the rollover event, the Honda sustained moderate severity damage to the left, top and right planes (**Figure 5**). The surface abrasions on both side planes were oriented vertically, and the abrasions on the roof were oriented laterally consistent with the direction of the rollover and indicated that the vehicle did not roll beyond 3-quarter turns. The direct contact extended 333 cm (131.1 in) from the top of the backlight header forward to the hood and extended 112 cm (44.1 in) from roof side rail to roof side rail. The roof deformed in a V-pattern consistent with probable contact with the curb during the rollover sequence. The maximum vertical crush measured 38 cm (15 in) and was located on the windshield header 60 cm (23.6 in) inboard of the right A-pillar. The maximum lateral crush was 10 cm (3.9 in) and was located on the left roof side rail 15 cm (5.9 in) aft of the windshield header. The A-pillars, B-pillars and roof side rails were cut by the first responders during the removal of the driver. The windshield was fractured in the crash, but was also cut and removed. The left and right door glazing disintegrated as a result of this multiple impact crash sequence. The left and right rear quarter windows and the backlight were intact. The CDC assigned for the rollover event was 00TDDO5.

**Figure 5: Rollover damage to the Honda CR-V.**

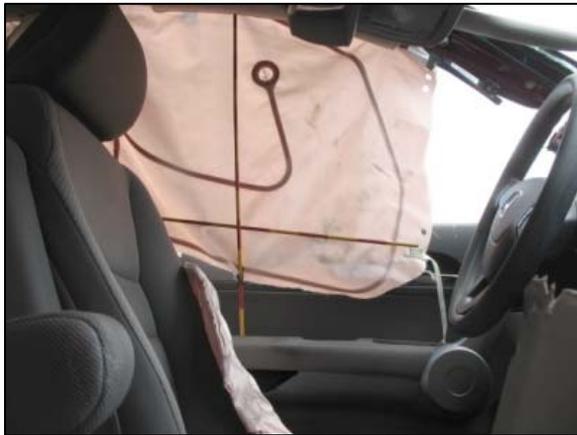
rectangular in shape and measured 172 cm (67.7 in) in length. At both the front and rear seating positions, the IC air bag measured 48 cm (18.9 in) in height and extended vertically to below the beltline at each outboard seating position. The IC provided head protection from the C-pillar forward to a point located 56 cm (22.0 in) forward of the B-pillar. A triangular shaped void was present forward of the IC at the front seating position. The void measured 28 cm (11 in) in length along the window sill, 36 cm (14.2 in) in height along the rear edge and 16 cm (6.3 in) in height at the forward most aspect. The air bag was tethered to the A-pillar by a 32 cm (12.6 in) long strap. The tether straps on both sides were cut by EMS during the removal of the driver. There was a scuff mark from contact with the ground on the outboard side of the left IC at the left front window opening. This scuff mark was located 2 to 23 cm (0.8 to 9.1 in) aft of the front edge of the air bag, and 6 to 40 cm (2.4 to 15.7 in) above the lower edge of the air bag. **Figures 6 and 7** depict the IC air bags.

**Figure 6: Left curtain air bag of the Honda CR-V.**

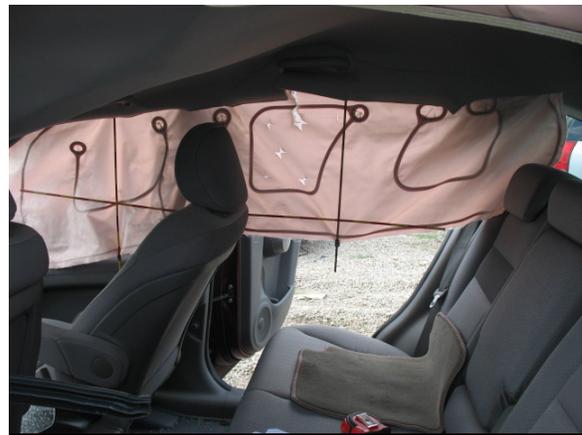
**Figure 7: Honda CR-V's right curtain air bag.**

The inboard side of the right IC had food particles adhered to the air bag near the B-pillar. The food was consistent with a plate of food found in the rear right seat at the time of the inspection. The right curtain had been cut vertically at the top of the air bag extending down 14 cm (5.5 in) by a first responder cutting the right roof side rail. This cut was 46 cm (18.1 in) forward of the C-pillar.

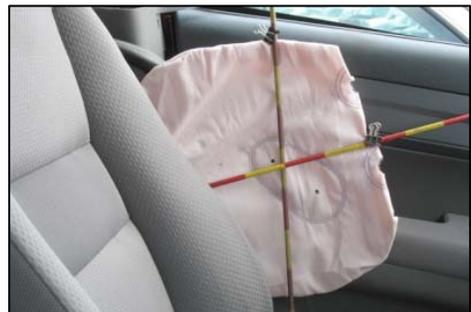
The Honda CR-V was equipped with side impact air bags located in the outboard aspect of the front seat backs. The left side air bag deployed as a result of the contact with the ground during the rollover. The right side air bag did not deploy. The left side air bag measured 33 cm (13 in) in height and 28 cm (11 in) in width. This air bag contained two vent ports at the 2 and 4 o'clock positions at the front edge of the bag. The left side air bag (**Figure 8**) was free from occupant contact points and damage.

**Figure 8: Honda CR-V's driver side seatback mounted air bag.**

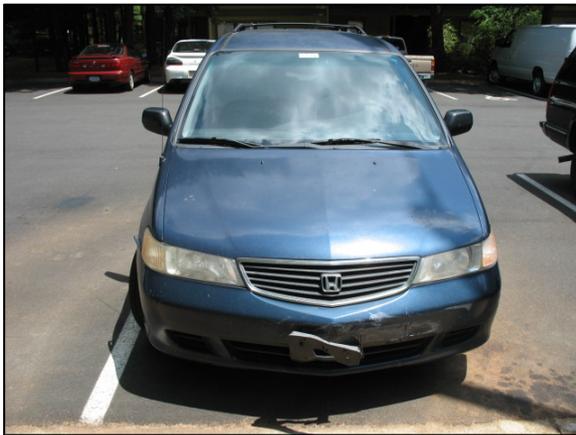
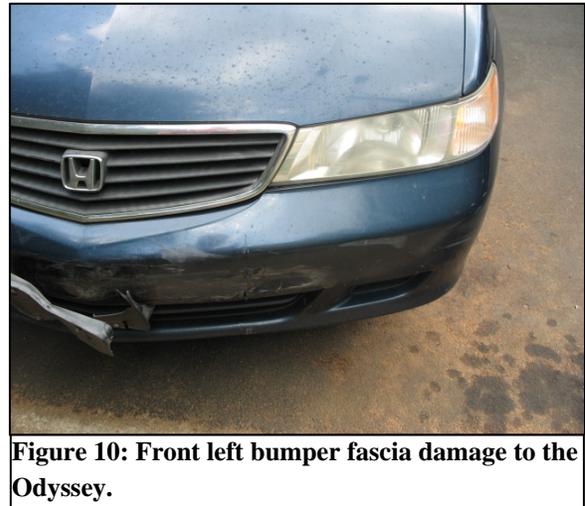
The front of the Honda Odyssey sustained minor-severity damage as a result of the multiple impact crash. The owner refused to fully participate and only allowed a visual exterior inspection and photographs, no exterior measurements were obtained from the vehicle. The Event 1 impact damage was located on the left half of the vehicle's front bumper and had a direction of force within the 11 o'clock sector. The direct damage began at the approximate center of the bumper fascia and extended to the left bumper corner. The CDC assigned for the initial impact was 11FYEW1. The Event 1 damage was overlapped by the secondary impact damage with the steel sign at the roadside. The CDC assigned to the secondary impact was 12FLEN99. **Figures 9 and 10** depict the frontal damage sustained by the Odyssey.

**Figure 9: Overall view of the frontal damage to the Odyssey.**

**Figure 10: Front left bumper fascia damage to the Odyssey.**

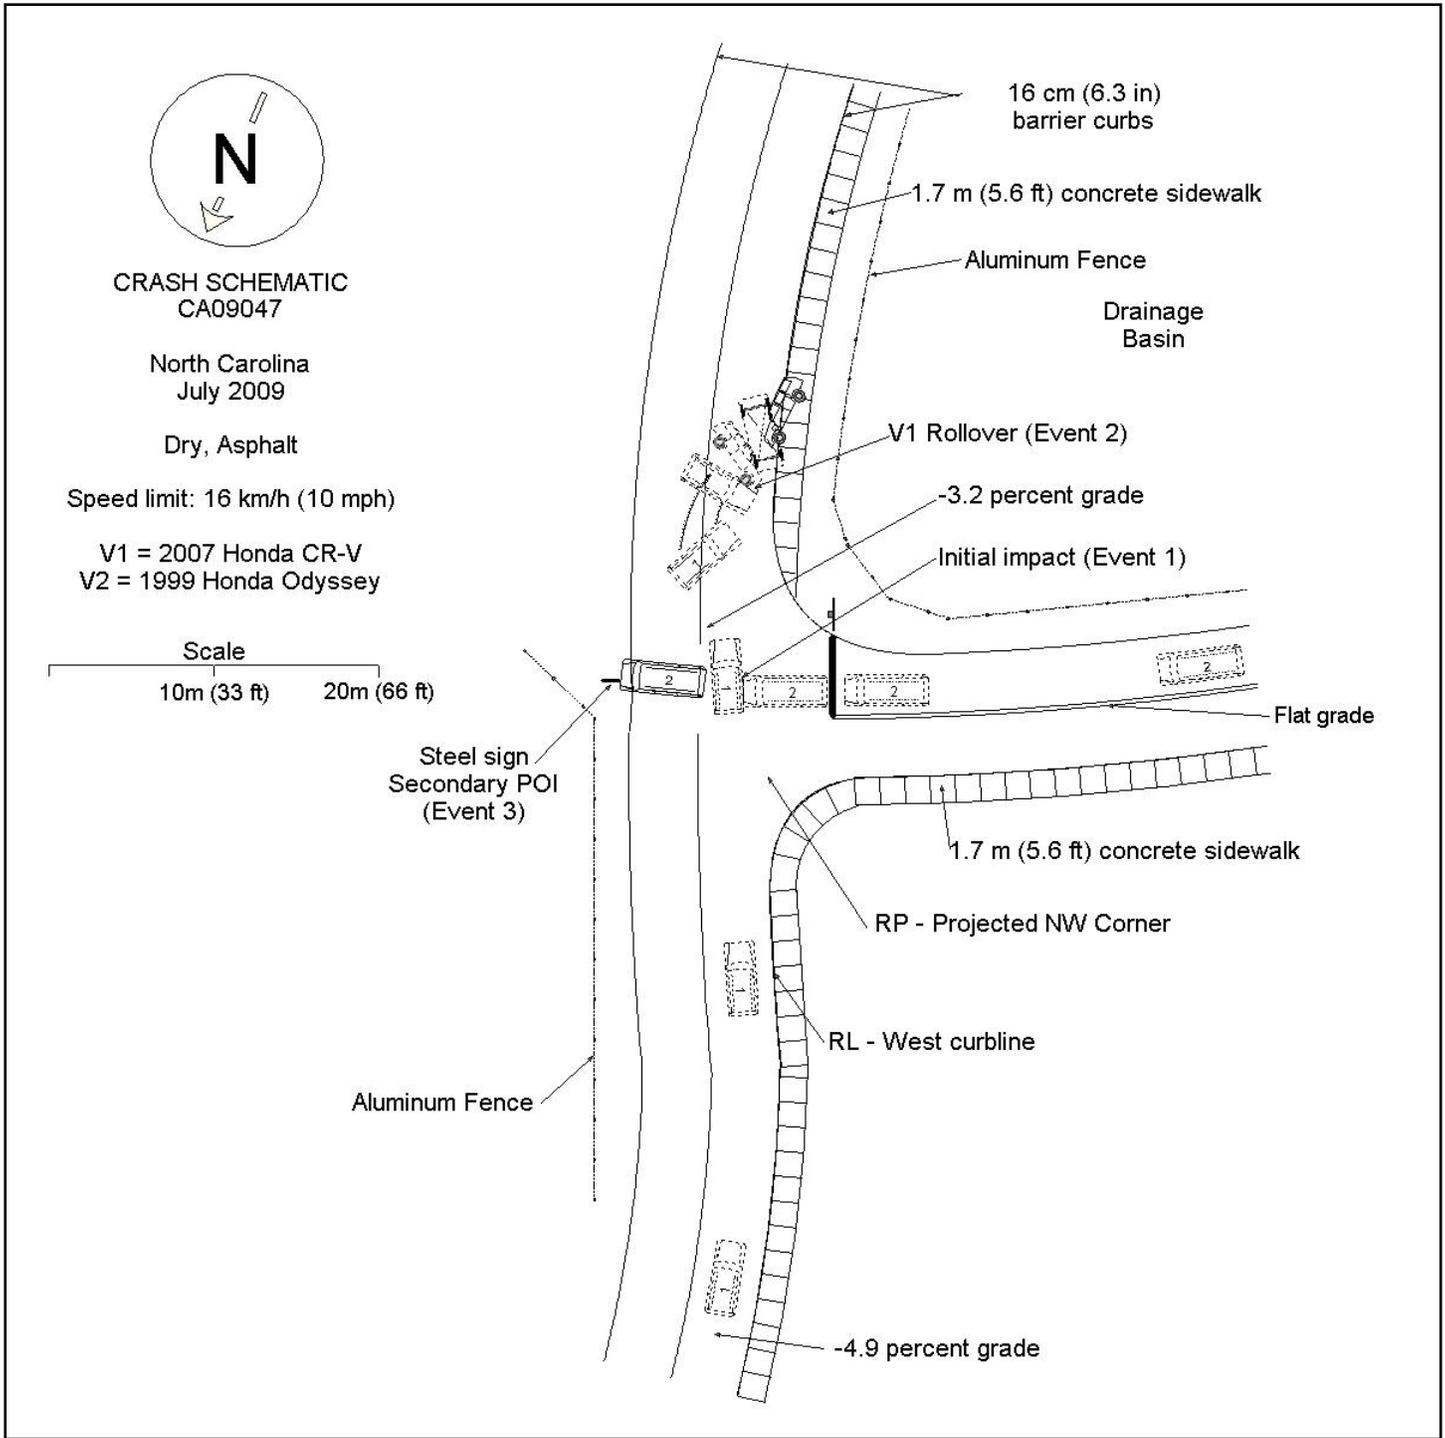
**Figure 11: Crash Schematic**

The force of the impact rearward of the Honda CR-V’s center of gravity caused the vehicle to initiate a clockwise (CW) rotation. The Honda CR-V rotated approximately 125 degrees CW and deposited yaw marks on the roadway attributed to the left front and left rear tires. The left front yaw mark measured 3.2 m (10.5 ft) and the left rear yaw mark measured 5 m (16.4 ft) in length. The Honda rolled, left side leading, over the left front tire as the left front rim contacted the pavement resulting in a trip-over (Event 2). A scratch mark was observed on the pavement at the end of the front left tire mark. The vehicle rolled 3-quarter turns and departed the west road side. The Honda CR-V came to rest on its right side facing north, partially on the sidewalk and partially in the southbound travel lane. The (uninterrupted) distance from trip to final rest was approximately 7 m (23 ft). The Honda Odyssey traveled east across the intersection and impacted a steel information sign on the east road side (Event 3). The vehicle came to rest facing east with its front wheels contacting the east curb in contact with the sign.
