CALSPAN ON-SITE ROLLOVER CRASH INVESTIGATION

SCI CASE NO.: CA09051

VEHICLE: 2007 HONDA PILOT

CRASH DATE: JUNE 2009

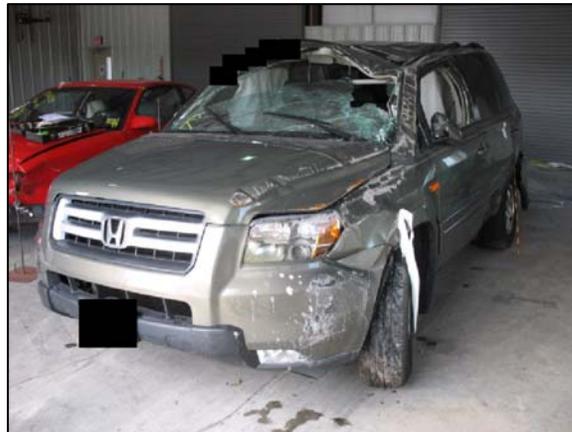
Figure 1: Left front oblique view of the 2007 Honda Pilot.

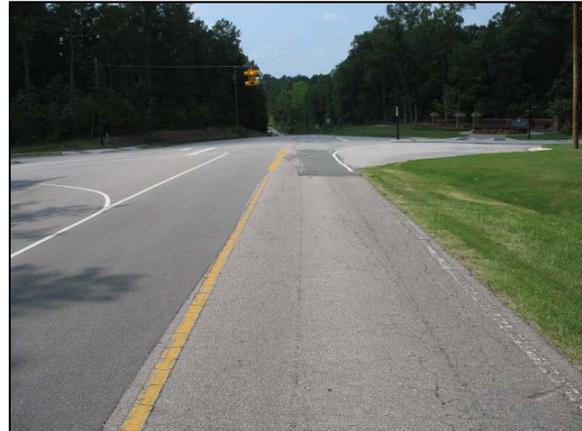
Figure 2: Southbound approach to the intersection.

The restrained 35-year-old female driver of the Honda Pilot was operating the vehicle on a southbound approach to the four-leg intersection (**Figure 2**). The direction of her approach was straight and level and was controlled by a yellow caution light. The Honda was traveling at a police estimated speed of 72 km/h (45 mph). It was the intent of the Honda to travel straight through the intersection. The 48-year-old male driver of the Pontiac was operating the vehicle westbound approaching the intersection. The Pontiac's direction of travel was controlled by a stop sign. The driver of the Pontiac was operating the vehicle at an EDR recorded speed of 72 km/h (45 mph) five seconds prior to Algorithm Enable (AE), and applied his brakes three seconds prior to AE. The Pontiac decelerated to an EDR recorded speed of 60 km/h (37 mph) two seconds prior to AE. The EDR-reported speed one second prior to AE was 10 km/h (6 mph). This data point under-reported the actual speed of the Pontiac. The data may have been a post-impact value. Based on the crash reconstruction and EDR data analysis, the reconstructed minimum speed of the Pontiac, one second prior to the impact, was approximately 31 km/h (19 mph). The reconstructed minimum speed calculation assumed locked-wheel braking. The Pontiac entered the intersection coincident with the Honda. The Chevrolet was stopped in the eastbound left turn waiting to initiate a left turn.

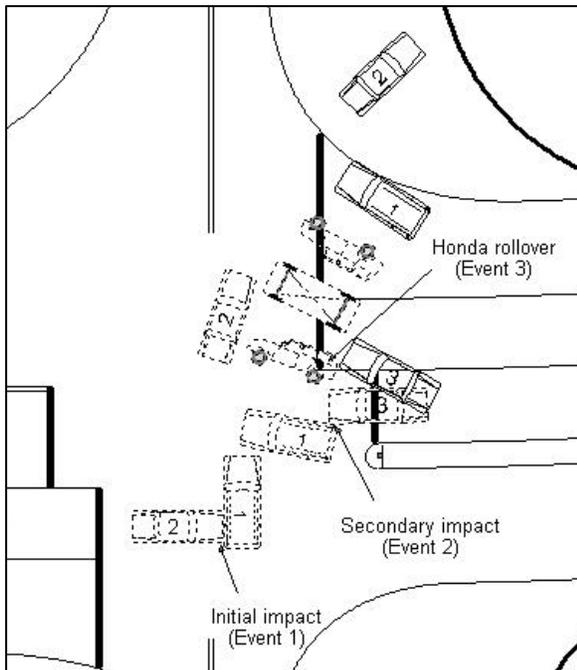
Figure 3 is an image, cropped from the crash schematic, depicting the crash sequence. The front plane of the Pontiac impacted the rear aspect of the Honda's left plane within the intersection

(Event 1). The directions of force were within the 11 o'clock sector for the Honda and within the 2 o'clock sector for the Pontiac. The damage algorithm of the WinSMASH program was used to calculate the severity of the crash. The total delta-V of the Honda was 7 km/h (4.3 mph). The longitudinal and lateral delta-V components were -6.1 km/h (-3.8 mph) and 3.5 km/h (2.2 mph). The total delta-V of the Pontiac was 13.0 km/h (8.1mph) with longitudinal and lateral components of -6.5 km/h (-4.0 mph) and -11.3 km/h (-7.0 mph), respectively.

Figure 3: Crash Schematic excerpt depicting the crash sequence.

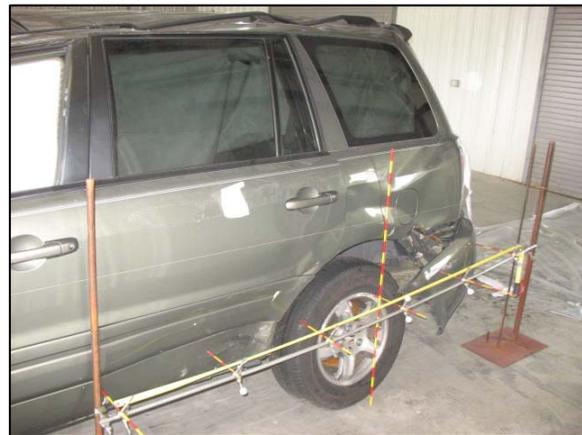
The exterior of the Honda sustained moderate severity damage to the left, right, and top planes as a result of this multiple impact crash. The rear aspect of the left plane sustained damage from the initial impact (**Figure 4**). The combined length of the direct and induced damage measured 216 cm (85.0 in). The damage began 173 cm (68.1 in) aft of the left front axle and extended rearward to the left rear bumper corner. The maximum crush measured 9 cm (3.5 in) and was located at C4, 271 cm (106.7 in) aft of the left front axle. The crush profile was documented at the lower door level for the impact and was as follows: C1 = 0 cm, C2 = 5 cm (2 in), C3 = 5 cm (2 in), C4 = 9 cm (3.5 in), C5 = 3 cm (1.2 in), C6 = 0 cm. The Collision Deformation Classification (CDC) assigned for this impact was 11LZEW1.

Figure 4: Event 1 damage to the left side of the Honda.

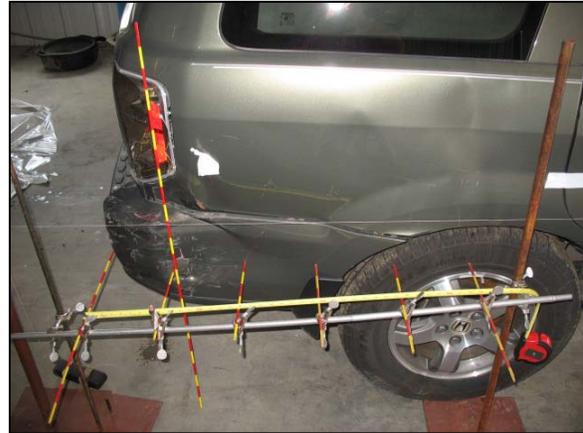
The rear aspect of the Honda's right plane sustained minor damage as a result of the Event 2 impact (**Figure 5**). The combined direct and induced damage (Field L) measured 99 cm (39 in) and began 4 cm (1.6 in) rear of the right rear axle and extended to the right rear bumper corner. The direct damage measured 45 cm (17.7 in) and began 58 cm (22.8 in) rear of the right rear axle and extended rearward to the right rear bumper corner. The maximum crush measured 9 cm (3.5 in) and was located at C2, 83 cm (32.7 in) aft of the right rear axle. The residual crush profile measured at the lower door elevation was as follows: C1 = 7 cm (2.8 in), C2 = 9 cm (3.5 in), C3 = 7 cm (2.8 in), C4 = 3 cm (1.2 in), C5 = 1 cm (0.4 in), C6 = 0 cm. The CDC assigned for this impact was 03RBEW1.

Figure 5: Secondary (Event 2) damage to the right rear of the Honda.

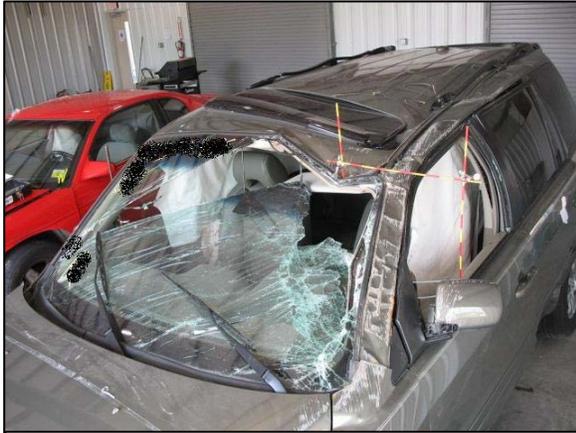
As a result of the rollover event, the Honda sustained moderate-severity damage to the left and top planes consisting of surface abrasions and roof deformation. The windshield glazing was completely fractured with two laminate tears emanating from the upper center aspect. The first tear extended down and right to the base of the right A-pillar. The second tear extended down and left to the base of the left A-pillar. The left front window disintegrated as a result of the rollover sequence. The left rear, left rear quarter, left third row, backlight and all right side glazing was undamaged subsequent to the crash. The sunroof was intact and closed at the time of the inspection. The scratches on the roof were oriented in a single direction. The direct contact damage to the roof extended 132 cm (52 in) laterally from the left roof side rail to the right roof side rail. The longitudinal direct contact damage extended 377 cm (148.4 in) from the leading edge of the hood to the backlight header. The maximum vertical crush was located on the windshield header 17 cm (6.7 in) inboard of the left A-pillar. The maximum vertical crush measured 17 cm (6.7 in). The maximum lateral crush measured 8 cm (3.1 in) and was located on the left A-pillar at the junction with the roof side rail. All four passenger compartment doors remained closed during the crash sequence and were operational post-crash. The rear hatch was jammed shut post-crash. **Figures 6 and 7** depict the rollover damage sustained by the Honda. The CDC assigned for the rollover was 00TDDO3.

Figure 6: Honda rollover damage from above, left front.

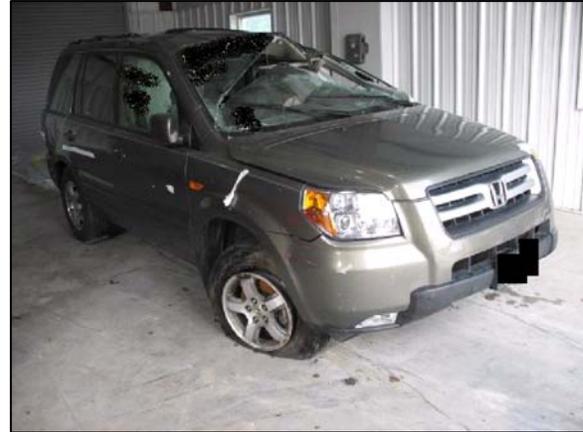
Figure 7: Honda rollover damage from the front right corner.

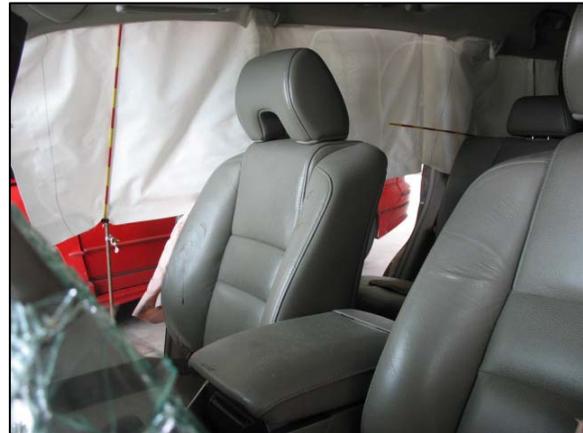
The IC air bags deployed from their respective roof side rails. The curtain air bags were rectangular in shape and measured 220 cm (86.6 in) in length. At the front seating positions, the air bag was 56 cm (22 in) in height, and 52 cm (20.5 in) in height at the second and third row seating positions. Vertically, the curtain air bags extended below the beltline at each outboard seating position. The curtains provided head protection from the roof side rail to the beltline and from the D-pillar to a point 51 cm (20 in) forward of the B-pillar. At the front of each curtain air bag was a triangular void that measured 28 cm (11 in) in length along the window sill, 32 cm (12.6 in) high at the rear edge and 20 cm (7.9 in) in height at the forward edge. The air bag was tethered to the A-pillar by a 28 cm (11 in) long strap. There were no occupant contacts to the left IC air bag. The left IC had a scuff mark attributed to contact with the ground on the outboard side. This scuff mark was located 21 to 57 cm (8.3 to 22.4 in) aft of the front edge of the membrane and 16 to 32 cm (6.3 to 12.6 in) above the lower edge of the membrane. Both curtains were labeled with the identification number *6082140A SI/PA 6.6*. There was no contact evidence or damage to the right IC air bag. **Figures 8 and 9** depict the IC air bags.

Figure 9: Right IC air bag of the Honda.

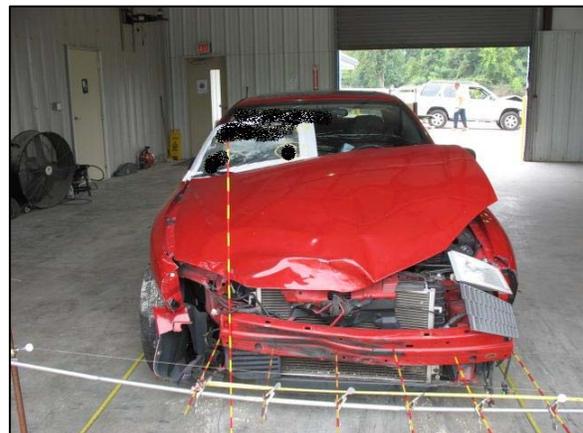
The front plane of the Pontiac Sunfire sustained moderate-severity damage from the Event 1 impact with the Honda (**Figure 10**). The direct damage extended across the entire 142 cm (56 in) frontal end width of the vehicle. The maximum crush measured 10 cm (3.9 in) and was located at C6, the front right bumper corner. A crush profile was documented along the full width of the front bumper beam and was as follows: C1 = 7 cm (2.8 in), C2 = 5 cm (2 cm), C3 = 3 cm (1.2 in), C4 = 5 cm (2 in), C5 = 8 cm (3.2 in), C6 = 10 cm (3.9 in). The CDC assigned for this impact was 02FDEW1.

Figure 10: Frontal damage to the Pontiac.

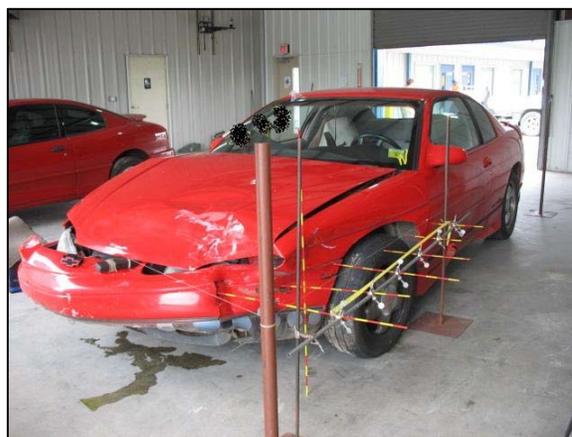
The forward aspect of the Chevrolet's left plane sustained moderate-severity damage as a result of the impact with the Honda (Event 2). **Figure 11** is a left front oblique view of the Chevrolet. The combined direct and induced damage length measured 132 cm (52 in) and began 45 cm (17.7 in) aft of the left front axle extending forward. The direct contact damage measured 46 cm (18.1 in) and began 41 cm (16.1 in) forward of the left front axle. The maximum crush measured 27 cm (10.6 in) and was located at C6, 86 cm (33.9 in) forward of the left front axle. The residual crush profile measured at the mid door elevation was as follows: C1 = 0 cm, C2 = 4 cm (1.6 in), C3 = 12 cm (4.7 in), C4 = 16 cm (6.3 in), C5 = 21 cm (8.3 in), C6 = 27 cm (10.6 in). The front end of the Chevrolet was shifted to the right by 18 cm (7.1 in). The CDC assigned for this impact was 69LFEW2.

Figure 11: Left side damage to the Chevrolet.
