**CALSPAN ON-SITE SIDE IMPACT INFLATABLE OCCUPANT PROTECTION  
SYSTEM CRASH INVESTIGATION  
SCI CASE NO: CA09053**

**VEHICLE 1: 2007 HONDA CIVIC  
LOCATION: NEW YORK  
CRASH DATE: JULY 2009**

1. <i>Report No.</i> CA09053	2. <i>Government Accession No.</i>	3. <i>Recipient's Catalog No.</i>	
4. <i>Title and Subtitle</i> Calspan On-Site Side Impact Inflatable Occupant Protection System Investigation Vehicle: 2007 Honda Civic Location: New York		5. <i>Report Date:</i> September 2010

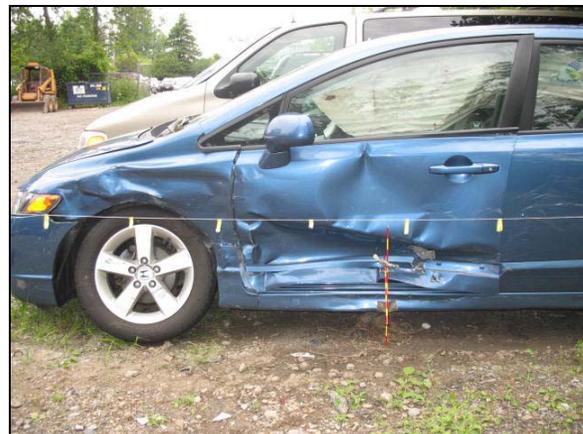
The exterior of the Honda sustained two separate areas of direct contact damage during the vehicle-to-vehicle crash sequence. **Figure 3** is a view of the damage to the forward aspect of the left plane (Event 1) of the Honda. The direct contact damage began 106 cm (41.7 in) forward of the left rear axle and extended 190 cm (74.8 in) forward. The impact resulted in a mostly lateral deformation to the left side front fender, door panel and sill areas. The Honda's left wheelbase was reduced by 5 cm (2.0 in) when

**Figure 3: Close-up view of the Honda's impact damage.**

compared to exemplar measurements. The crush profile was measured along the mid-door level with the following results: C1 = 0 cm (0 in), C2 = 8 cm (3.1 in), C3 = 10 cm (3.9 in), C4 = 6 cm (2.4 in), C5 = 12 cm (4.7 in), C6 = 2 cm (0.8 in). The maximum crush was located at C5. At the time of the SCI inspection, all four doors were latched closed and operational. The post crash condition of the Honda's window glazing were found to be in place and undamaged from impact forces. The Collision Deformation Classification (CDC) for this direct damage pattern was 11LYEW2.

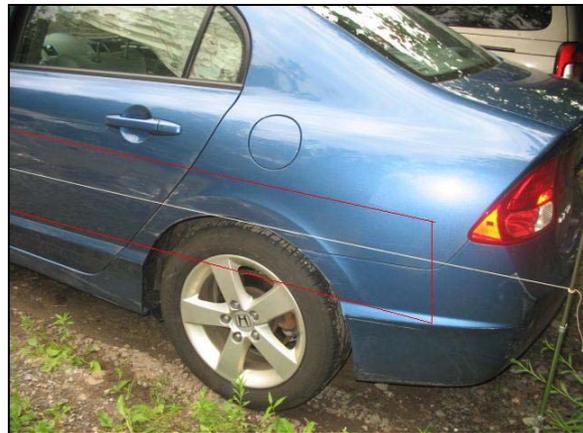
The Honda rotated CW as a result of the initial impact (event 1). The left side of the Honda then contacted the right side of the Toyota in a secondary side-swipe type impact (Event 2). The direct contact damage began 75 cm (38.2 in) aft of the left rear axle and extended 176 cm (50 in) forward. Direct contact damage (**Figure 4**) consisting of longitudinal surface scratches without sheet metal deformation was noted to the left rear door, adjacent fender and quarter panel areas. The residual crush profile yielded 0 cm for lateral deformation at all six "C" measurement locations. The CDC for this damage pattern was 12LZES1.

**Figure 4: Depicts the side-swipe type damage from event 2**

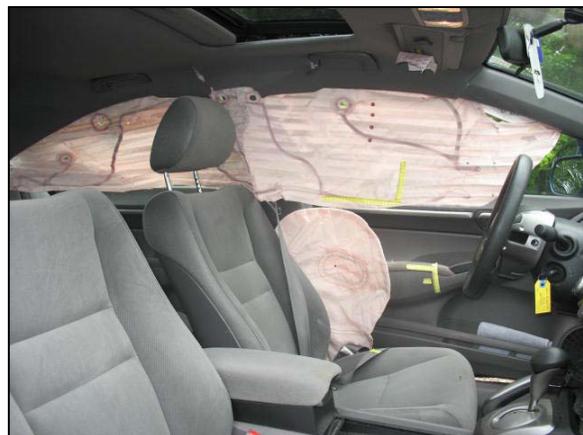
Interior component damage was identified in three separate areas in the driver seat position (**Figure 5**). Each damaged area exhibited characteristics of occupant contact. The first area of damage was located on the interior driver door panel. Multiple scuff marks were identified on the driver door armrest which were attributed to contact with the driver's left flank. The second damaged component was identified as the driver knee bolster. The right side of the knee bolster was displaced from its originally mounted position and contained a scuff mark located in the right lower corner. Further examination of this component revealed damage to the inside

**Figure 5: Lateral view of the Honda's left side interior.**

mounting brackets which held the rigid plastic bolster in place. The damage to the knee bolster was attributed to contact with the driver's right knee. The third area of damage was observed on the left IC air bag. This evidence consisted of frictional abrasions to the inboard surface of the air bag which measured 31 cm x 9 cm (12.2 in x 3.5 in), width x height. The abrasion was located 37 cm (14.6 in) aft of the leading edge and 3 cm (1.2 in) above the bottom edge of the deployed air bag. This damage pattern was attributed to contact with the driver's left shoulder.

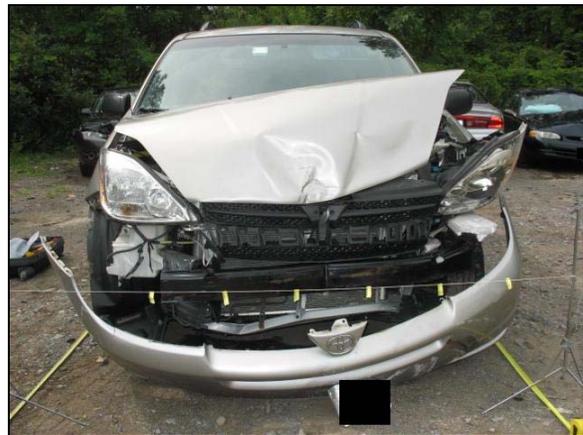
The Toyota sustained front and right plane damage as a result of the crash sequence. The first event produced distributed frontal damage (**Figure 6**) which consisted of deformation to the front bumper fascia, bumper reinforcement beam, both frame-rails and hood components. The direct contact damage included the entire front end-plane and measured 170 cm (66.9 in) in width. The crush profile, measured along the bumper reinforcement beam, was as follows: C1 = 28 cm (11.0 in), C2 = 25 cm (9.8 in), C3 = 25 cm (9.8 in), C4 = 20 cm (7.9 in), C5 = 13 cm (5.1 in), C6 = 2 cm (0.8 in). The maximum crush was located at C1. The CDC for this damage pattern was 01FDEW2.

**Figure 6: Front view of the Toyota damage.**

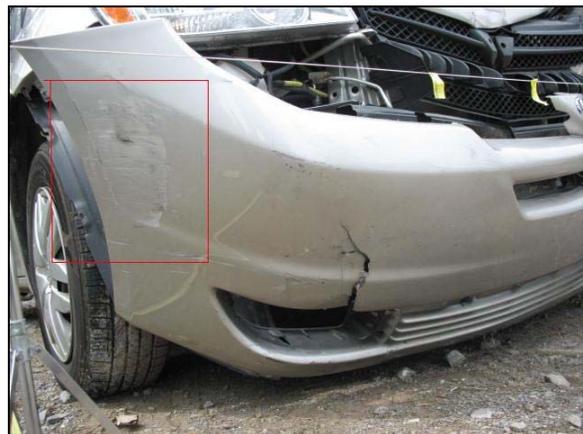
As the Toyota rotated CCW its right plane sustained direct contact damage (**Figure 7**) that started 47 cm (18.5 in) aft of the right front bumper corner and extended forward 19 cm (7.5 in) as a result of the secondary side-swipe type impact (Event 2). This damaged region consisted of linear abrasions to the right side of the plastic bumper fascia. Due to the overlapping induced damage, possible deformation from this event could not be identified. The CDC for this damage pattern was 05RFES1.

**Figure 7: Right oblique view depicting the side-swipe damage from Event 2.**

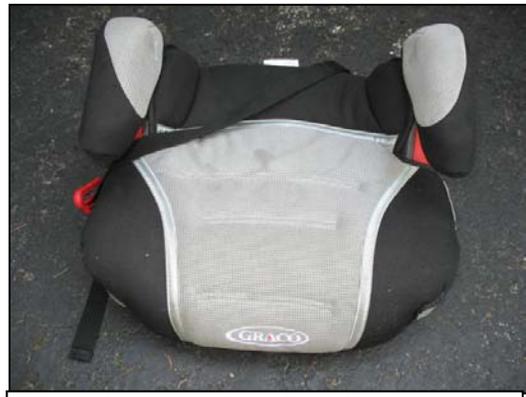
**Figure 8: Front view of the Graco TurboBooster.**

This type of CRS elevated the child in order to provide a better fit of the vehicle's 3-point safety belt system that was used to secure the occupant within the booster seat. An inspection of this CRS revealed indications of historical use. There was no loading evidence or stress marks identified on the seat.

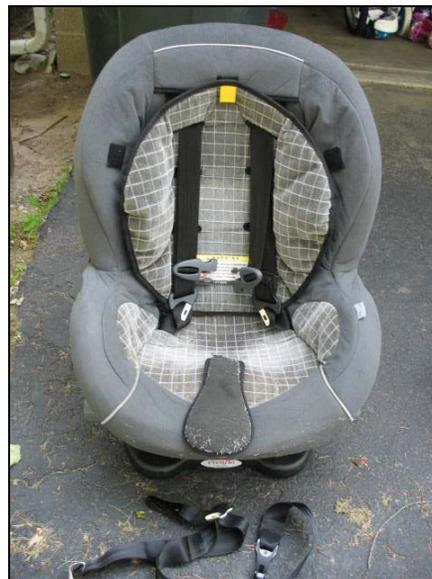
**Figure 9: Front view of the Evenflo Triumph.**

This CRS was designed with an internal 5-point harness system. There were three harness slots in the back of the shell. The harness was found to be routed through the top positioning slots. The lower base was designed with a 5-position tilt adjustment mechanism. Tilt position one was reserved for a rear-facing only installation. Tilt positions two through five were reserved for a forward-facing installation with position two being used for the most reclined forward facing position and position five being the most upright. The lower base adjustment was in tilt position four which produced an 18 degree recline angle at the time of this SCI inspection.

Further inspection of this CSS revealed indications of historical use on the LATCH system components; however, no discernable crash-related evidence was identified. The LATCH belt was creased and conformed to the shape of the forward-facing belt path from use. The driver reported that CRS was purchased new 3 year prior to the crash. Further, she indicated that she was familiar with CRS safety checkpoints and had visited one to learn about CRS installation. At the time of the crash, the CRS had been installed by LATCH for approximately 3 months without adjustments. The 5-point harness was adjusted to a “snug - one finger tightness” on the child with the chest retainer clip at the armpit level. The top tether measured 84 cm (33 in) in length and was found adjusted to its fully extended position. Based upon the age and weight of the 3-year-old female the CRS was an appropriate selection for use.

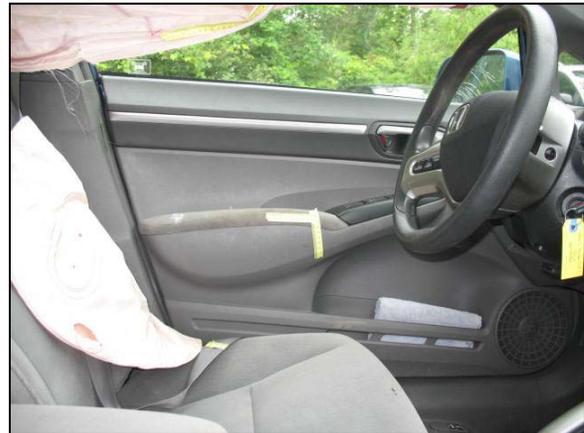
During maximum engagement, the left side of the driver’s torso contacted the left/front door panel armrest (**Figure 10**) which resulted in a fracture of the eighth and ninth rib bones located on the left side of the thoracic cage. Corresponding scuff marks were identified on the driver door armrest. The driver’s right knee contacted the knee bolster, which bent and displaced this vehicle component without producing injury to the driver. After maximum engagement the driver rebounded into his seatback where he received a 10 cm (4 in) diameter contusion to the dermis covering his left scapula. No discernable contact points were identified to the front aspect of the driver seatback as a result of this driver reported injury. The driver came to final rest within his original seating position.

**Figure 10: Right interior view of the contact evidence to Honda’s armrest.**
