CALSPAN ON-SITE CHILD RESTRAINT SYSTEM CRASH INVESTIGATION

SCI CASE NO: CA09054

VEHICLE: 2002 GMC ENVOY

CRASH DATE: AUGUST 2009

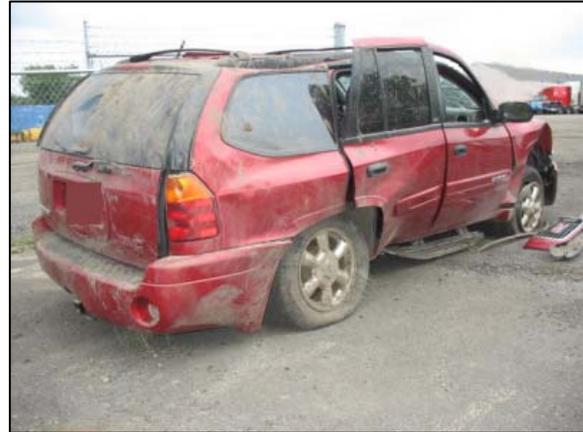
Figure 1: Right side view of the 2002 GMC Envoy.

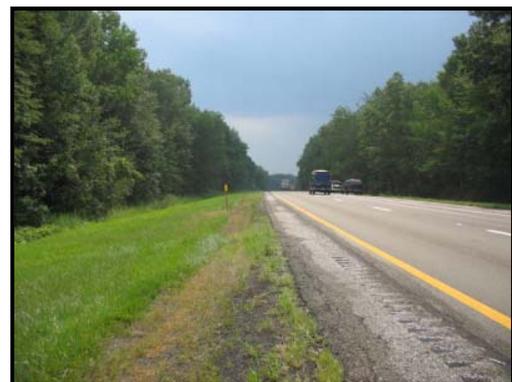
Figure 2: Westbound trajectory view of the GMC.

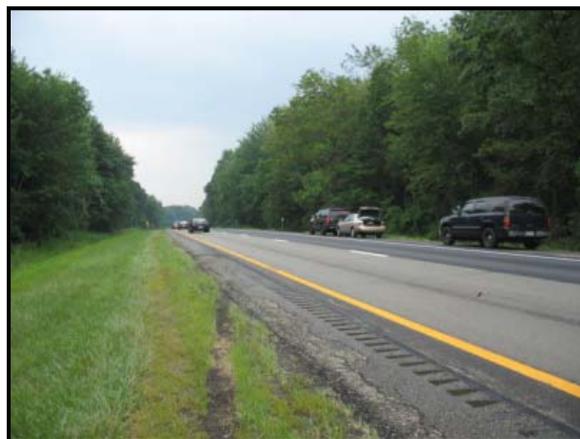
Physical evidence that was related to the trajectory and rollover crash of the GMC was identified during the SCI scene inspection. On the south road side, a rotating tire mark was observed departing the road shoulder. This mark was attributed to the left front tire and was oriented approximately 5 degrees left of the direction of the travel lane. It measured 25 m (82 ft) in length and travelled past a delineator post located 1.9 m (6.2 ft) south of the pavement edge. A scuff mark was noted to the delineator from an impact with the GMC's left mirror. Immediately west of the delineator, the tire mark began to arc back to the right. The tracking rotating tire mark transitioned into a yaw mark with the left rear tire off-tracking outside of the left front tire. Two yaw marks were observed reentering the westbound lanes, **Figure 3**. The left rear yaw mark measured 50 m (164 ft) in length. These marks resulted from an aggressive right steering input by the driver.

Figure 3: View of the GMC's left rear yaw mark.

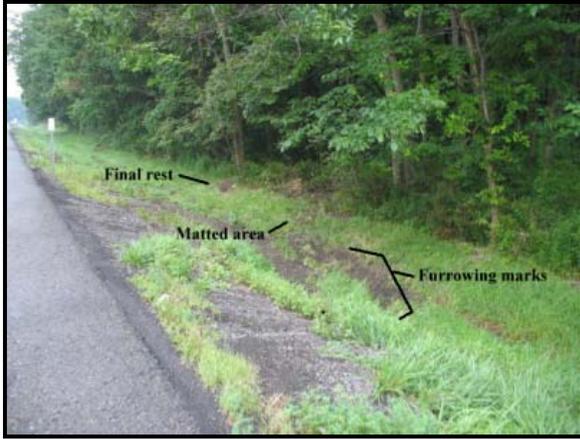
On the north side of the interstate, furrowing tire marks were observed in the sloped road side beyond the departure point. Refer to **Figure 4**. These marks were indicative of a tripped rollover event. At the base of the slope, a matted area in the terrain was observed. This area was related to the touchdown of the vehicle's roof during the second-quarter turn of the rollover. Three trees within the tree line sustained impact damage (**Figure 5**) and interrupted the rollover of the vehicle. A 10 cm (4 in) diameter tree was fractured approximately 1.5 m (5 ft) above the ground. A 38 cm (15 in) diameter tree was impacted by the left rear axle and was subsequently cut down post-crash. Impact damage was noted to a 10 cm (4 in) diameter tree adjacent to the final rest location of the vehicle. These trees stopped the GMC from entering the tree line, altered its rotation and redirected the vehicle back to the west.

Figure 4: View from the road departure along the trajectory path of the GMC.

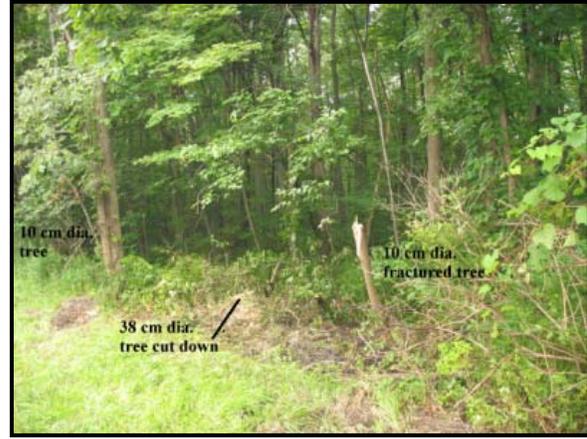
Figure 5: View of the tree impacts.

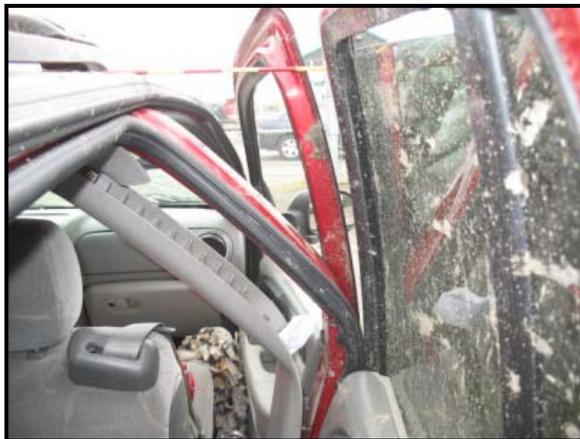
The left, top and right side planes of the GMC sustained impact damage consistent with the four-quarter turn rollover and impacts into the tree line. The GMC's left mirror was fractured (Event 1) and fragments were observed adjacent to the delineator post during the police investigation. As a consequence of the rollover (Event 2), the roof impacted the ground and buckled the B-pillars inboard. The roof deformed downward. The roof deformation created a gap at the top junction between the door frames and the roof side rail. The gap at the top of the front left door measured 11 cm (4.5 in). The gap at the top of the front right door measured 18 cm (7 in). The gap at the left and right rear doors measured 23 cm (9 in) and 27 cm (10.5 in), respectively. The maximum vertical deformation was located at the right B-pillar location and measured 13 cm (5 in), **Figure 7**.

Figure 7: View of the maximum deformation at the right B-pillar location.

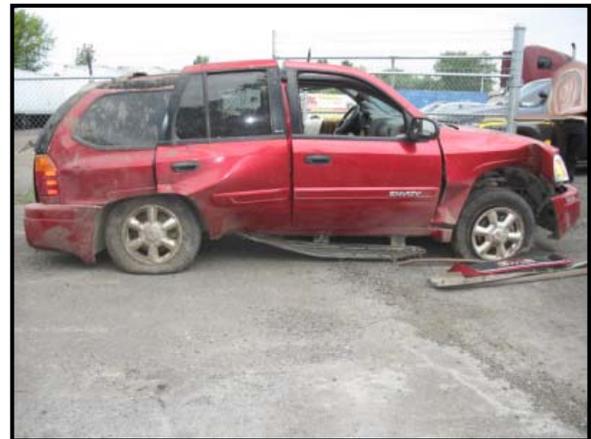
Figure 8: Overall view of the damaged right plane.

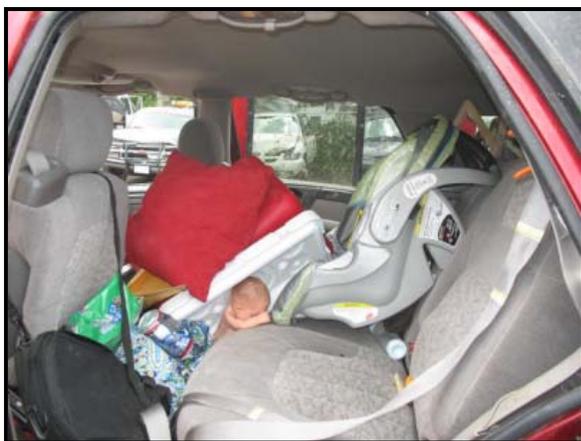
A possible occupant contact from the driver's lower extremities was noted to the knee bolster. This contact consisted of a scuff mark located 11 to 23 cm (4.5 to 9 in) left of the knee bolster centerline and 1 to 5 cm (0.5 to 2 in) below the top aspect. A second possible contact point was noted to the map light located inboard of the left side rail over the front left seating position. This component was slightly displaced within its housing from contact with the driver's head. There were multiple small areas throughout the interior that were soiled from displaced food items possibly masking any additional contact points. No occupant contacts were noted from the rear seat passengers. **Figure 9** is an overall view of the second row.

Figure 9: Overall view of the second row after removal of the left CRS (displaced cooler, lid and right CRS on the seat cushion).

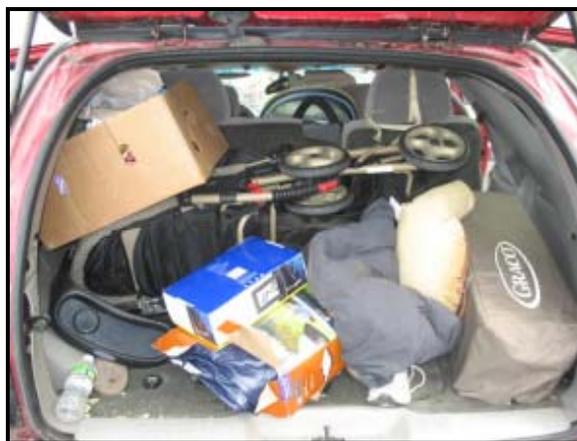
Figure 10: Cargo area contents.

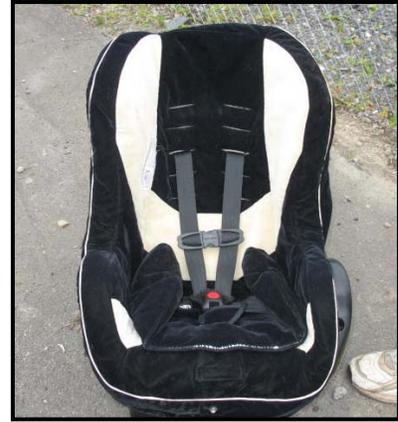
The 2-year-old female was restrained within the 5-point harness system of a Recaro Como CRS (**Figure 11**). The seat's date of manufacture was 10/19/2007 and was identified by the Model No. 331-01-MM14. The CRS was a convertible seat designed for a child weighing 2 to 32 kg (5 to 70 lb) and could be used in two modes. In the rear facing mode, the seat was designed for an infant weighing 2 kg to 16 kg (5 lb to 35 lb). In the forward-facing mode, the CRS was designed to be used by a child with weight of 9 kg to 32 kg (20 lb to 70 lb). The seat could be used by children up to 127 cm (50 in) in height. The CRS had an adjustable base. It was adjusted to a slightly reclined position. When placed on the vehicle's seat, the angle of the CRS shell measured 40 degrees aft of vertical. The instructions indicated the base should be in the fully upright position when used in the forward-facing mode. The CRS was designed with the Lower Anchors for Tethers and Children (LATCH) system. The LATCH system was not in use. The 5-point harness straps were in the middle slot of a five slot adjustment. The harness retainer clip and two-piece buckle were operational. There was no impact damage or stress marks to the CRS.

Figure 11: Recaro Como CRS.

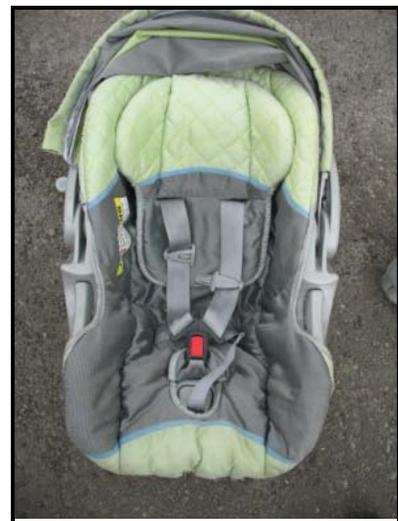
The 2-month-old male was positioned in a rear-facing manner within a Baby Trend Flex Loc (**Figure 12**) infant CRS in the second row right position. The seat was identified by the Model No. 6381. The date of manufacture was 04/11/2007. The CRS was designed with a detachable base and was rated for use by an infant weighing 2 to 10 kg (5 to 22 lb) with a height less than 72 cm (28.5 in). The CRS was an appropriate choice for use considering the age and 5 kg (12 lb) weight of the 2-month old male.

Figure 12: Baby Trend Flex Loc CRS.

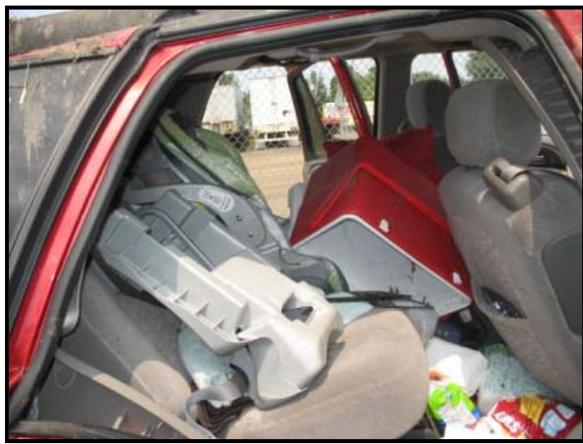
Figure 13 is a right interior view depicting the post-crash position the CRS and the base. At the time of the SCI inspection, the CRS was detached from the base and resting in

the center of the GMC's second row. The empty cooler was on top of the carrier. The CRS base was still restrained by the vehicle's safety belt; however, the base had rotated 90 degrees about the belt and was upside down resting against the seat back.

Figure 13: Post-impact position of the rear facing CRS and the second row interior.

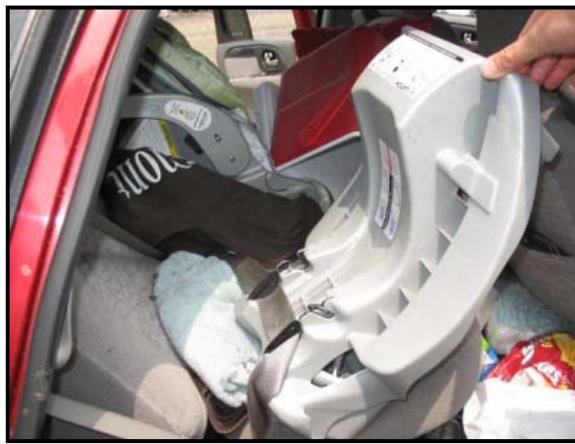
The base was restrained in a rear-facing manner with the belt webbing across the belt path and routed under the two metallic belt guides, **Figure 14**. Two rolled-up towels were located under base at the vehicle seat bight. It appeared that these towels were used during the installation to adjust the recline angle of the CRS.

Figure 14: View of the CRS base and vehicle safety belt.

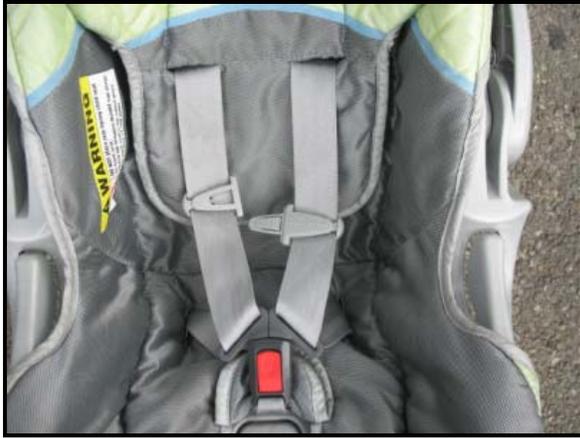
The CRS had a 5-point harness system. The harness was adjusted to the top slots of a three slot adjustment. The harness retainer clip and three-piece buckle operated properly. The left harness retainer clip was located 15 cm (6 in) below the top slot. The right clip was located 17 cm (6.8 in) below top slot, **Figure 15**. The clips were misaligned relative to the slots. The latch plates were each located 15 (6 in) above the shell when buckled into the center buckle. There was no loading evidence to the harness straps. Based on the child's reported post-crash location, it was determined that he was unrestrained at the time of the crash.

Figure 15: View of the CRS harness.

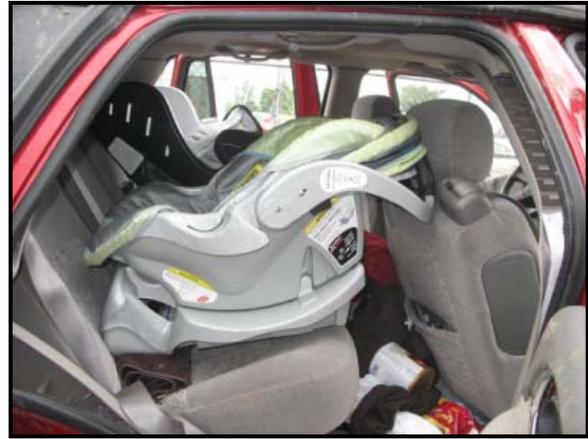
Figure 16 is a right view of the CRS repositioned in the second row right position for reference. The base was positioned on the towels and CRS snugly wedged between the seat bight and the front right seat back. The carrier handle was in contact with the front right seat back. An imprint of the carrier handle was noted to the upper aspect of the front seat.

Figure 16: Right view of the repositioned CRS.

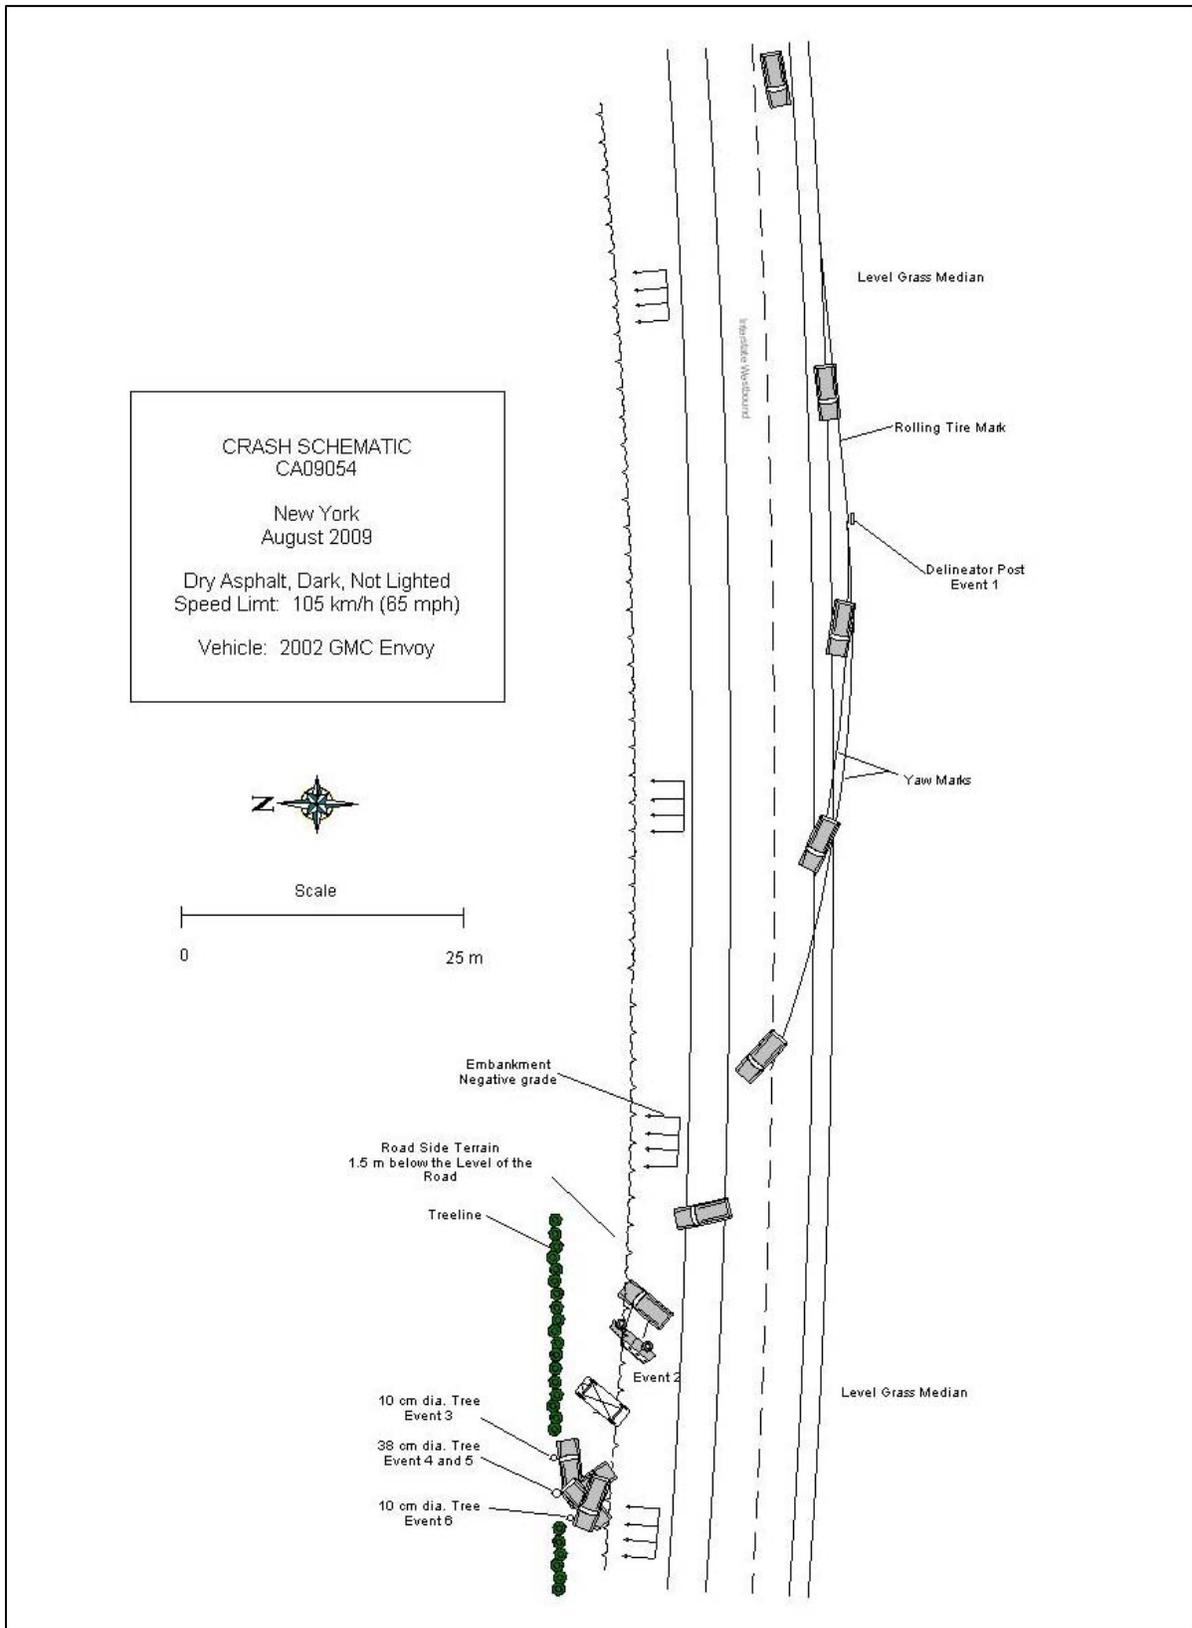
Figure 17: Crash schematic.
