CALSPAN ON-SITE CHILD RESTRAINT SYSTEM CRASH INVESTIGATION

SCI CASE NO.: CA09058

VEHICLE: 2007 NISSAN VERSA

CRASH DATE: MAY 2009

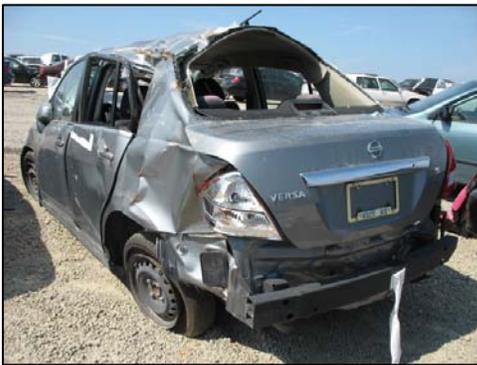
The exterior of the Nissan sustained moderate severity damage to the left, top and right planes as a result of the rollover event. The scratches on the roof were oriented in multiple directions as the vehicle had rolled onto the roof at least twice during the event. The direct contact damage to the roof extended 108 cm (42.5 in) laterally from roof side rail to roof side rail and 332 cm (130.7 in) longitudinally from the leading edge of the hood to the backlight header. The maximum vertical and lateral crush was at the same location, on the left roof side rail 59 cm (23.2 in) aft of the B-pillar. The maximum vertical crush measured 10 cm (3.9 in), and the maximum lateral crush measured 13 cm (5.1 in). The windshield glazing was completely fractured with a laminate tear that extended from the left A-pillar to the right A-pillar approximately one-third of the distance from the top of the windshield. The left rear door window and quarter glazing, the backlight and the right front door windows all disintegrated during the rollover. The left front, right rear and right rear quarter glass was not damaged during the crash. All four doors remained closed during the crash and were operational post-crash. **Figures 3 and 4** depict the rollover damage sustained by the Nissan. The CDC assigned for the rollover was 00TDDO3.

Figure 3: Rollover damage to the Nissan from the left rear.

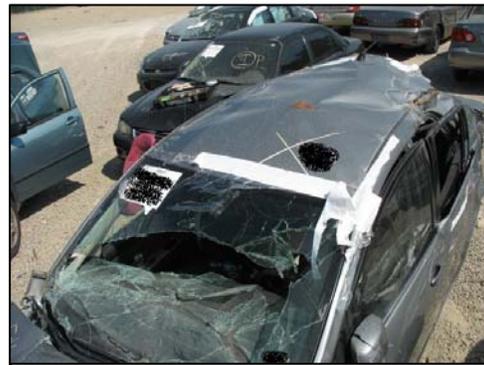
Figure 4: Overhead view of the rollover damage.

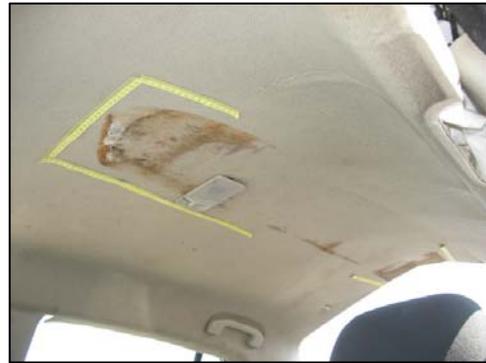
The Nissan sustained moderate severity interior damage that was attributed to passenger compartment intrusion, occupant/CRS contact, and air bag deployment. The front right seatback and head restraint were deformed forward by contact with the unrestrained second row left CRS. This contact also resulted in three horizontal scuff marks to the cloth fabric on the rear aspect of the head restraint. All three marks were 6 cm (2.4 in) in width and were located 7, 10 and 14 cm (2.8, 3.9 and 5.5 in) below the top of the right head restraint. The front right seatback was displaced forward and there was a Z-shaped scuff mark in the cloth on the rear aspect of the seatback. This scuff mark was located 26-45 cm (10.2-17.7 in) below the top of the seatback and 10-28 cm (3.9-11 in) right of the left edge of the seat. The roof was abraded with a plastic and cloth transfer that was 113 cm (44.5 in) in length and 22 cm (8.7 in) in width, attributed to contact with the second row left CRS (**Figure 5**).

Figure 5: Roof contact to the Nissan.

This contact began at the backlight header and extended 113 cm (44.5 in) forward. It extended 55 cm (21.7 in) left of the right roof side rail and ended at the backlight header, 62 cm (24.4 in) left of the right roof side rail. The headliner was also torn at the front edge of this contact. There was a scuff mark on the second row center seat back attributed to the movement of the second row right CRS as it reached the end of the slack in the belt system. This scuff mark was located 58-80 cm (22.8-31.5 in) left of the right edge of the seatback and 36-56 cm (14.2-22 in) above the bight of the seat.

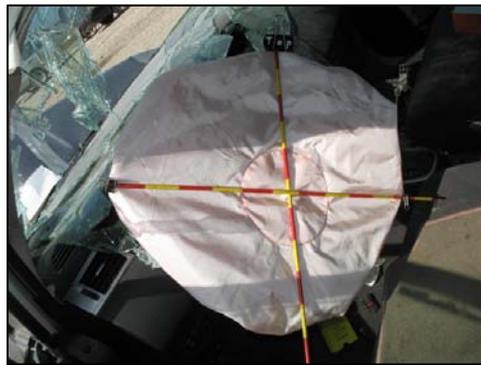
Figure 6: Driver's frontal air bag.

There were no occupant contact on the air bag; however, the left side of the face of the air bag included a plastic deployment transfer. The front right air bag was mounted within the top aspect of the right instrument panel. The front right seat was not occupied during the crash; therefore the CAC system suppressed the deployment of the air bag.

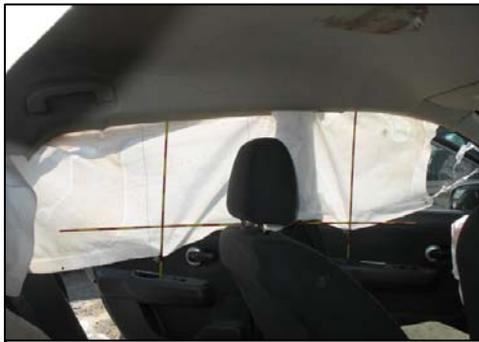
The IC air bags deployed from their respective roof side rails. The IC air bags measured 172 cm (67.7 in) in length. At the front and second row seating positions, the IC's were 42 cm (16.5 in) in height. The air bag was tethered to the A-pillar by a 35 cm (13.8 in) long strap. The IC's provided complete longitudinal coverage across the rear side glazing, and coverage across the front side glazing with the exception of a void at the front of the curtain at the A-pillar area. This void measured 39 cm (15.4 in) in width, 36 cm (14.2 in) in height at the rear and 16 cm (6.3 in) in height at the A-pillar. Vertically, the IC's extended 5 cm (2 in) below the beltline at each outboard seating position. The inboard side of the left IC contained a makeup transfer attributed to the left side of the driver's face. This transfer was located 7-17 cm (2.8-6.7 in) above the bottom of the IC and 61-69 cm (24-27.2 in) aft of the front edge of the IC. **Figures 7 and 8** depict the side air bags. Both IC's were labeled with the nomenclature:

Figure 7: Left inflatable curtain air bag.

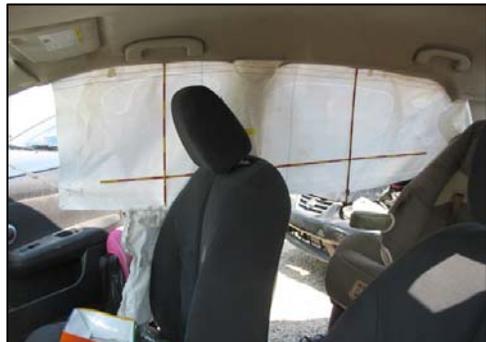
Figure 8: Right inflatable curtain air bag.

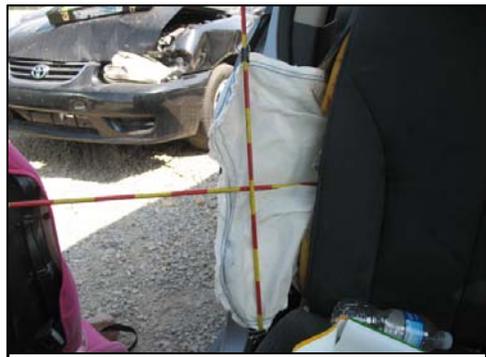
The right side impact air bag deployed from a 28 cm (11 in) panel in the upper outboard aspect of the right seatback. The air bag measured 11 cm (4.3 in) in width and 29 cm (11.4 in) in height. The air bag was not vented or tethered. There was no damage to the air bag and no occupant contact evidence on the air bag. **Figure 9** depicts the front right side air bag.

Figure 9: Right side impact air bag.

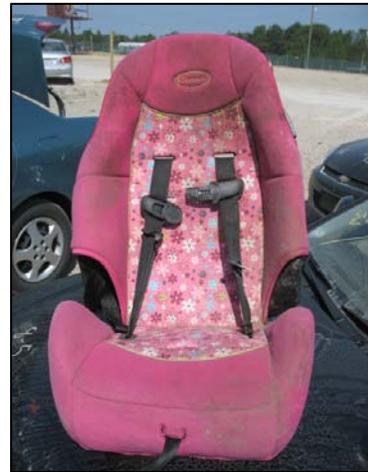
Figure 10: Second row left CRS.

The second row left CRS was fully ejected from the Nissan during the rollover sequence. The safety belt securing the CRS to the vehicle was not buckled at the on-set of the crash. The driver believes that the child passenger unbuckled the vehicle's safety belt prior to the crash. The driver stated in the interview that she had turned around after hearing her daughter playing with the safety belt prior to departing the roadway to the right. The driver further stated that the child passenger often buckled herself into the CRS. The driver could not recall during the interview if she had buckled the child into the CRS that day, or if the child had secured herself.

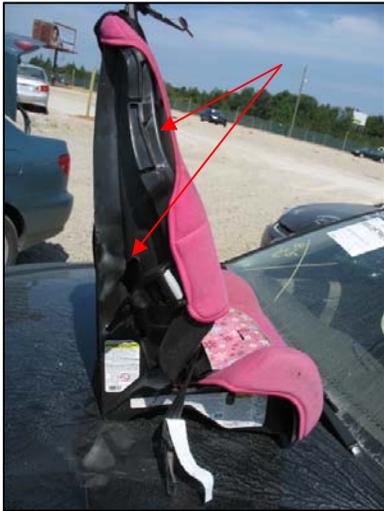
The right side of the shell of the CRS sustained moderate damage, and the left side and back of the seat sustained minor damage in this rollover crash sequence. The right side displayed evidence of color loss due to stress loading that was 30 cm (11.8 in) in height along the right side support. There was a 22 cm (8.7 in) crack in the shell on the lower section that originated at the right side and extended to the attachment point for the crotch strap of the 5-point harness and continued towards the left side of the lower section. The lower attachment of the 5-point harness had detached from the CRS. There was a 10 cm (3.9 in) abrasion on the back aspect of the right side, and further color loss due to stress loading at the right side belt path. There was an 8 cm (3.1 in) abrasion adjacent to the

right side belt positioning clip for the shoulder belt when used as a booster seat. On the rear aspect of the CRS, there was abrasion on the shell at both rail sections and on the right rail, a 4 cm (1.6 in) wide by 14 cm (5.5 in) high section where a thin strip of plastic had separated from the shell. At the right side of the shell, there were two areas of color loss due to stress loading near the opening for the belt path and a 5 cm (2 in) area of stress loading on the upper right aspect neat the shoulder strap positioning clip. **Figures 11 and 12** depict the damage to the CRS used in the second row left seating position.

Figure11: Damage to the right side of CRS.

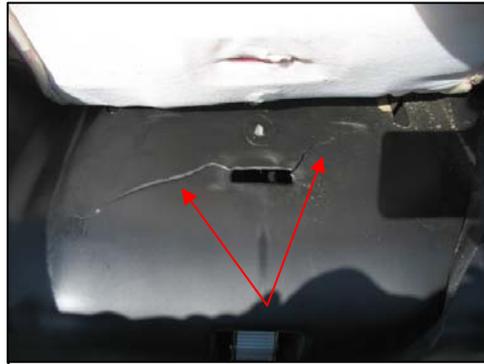
Figure 12: Crack in lower section of shell of the CRS.

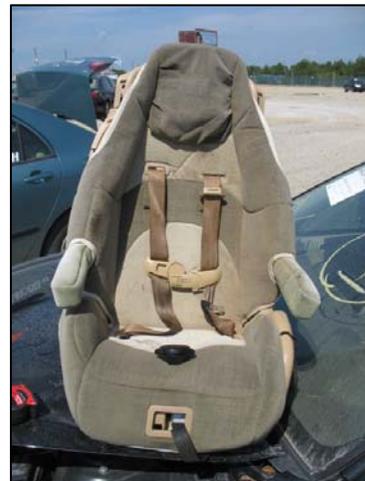
Figure 13: Second row right CRS.

hardware of the CRS. There was no damage to the shell of the CRS in the second row right seating position. The second row right CRS remained in the vehicle during the rollover sequence and the child remained harnessed in the CRS. **Figure 13** depicts the CRS used in the second row right seat.
