**CALSPAN ON-SITE HYBRID VEHICLE CRASH INVESTIGATION
SCI CASE NO.: CA09059**

VEHICLE: 2006 HONDA CIVIC HYBRID

LOCATION: NORTH CAROLINA

CRASH DATE: SEPTEMBER 2009

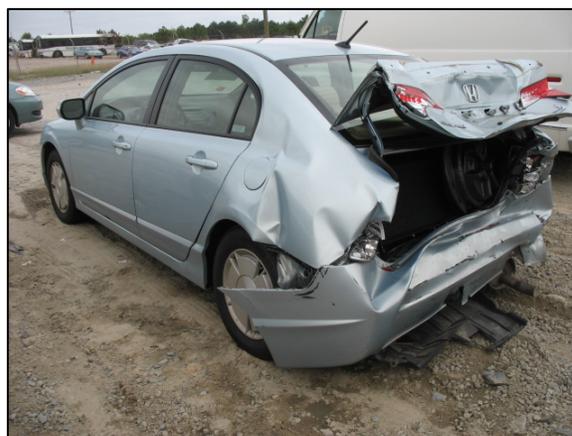
Figure 1: Left rear oblique view of the 2006 Honda Civic.

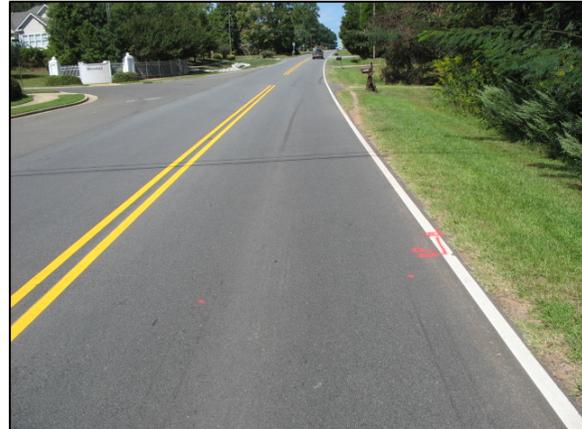
The crash occurred during the daylight hours of September 2009 in the northbound lane of a two-lane undivided roadway (**Figure 2**). The roadway extended in a north/south direction and had a shallow right curve in the area of the crash. The grade transitioned from a downhill grade of -3.2 percent in the pre-crash area to an uphill grade of 1.6 percent near the point of impact. An intersecting two-lane roadway extended west from the area of the crash. The weather conditions at the time of the crash were dry and clear. The traffic lanes were surfaced with asphalt and were 3.3 m (10.6 ft) in width.

Figure 2: Northbound trajectory view of the Honda at the area of the impact.

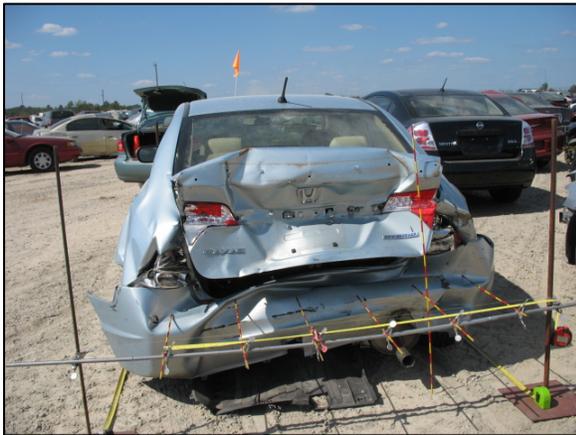
The rear of the Honda Civic sustained moderate-severity damage. The impact involved the rear bumper, trunk, and rear quarter panels of the Honda (**Figure 3**). The combined width of the direct and induced damage (Field L) extended across the entire 140 cm (55.1 in) end width of the vehicle. Longitudinal crush was present to the bumper beam, trunk area, spare tire well, and both rear quarter panels of the Honda. A crush profile measured along the damaged rear bumper was as follows: C1 = 19 cm (7.5 in), C2 = 25 cm (9.4 in), C3 = 34 cm (13.4 in), C4 = 33 cm (13 in), C5 = 30 cm (11.8 in), C6 = 33 cm (13 in). The maximum crush was located at C3; 13 cm (5.1 in) left of the centerline of the vehicle and measured 34 cm (13.4 in). The residual longitudinal distance from the deformed bumper to the hybrid battery was 54 cm (21.3 in) at the C3 location. This distance is depicted in **Figure 4**. The crash-related damage to the back of the Honda did not extend forward to the location of the hybrid battery. The battery was located forward of the carpeted panel in Figure 4.

Figure 3: Back view of the damaged Honda.

The backlight, all side windows and the windshield were undamaged. The left front and right front doors remained closed during the crash and were operational post-crash. The right rear and left rear doors were jammed shut post-crash. The Collision Deformation Classification (CDC) assigned for this impact was 06BDEW4.

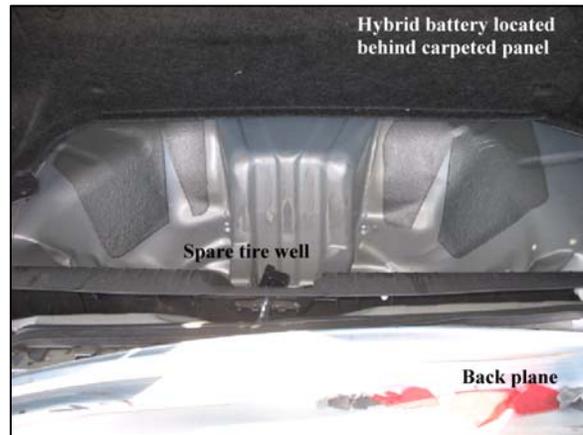
Figure 4: Residual distance between the damaged rear of the trunk and the hybrid battery.

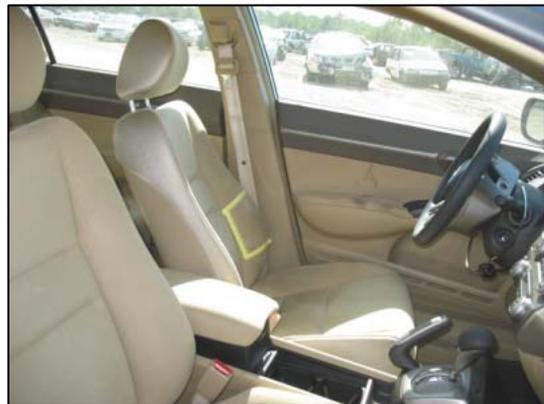
The Honda Civic sustained minor-severity interior damage that was attributed to occupant loading. A scuff mark to the left bolster of the driver seat was identified during the SCI inspection. This scuff mark was located 0-9 cm (0-3.5 in) right of the left edge of the seat back and 35-49 cm (13.8-19.3 in)

Figure 5: Interior view of the driver seat depicting the seat deformation.

below the top of the seat (**Figure 5**). The seat back angle adjustment was jammed. The outboard track of the driver was damaged by the driver loading and allowed the left side of the seat to be displaced rearward 10 cm (3.9 in). This resulted in a 15 degree counterclockwise (CCW) rotation of the driver's seat. This rotation resulted in the 16 cm (6.3 in) intrusion of the left corner of the seat back into the area occupied by the rear left passenger.

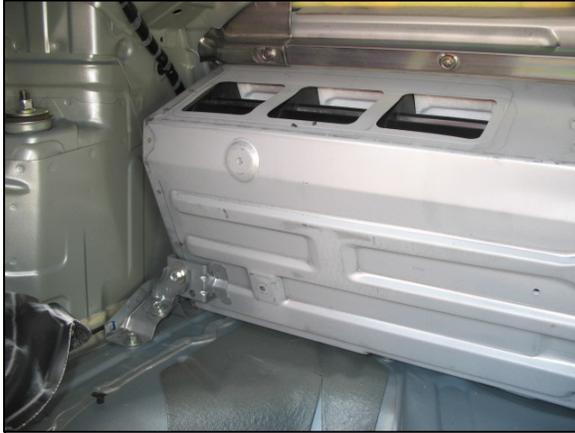
The Honda was visually inspected for compliance with FMVSS No. 305. The rear impact damage did not involve the area of the propulsion battery. The carpet panels at the front of the trunk were removed to expose the hybrid battery and its ventilation system during the SCI inspection. The battery pack was visually inspected for damage and leakage. None was found. No damage was evident to the battery pack itself, the mounting points, or the attachment brackets. The intake and output ducts of the ventilation system were properly aligned. There was no apparent damage to the electrical connectors or wiring. The electrical isolation test was not conducted. **Figures 6 and 7** depict the hybrid battery in the trunk of the Honda.

Figure 6: Left side of the hybrid battery pack and ventilation intake with the duct removed.

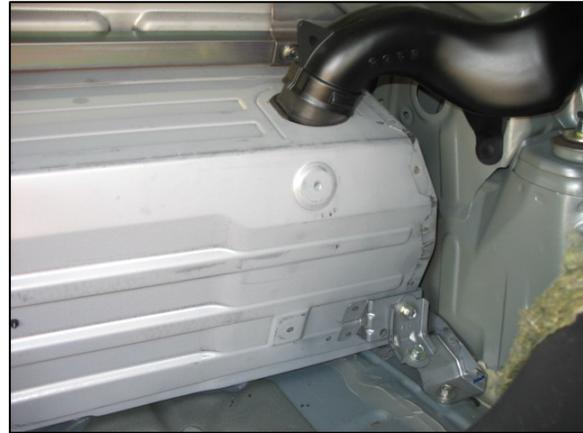
Figure 7: Right half of the hybrid battery pack and the ventilation exhaust.

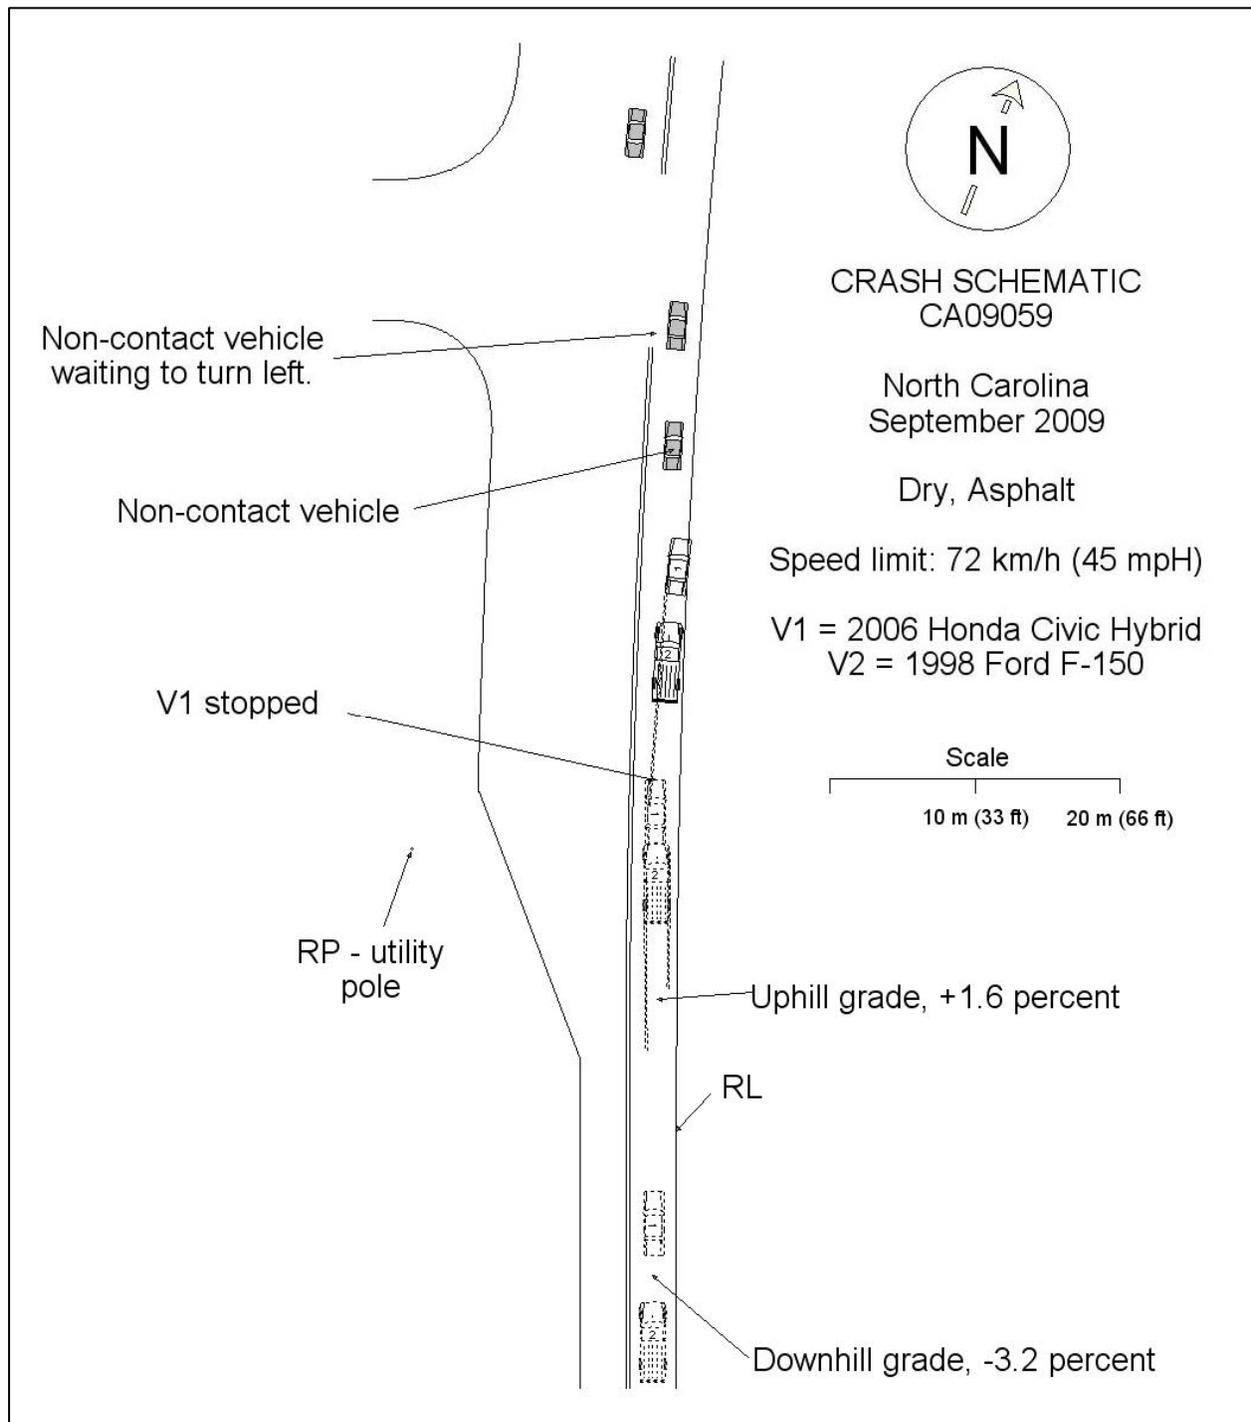
Figure 8: Crash Schematic

The front of the Ford impacted the rear of the Honda in a 12/6 o'clock impact configuration. The Honda was displaced forward 17.1 m (56.1 ft) and slightly to the right. A skid mark that measured 15.7 m (51.5 ft) in length was deposited on the roadway by the left rear wheel of the Honda and denoted its movement. The Honda came to rest partially off the right roadside straddling the east fog line. The Ford continued its northbound trajectory and came to rest on the roadway 15.5 m (50.9 ft) north of the impact.
