CALSPAN REMOTE ROLLOVER CRASH INVESTIGATION

SCI CASE NO.: CA09062

VEHICLE: 2006 FORD EXPLORER

CRASH DATE: JUNE 2006

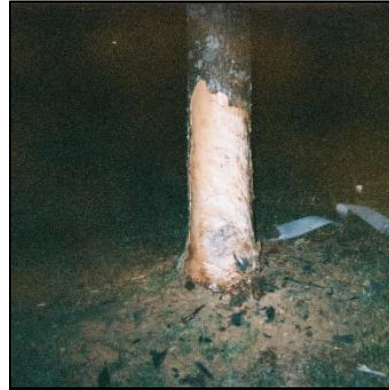
The right aspect of the Ford's front plane impacted the tree. The impact crushed the corner of the bumper and engaged the right side surface of the Ford as the vehicle continued in a northerly direction. The impact force was within the 12 o'clock sector and was outside the scope of the WinSMASH reconstruction program due to the corner engagement. This impact separated the right front wheel from the vehicle, displaced the right A-pillar rearward, and opened the right front door. The Ford initiated a slight clockwise (CW) yaw as it continued in a northerly direction for a distance of 8.7 m (28.5 ft) to impact with a second 38 cm (15 in) diameter tree. This second tree impact involved

the right aspect of the Ford's front plane and accentuated the CW yaw as the Ford separated from the tree with its center of gravity redirected in a northwesterly direction. The video images of the Ford showed severe frontal damage; however, a crush profile could not be estimated from the video due to the poor quality of the tape. The direction of force was estimated at 11 o'clock. Due to the lack of detailed images and overlapping damage from the tree impacts, a delta V was not generated for the second tree impact. **Figure 2** is a view of one of the struck trees at the crash site.

Figure 2. Struck tree at the crash site.

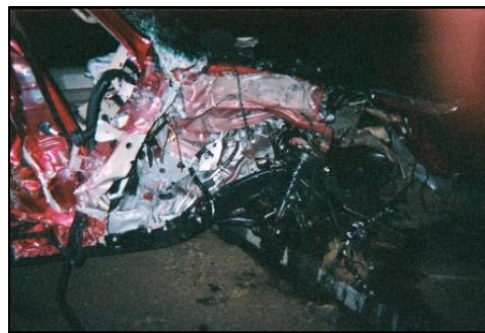
The initial impact with the tree involved the right aspect of the Ford's front plane. The 12 o'clock direction of force impact crushed the front bumper outboard of the frame rail. As the Ford continued forward, the right side area engaged the tree in a continuous impact event. The damage extended to the right C-pillar area of the Ford (**Figure 3**). The impact resulted in separation of the right front fender, the right front tire and wheel from the driveline and suspension, and

Figure 3. Right side view of the initial impact damage to the Ford.

rearward displacement of the right A-pillar. As a result of pillar displacement, the right front door deformed and opened. The right front tire separated from the alloy wheel. The CDC for this impact was estimated at 12-FRAE-9.

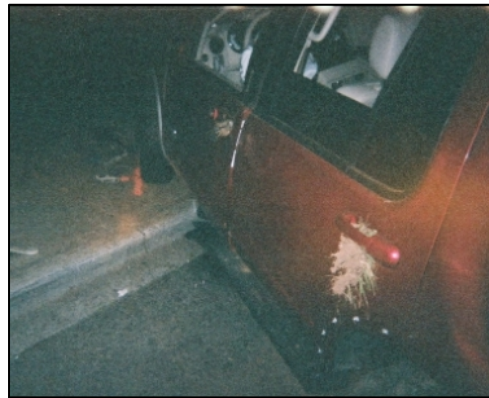
The rollover of the Ford was classified as a tripped event based on the de-beading of the left side tires. The alloy wheels did not appear to be damaged. Dirt and grass debris was embedded into the side surfaces of the vehicle supporting the four-quarter turn rollover (**Figure 4**). The maximum vertical roof crush was estimated at 10-13 cm (4-5 in) located at the right upper A-pillar area. Photographic documentation was not sufficient to establish the extent of lateral roof crush. It should be noted that the majority of the vertical roof crush was caused during the initial right front corner impact with the first tree. The crush/displacement was the result of rearward displacement of the A-pillar, deflecting the roof structure downward. This initial impact also caused the right door to open and partially separate. The driver's door remained closed during the crash. The on-scene images indicated the driver's door glazing was fully open at the time of the crash. The left rear door glazing was 2/3rds open and was not damaged. The left rear door quarter window was intact while the rear quarter window was disintegrated. The backlight remained closed and intact. All right side glazing appeared to have disintegrated during the crash events. The CDC for the rollover was estimated at 00-TDDO-3.

Figure 4. Left side view of the Ford.

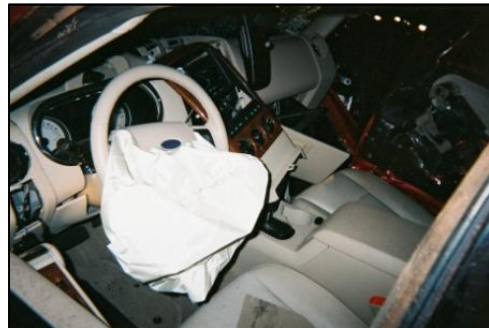
The interior of the Ford Explorer sustained extensive damage that was associated with the frontal impact events. The right A-pillar was displaced rearward. As a result, the right and center instrument panel intruded rearward into the occupant compartment. The rearward displacement separated the upper instrument panel from the mid panel and displaced the driver's knee bolster panel. **Figure 5** is an overall interior view of the Ford.

Figure 5. Interior view of the Ford.

The unrestrained driver's left knee impacted the left mid/lower instrument panel outboard of the bolster. The panel was fractured with separation of a switch panel. The rear view mirror was separated from its windshield mount.

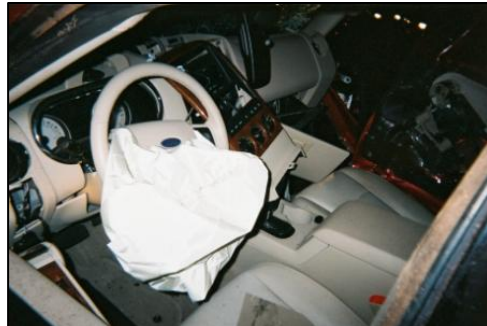
The driver's air bag deployed from the four-spoke steering wheel rim through asymmetrical cover flaps. The air bag appeared to be free of damage and occupant contact.

The frontal impacts with the trees deployed the driver’s CAC frontal air bag. The driver responded to these frontal crash forces by moving forward and to his left as the Ford began to rotate CW. The driver’s left knee impacted the left lower instrument panel. This contact fractured the panel and displaced a switch panel. It is unknown if an injury occurred from this contact point.

Figure 6. Deployed driver’s air bag and the left knee contact to the left instrument panel.
