CALSPAN ON-SITE HYBRID VEHICLE CRASH INVESTIGATION
SCI CASE NO: CA09064

VEHICLE: 2010 TOYOTA PRIUS

LOCATION: PENNSYLVANIA

CRASH DATE: AUGUST, 2009

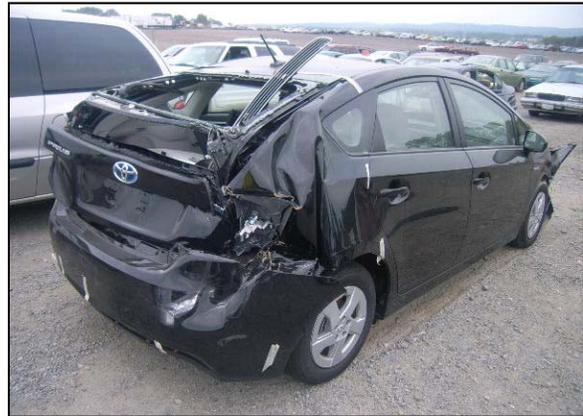
Figure 1: Right rear oblique view of the Toyota. (Image supplied by the insurance salvage facility).

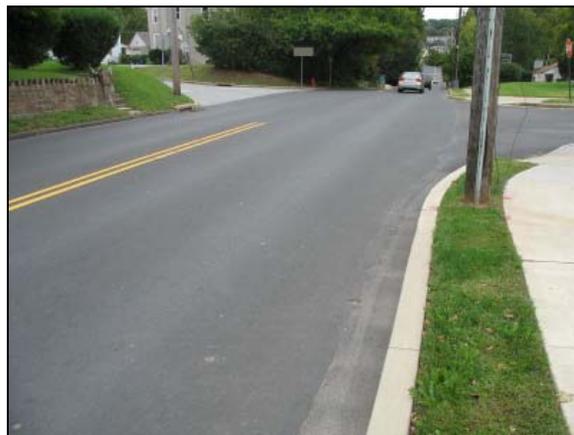
Figure 2: Eastbound view of the intersection.

flow through the area was controlled by stop signs for the north/south traffic. The total width of the east/west road measured 10.3 m (33.8 ft). The traffic lanes were separated by a double-yellow centerline and bordered by 15 cm (6 in) concrete curbs. The posted speed limit was 40 km/h (25 mph). There was no physical evidence of the crash observed at the time of the SCI scene inspection. The points of impact in the multiple event crash and final rest positions of the vehicles were unknown. **Figure 2** is an eastbound view of the intersection.

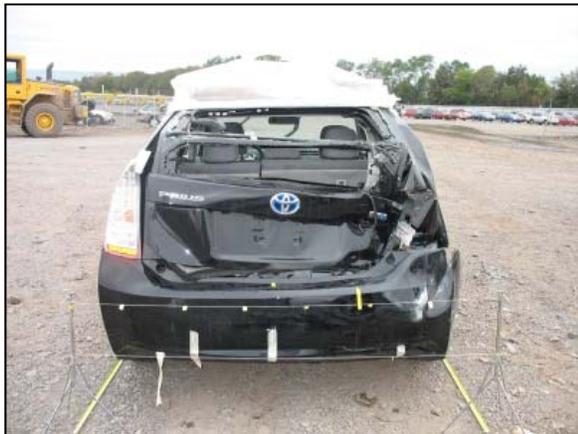
The back and front planes of the Toyota Prius sustained impact damage consistent with the multiple event crash sequence. **Figure 3** is a rear view of the Toyota's back plane damage. **Figure 4** is a right lateral view at the back plane depicting the extent of crush. The direct contact damage began 36 cm (14 in) right of center and extended 43 cm (17 in) to the right rear corner. The combined width of the direct and induced damage extended across the full 157 cm (62 in) end width of the vehicle. Crush profiles were measured along the bumper reinforcement bar and

along rear body structure immediately below the rear hatch opening. The maximum crush at the bumper elevation was located at the right corner (C6) and measured 2 cm (0.8 in). The primary impact damage was above the level of the bumper. The maximum crush at the corner of the right quarterpanel measured 35 cm (13.8 in). An average of the measured crush profiles was used as input data in the WinSMASH model to calculate the severity of the crash. The averaged crush profile was as follows: C1 = 0, C2 = 0, C3 = 1 cm (0.4 in), C4 = 1 cm (0.4 in), C5 = 9 cm (3.5 in), C6 = 19 cm (7.5 in). The backlight glazing was disintegrated. The side glazing was intact. There was no change in the wheelbase dimensions. The Collision Deformation Classification (CDC) was 06-BREW6.

Figure 3: Back view of the Toyota Prius.

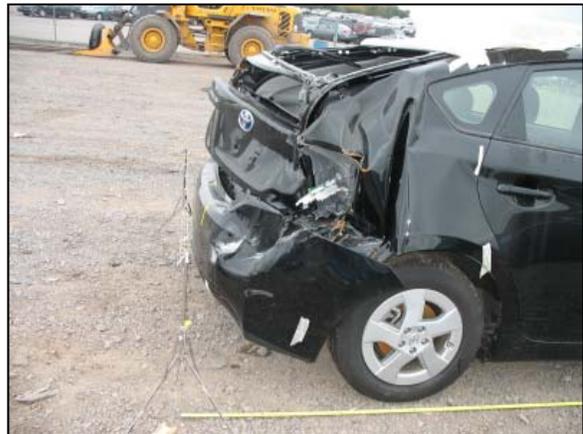
Figure 4: Right view at the back plane depicting the extent of crush.

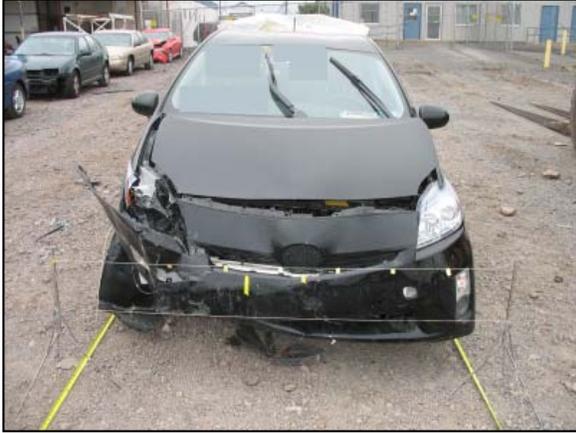
The Toyota sustained minor severity damage as a result of the front impact with the Kia, **Figures 5 and 6**. The direct contact damage began 24 cm (9.5 in) right of center and extended 42 cm (16.5 in) to the right corner. The combined width of the direct and induced damage extended across the entire 142 cm (52 in) front end width. The offset angular impact force deformed the right end of the front bumper reinforcement 5 cm (2 in) to the left. The crush profile documented at the bumper elevation was as follows: C1 = 0, C2 = 0, C3 = 0, C4 = 2 cm (0.8 in), C5 = 3 cm (1.2 in), C6 = 2 cm (0.8 in). The maximum crush was located above the bumper elevation on the upper radiator support, 34 cm (13.2 in) right of center. The maximum crush measured 10 cm (4 in). The windshield was not fractured. All the doors remained closed during the crash and were operational at the time of the SCI inspection. The CDC was 01-FREW1.

Figure 5: View of the frontal damage to the Toyota.

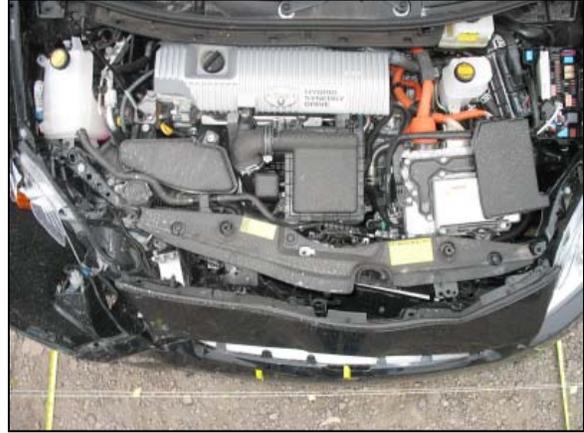
Figure 6: Overhead view of the frontal deformation.

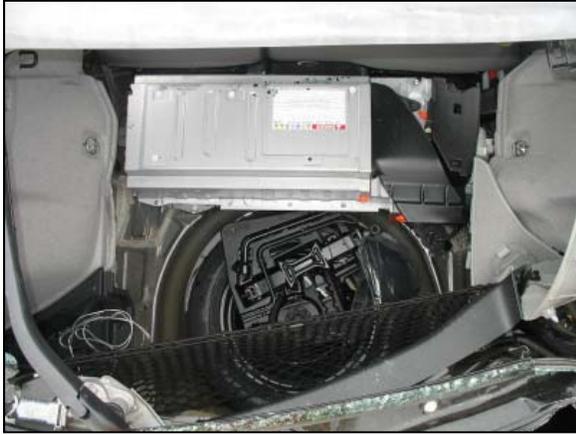
The force of the impact above the level of the Toyota's rear bumper resulted in deformation of the right interior trim panels in the cargo area that initially appeared significant. However, after inspection it was determined that the deformation of these soft structures did not pose a threat to the integrity of the hybrid battery compartment. The right floor area of the cargo area was not significantly buckled or damaged. Only minor structural intrusion was identified at the right rear aspect of the cargo area. **Figure 7** is an overhead view down through the disintegrated backlight of the rear cargo area. **Figure 8** is a left lateral view depicting the minor right floor deformation in relation to the location of the hybrid battery. The distance between the second row seat backs and the back wall of the cargo area was reduced 4 cm (1.5 in) on the right.

Figure 7: Overhead view through the disintegrated backlight of the cargo area and hybrid battery.

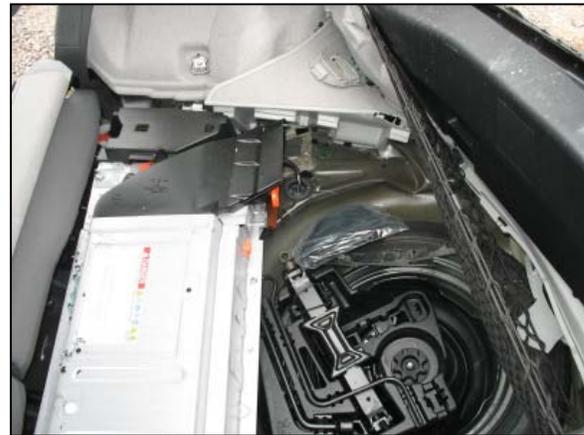
Figure 8: Left lateral view of the right floor deformation aft of the hybrid battery.

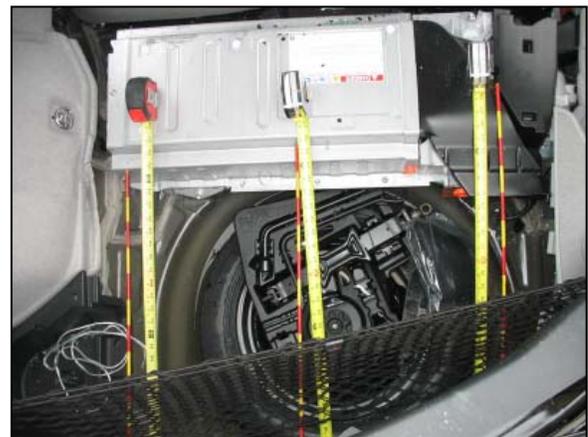
Figure 9 is a view of the hybrid battery and deformed cargo area. Calibrated reference sticks and tape measures were use to quantify the extent of the deformation relative to the battery compartment location. The tape measures depict the intrusion along the structural back wall of the cargo area. The reference sticks depict the 11 cm (4.5 in) extent of the intrusion of the soft trim panels above the level of the back wall (on the rear hatch door).

Figure 9: View depicting the relationship of the hybrid battery to the rear deformation of the

The Toyota was visually inspected for compliance with FMVSS No. 305. The rear impact damage did not involve the area of the propulsion battery. There was no damage of the general area surrounding the battery compartment mounting points, nor was there damage to the battery cover or battery cells. There was no leakage detected during the SCI vehicle inspection. The battery propulsion system components were not displaced or damaged by this impact event. Disassembly of the battery compartment was not allowed by the salvage facility. The electrical isolation test was not conducted. Observations of the inspection indicated the battery propulsion system was in compliance with FMVSS 305.

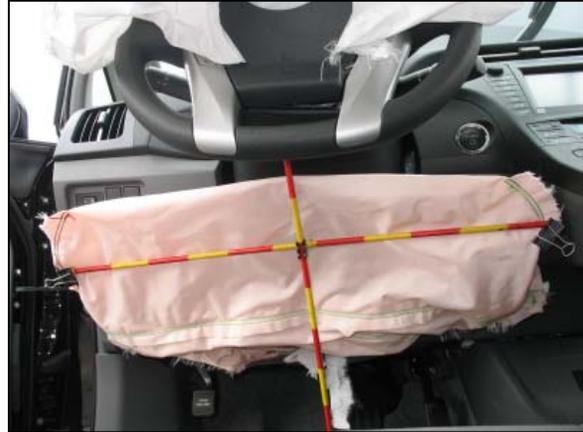
The vehicle was equipped with a knee bolster air bag in the lower left aspect of the instrument panel. The air bag was concealed behind the vinyl bolster panel by two symmetrical cover flaps that measured 24 cm x 4 cm (9.6 in x 1.6 in), width by height. The trapezoidal-shaped knee air bag measured 30 cm (12 in) in height. The width of the bag at the bolster interface was 30 cm (12 in) and expanded to 56 cm (22 in). There was no contact evidence observed on the knee air bag. **Figure 10** is a view of the deployed knee air bag. The seat-mounted side impact air bags and side impact IC air bags did not deploy.

Figure 10: Deployed driver knee air bag.

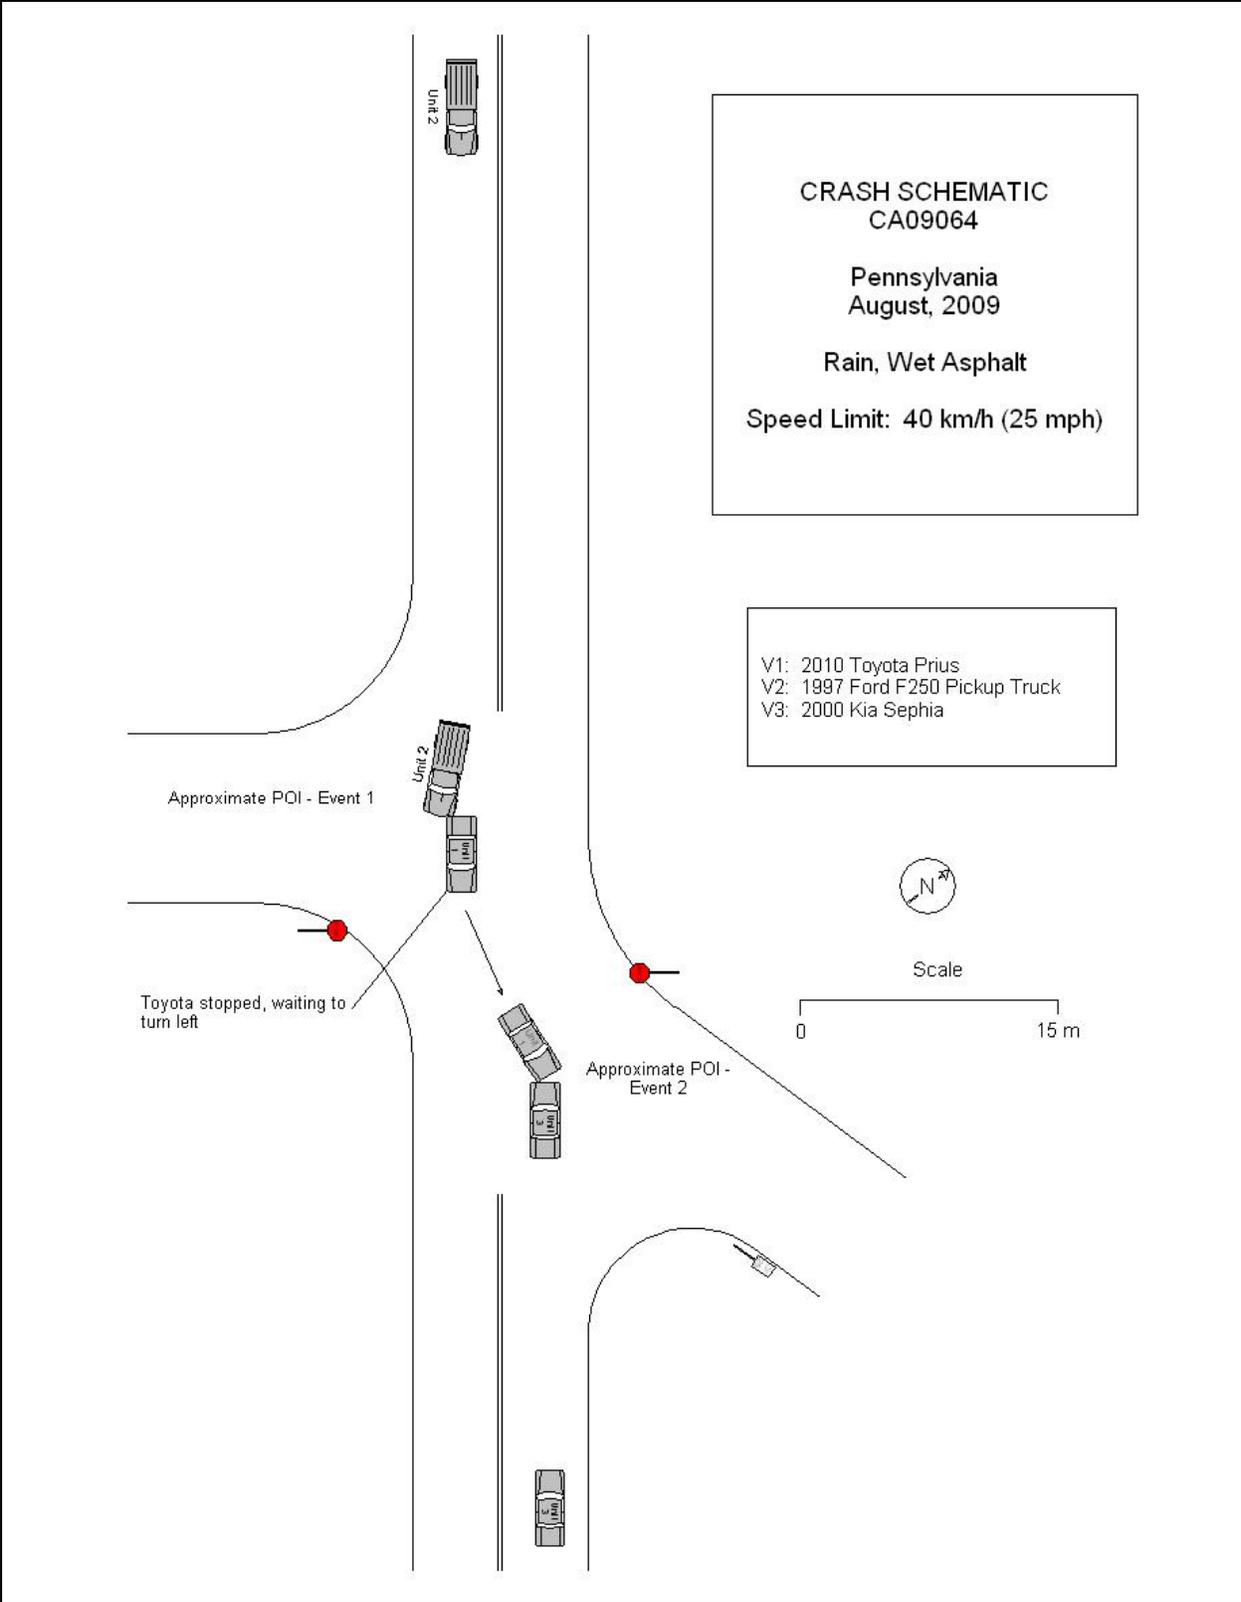
The Toyota Prius was driven by a 54-year-old restrained female. She was returning to her residence located on the north leg of the intersection at the end of the work day. The vehicle was eastbound and had come to a complete stop with the left turn signal on. The driver was waiting for opposing traffic to clear in order to execute a left turn. She indicated that she was stopped for approximately 10 seconds. The Ford F250 was also eastbound driven by a 53-year-old unrestrained male. The driver of the Ford reported that he attempted to brake but could not stop because of the wet pavement. He steered his vehicle to the right in an attempt to avoid the stopped Toyota and pass it on the right. The Kia Sephia was westbound driven by a 24-year-old female. A schematic of the crash is attached to the end of this report as **Figure 11**.

Figure 11: Crash schematic.
