**CALSPAN ON-SITE MOTORCOACH FIRE INVESTIGATION**

**SCI CASE NO.: CA09068**

**VEHICLE: 2007 MCI MODEL D4505 MOTORCOACH**

**LOCATION: MICHIGAN**

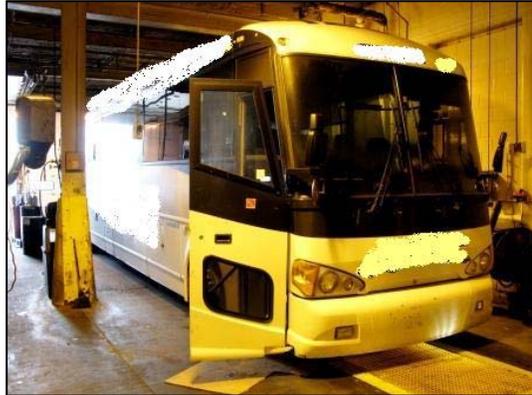
**Figure 1. Front right view of the 2007 MCI motorcoach.**

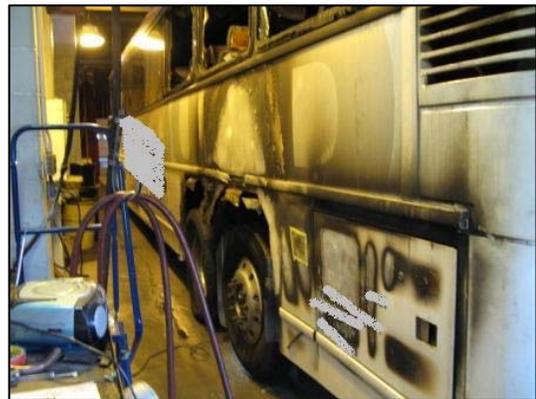
The fire spread through the undercarriage and involved the left rear tires. The tires became a source of fuel for the fire as the fire burned upward onto the left side of the motorcoach. The fiberglass splash shield over the axle positions was consumed by the fire with only the center portion of the shield and the mounting brackets remaining. Smoke staining began on the side body panels forward of the drive axle and extended to the back corner. The paint began to blister 13 cm (5 in) aft of the centerline of the drive axle with complete burning of the painted surfaces extending 79-175 cm (31-69 in) aft of the drive axle and over the tag axle location. The high heat area was directly over the tag axle and resulted in buckling

**Figure 2. Fire damage to the left rear side of the motorcoach.**

of the body panels (**Figure 2**). The aluminum trim at the midline of the body panels was melted over a 33 cm (13 in) area above the tag axle. The high heat burn pattern extended vertically to a point that was 11 cm (4.5 in) below the beltline. The blistering of the paint ended 206 cm (81 in) aft of the drive axle.

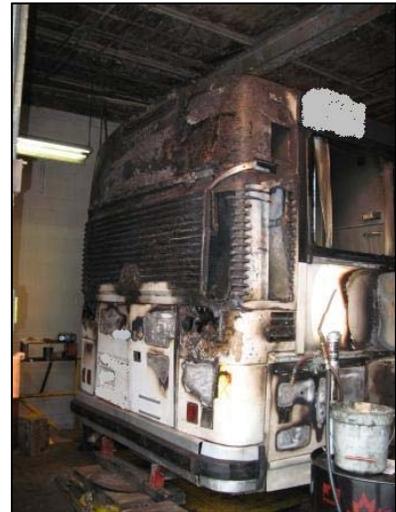
The fire damage to the back plane of the motorcoach extended from the mid-body line, upward to the top of the vehicle (**Figure 3**). The rear bumper was a painted aluminum channel with a wide rub strip. There was no damage to the bumper system or to the taillight/backup light lenses located above the bumper corners. The engine compartment was concealed by two center closing sheet metal surfaced doors. The paint was burned from the mid area of the right door with burning of the paint to the upper center aspects of both doors. The formed corner panels located outboard of the engine compartment doors were burned through at the level of the upper doors. These areas housed the taillight and turn signal assemblies.

**Figure 3. Fire damage to the back of the MCI motorcoach.**

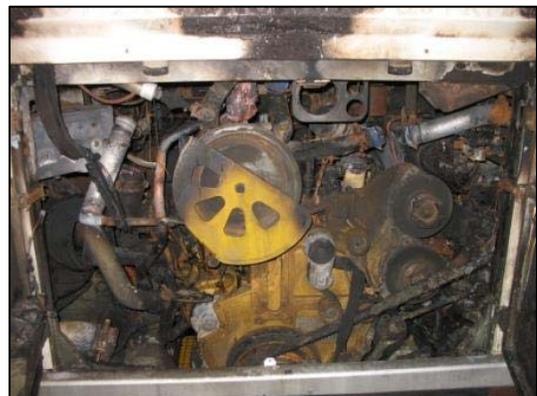
The fire spread rearward into the engine compartment (**Figure 4**) and burned most of the combustible components. The fire evidence was predominately high within the engine compartment, as the paint remained intact on the engine block. There was no evidence of high heat oxidation in the engine compartment.

**Figure 4. Engine compartment of the MCI motorcoach.**

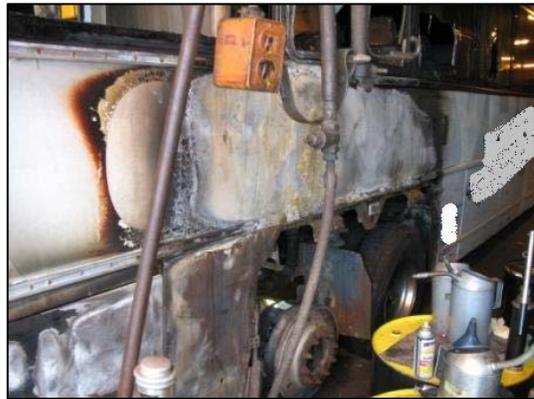
The damage to the right side of the motorcoach began at the forward edge of the drive axle opening and extended to the back right corner (**Figure 5**). The paint was burned from the sheet metal surfaced body panels with distortion of the panels over the drive and tag axle locations. There was melting of the trim over the axle positions and to the trim at the beltline forward of the I-pillar, over the tag axle. The window trim was also melted at his location.

**Figure 5. Right side fire damage over the rear axle areas.**

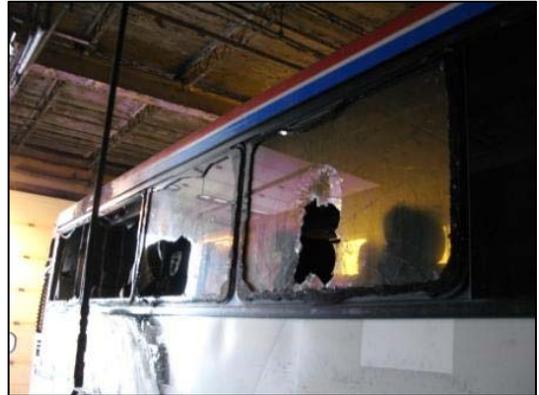
The right side glazing consisted of eight windows in the passenger compartment area. The windows were the same as the left side with two separated glazing panels forming the window units. The four forward windows were intact with smoke staining to the inside surfaces. The firefighters used a pike pole to impact and disintegrate the four rear outer glazing panels (**Figure**

6). The fifth and sixth laminated glazing panels were penetrated and holed with the majority of the glazing remaining in the window frame. The last two right side laminated glazing panels were completely removed from the motorcoach. The perimeter gaskets were burned from the seventh window frame with majority of the gasket remaining in the last right side window frame.

**Figure 6. Firefighter induced damage to the right side glazing panels.**

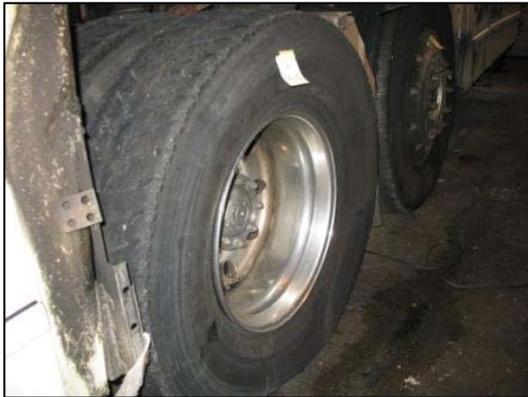
The left outer drive axle tire exhibited minor severity fire damage that involved the tread and the inner and outer sidewalls. The burn pattern was not full thickness to the tire; however, the tire was aired out and de-beaded from the alloy wheel (**Figure 7**). During the tow and transfer process of the motorcoach, the tire rotated on the alloy wheel. The burn pattern, which was at the top of the tire at the time of the fire, was at the 5 o'clock position at the time of the SCI inspection. There was no fire damage, heat transfer, or smoke staining to the alloy wheel.

**Figure 7. Left outer drive axle tire and wheel.**

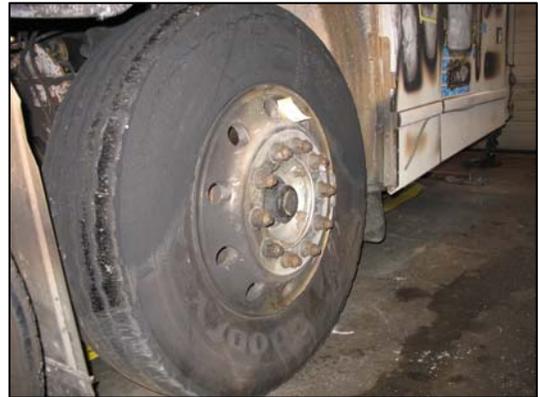
**Figure 8. Fire damage to the left tag axle tire.**

The upper half of the inner sidewall of the left tag axle tire was burned full-thickness with the top area of the tread burned with residual tread depths of 0-3 mm (0-4/32 in). The tire was flat and de-beaded from the alloy wheel. **Figure 8** is the tire damage to the left tag axle tire.

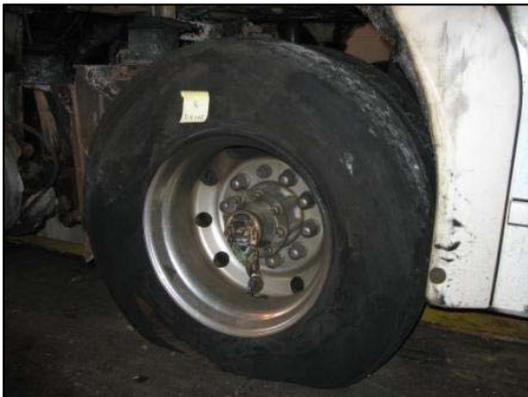
The right inner drive axle tire was burned in a similar pattern to the outer tire. The inboard sidewall was burned full-thickness resulting in air loss. The tire de-beaded from the alloy wheel. The tread block was burned and the tire had rotated on the wheel approximately 180 degrees during the towing process. The alloy wheel was intact with minimal evidence of heat discoloration (**Figure 9**).

**Figure 9. Right outer drive axle tire damage.**

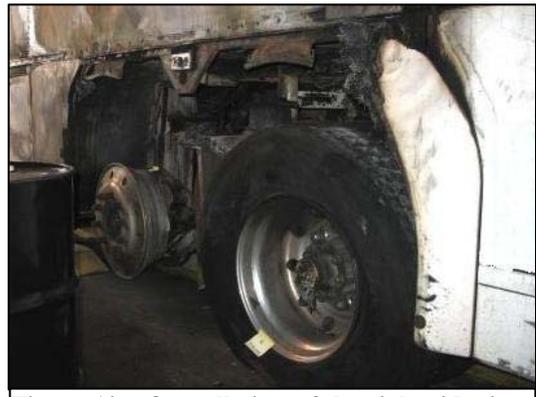
The right tag axle tire was completely consumed by the fire (**Figure 10**). The only remaining tire evidence was the bead wires that were draped around the brake and axle assemblies. The upper inboard aspect of the tag axle alloy wheel was burned and melted by the fire. The outer half of the wheel was intact with high heat discoloration at the 6 o'clock position of the wheel. The steel lug nuts that secured the wheel to the axle were in place and rusted. The decorative lug nut caps were completely burned.

**Figure 10. Overall view of the right side tire and tag axle wheel damage.**

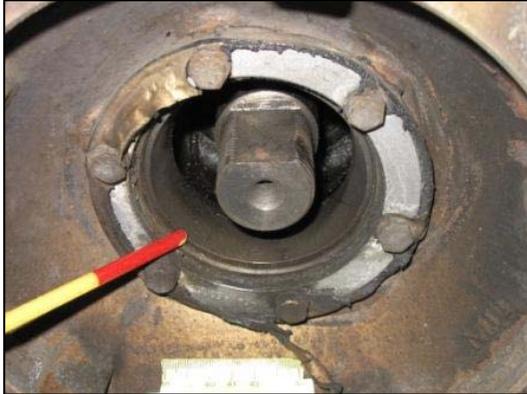
with the appearance of an impact by a hammer-like tool. The outer wheel bearing race was intact within the hub assembly; however, the tapered roller bearings, the oil seal, and the inner race were missing from the assembly. Oil was still present in the hub assembly. The inner wheel bearing also appeared to have separated. The repair facility manager stated to the SCI investigator that this wheel bearing and wheel assembly was not altered or disassembled by the motorcoach company prior to the SCI investigation. **Figures 11 and 12** are views of the right tag axle shaft and the wheel bearing races.

**Figure 11. Right tag axle shaft and the wheel bearing races.**

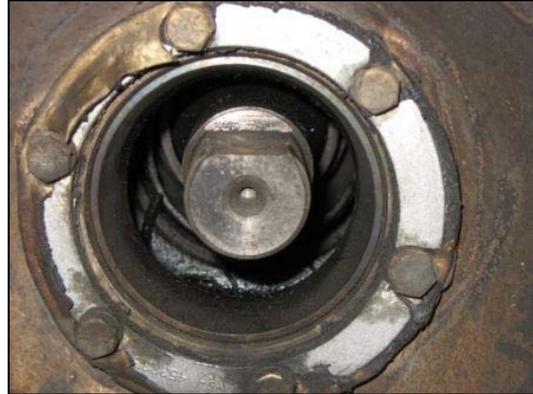
**Figure 12. Close-up view of the wheel bearing races with the seals, tapered roller bearings and inner races missing.**

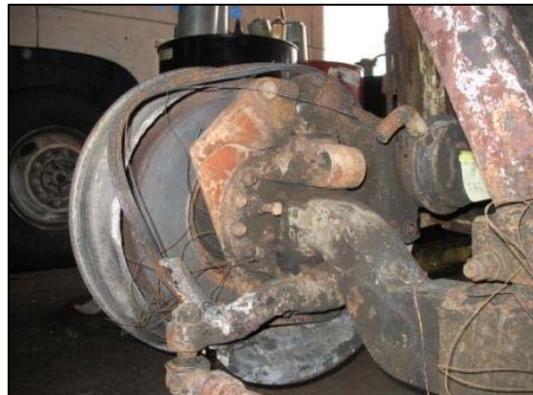
The right tag axle disc brake caliper and rotor were in place at the axle position. Remnants of wheel end grease or wheel end oil were present on the brake caliper and the axle and king pin assembly. The air brake line was completely burned. The bushings to the right trailing arm were charred but intact (**Figure 13**).

**Figure 13. Undercarriage view of the right tag axle brake assembly and the melted alloy wheel.**

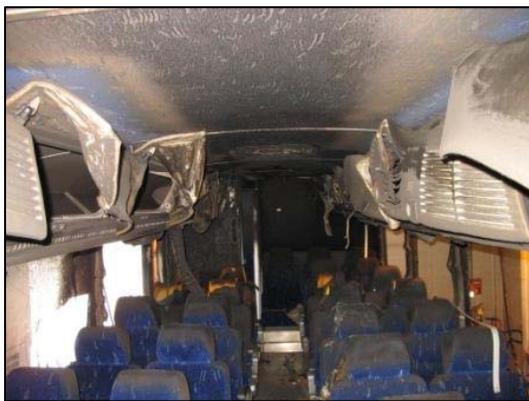
The interior of the motorcoach sustained moderate severity damage. The fire spread to the interior through the side windows over the rear axle locations (**Figure 14**). There was no burn-through of the plywood floor or of the side body panels.

**Figure 14. Rearward view of the fire damage to the interior of the motorcoach.**

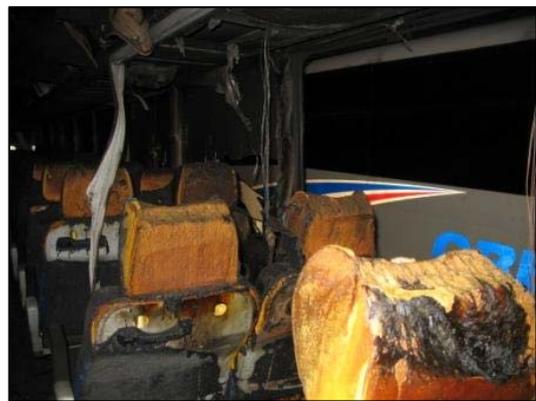
The fire involved the fabric covered seats with heat and smoke damage extending forward to the windshields. The left (14<sup>th</sup> row) three passenger seat had slight heat damage with smoke staining to the upper seat backs and head restraints. The fabric of the posterior aspects of the upper seat backs and the head restraints was burned and melted on left rows 7-13. There was similar, but more severe damage to the right seat backs and head restraints at rows 8-13 (**Figure 15**). The upper aspect of the head restraint foam padding was melted at the rear rows.

**Figure 15. Fire/heat damage to the right row seatbacks.**

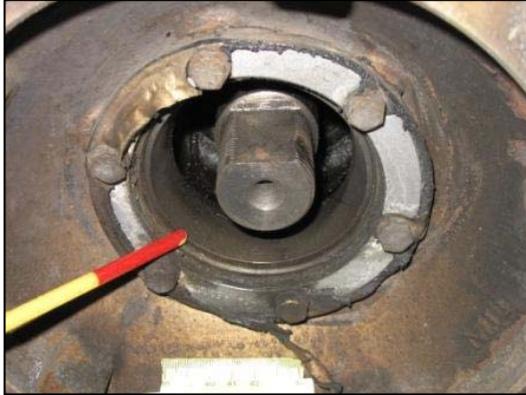
The SCI inspection revealed that the right tag axle wheel bearing adjustment nut and the wheel bearings ran out of position (**Figure 16**) resulting in a misalignment of the rotating wheel end system consisting of the wheel, hub, and brake rotor relative to the axle spindle. As a result, the disc brake rotor, tire and wheel of the motorcoach were misaligned as the vehicle was traveling at highway speeds. The tag axle tire subsequently overheated and self-combusted (**Figure 17**). The fire spread throughout the rear undercarriage of the motorcoach and into the interior causing significant damage to the vehicle. Axle oil was still present in the bearing and hub area of the tag axle. The presence of this oil indicated that the fire originated outboard of the bearing area.

**Figure 16. Damaged wheel bearing of the right tag axle.**

***Determination of Cause:*** In evaluating the right tag axle wheel end, the wheel hubcap and outboard wheel bearing was found missing along with the associated bearing retention hardware. On a disc brake wheel end, when the outer bearing is missing, vehicle loads are transferred to the brake caliper, brake pads, and rotor causing the brake to overheat and cause a tire fire. This fire is consistent with the loss of the outer wheel bearing being the most probable cause for the tire fire. Since no disassembly was conducted, the root cause for the loss of the wheel bearing and the condition of the inner bearing could not be determined.

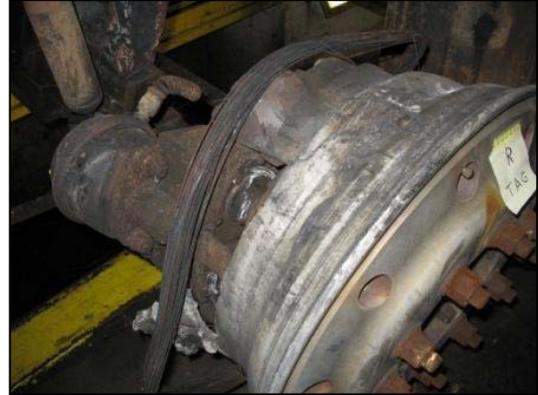
**Figure 17. Fire damage to the right tag axle alloy wheel and the remnants of the tire.**

***Determination of Origin:*** Exterior inspection of the motorcoach shows the majority of damage is located directly above the right side rear axles. From there, the fire propagated to the left side rear axle area and into the interior through the windows directly over the two rear axles. The fire did not progress forward as the luggage compartment was undamaged, but did progress rearwards into the engine compartment. The two drive axle tires exhibited similar amounts of damage and the tag axle tire was completely consumed. Passengers reported hearing a "popping" sound, smelling smoke, and reported this to the driver who also reported seeing smoke from the right rear axle area. This analysis places the area of origin at the right side tag axle wheel end.
