**CALSPAN ON-SITE INFLATABLE CURTAIN AIR BAG
NON-DEPLOYMENT CRASH INVESTIGATION
SCI CASE NO.: CA09071**

VEHICLE: 2009 DODGE JOURNEY

LOCATION: NORTH CAROLINA

CRASH DATE: SEPTEMBER, 2009

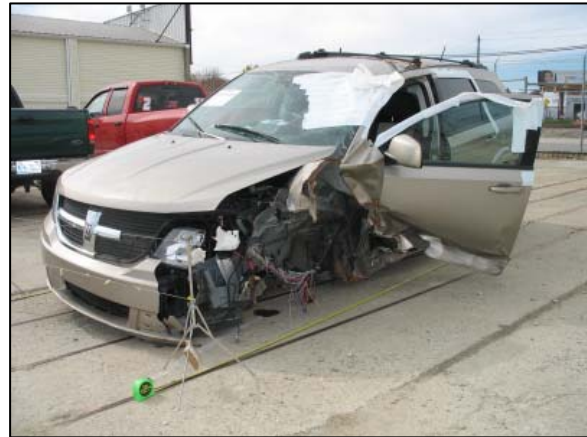
This on-site investigation focused on the non-deployment of the Inflatable Curtain (IC) air bags in a 2009 Dodge Journey. **Figure 1** is a front left oblique view of the vehicle. The Dodge Journey was equipped with front safety belt pretensioners, a Certified Advanced 208-Compliant (CAC) frontal air bag system, front seat-mounted side impact air bags and roll-sensing IC air bags. The Dodge was involved in offset head-on crash with a 1997 Ford Thunderbird. The force of the impact actuated the safety belt pretensioners and deployed the CAC frontal air bags in the Dodge. The frontal air bags in the Ford also deployed. The Dodge subsequently rotated counterclockwise and rolled four-quarter turns to the right, coming to rest on its wheels. The 63-year-old male driver of the Dodge reported that the roll-sensing IC air bags did not deploy during the crash. The driver and the 60-year-old female front right passenger were transported by helicopters to a regional trauma center where they were treated for minor severity injuries and released.

Figure 1: Front left oblique view of the Dodge.

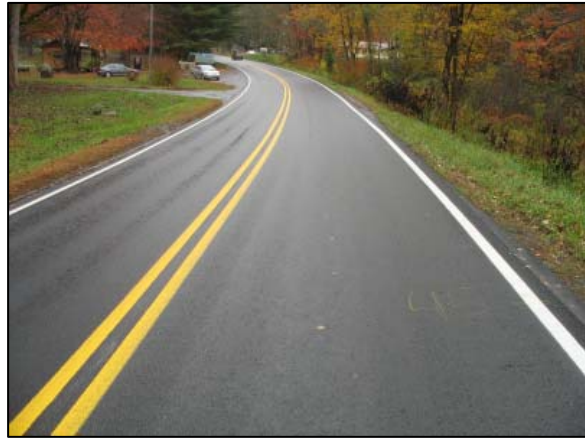
Figure 2: Eastbound trajectory view of the Dodge 45 m from the POI.

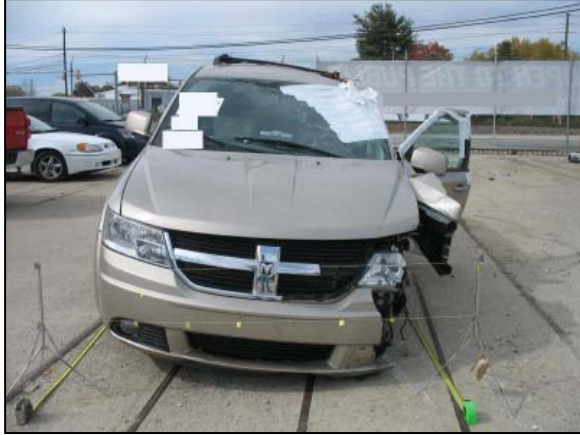
The Dodge Journey sustained moderate severity impact damage to the front, sides and top plane as a result of the multiple event crash sequence. **Figure 3** is a view of the frontal damage to the Dodge Journey. The direct contact damage to the front plane as a result of the initial impact (Event 1) began 55 cm (21.8 in) left of center and extended 21 cm (8.2 in) to the left front corner. The frontal deformation began immediately outboard of the left end of the bumper reinforcement beam. The residual crush was measured along the reinforcement beam and was as follows: C1 = 6.0 cm (2.1 in), C2 = 2.0 cm (0.8 in), C3 = 3.0 cm (1.2 in), C4 = 3.0 cm (1.2 in), C5 = 1.0 cm (0.4 in), C6 = 0. The left frame rail was not damaged. The vehicle engagement continued rearward onto the left fender, fractured and separated the left front wheel assembly, deformed the left front door panel and transitioned to scuffing contact that ended at the rear wheel opening. The vehicle's battery was located in the front left corner of the engine compartment and was completely fractured. A wiring harness from the engine compartment to the interior was visibly damaged during the crash and was exposed. **Figure 4** is a left view of the damage at the left fender. The damaged battery is highlighted in the figure and the wiring harness is visible. The Collision Deformation Classification (CDC) of Event 1 was 12FLEE9.

Figure 3: View of the frontal impact damage.

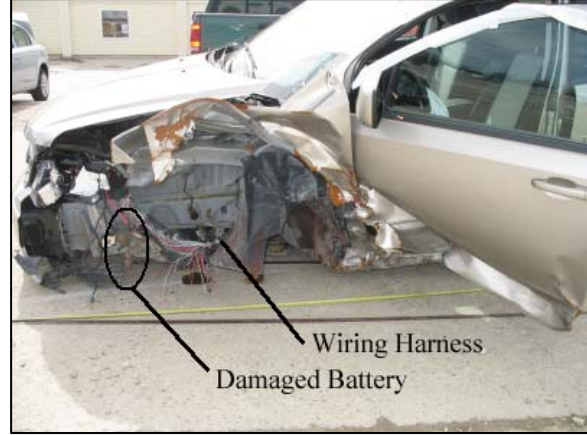
Figure 4: Left side view of the damage at the fender. Note the damaged battery and exposed/damaged wiring harness.

Initially, the EDR imaging was attempted through the Diagnostic Link Connector (DLC). Twelve volt (12-V) external power was applied the vehicle's fuse block located in the engine compartment. However, impact damage to the vehicle's electrical system prevented the power-up of the Dodge. The ORC module was located and removed to facilitate a direct to module imaging. The EDR data was successfully imaged and the ORC was reinstalled. A copy of the imaged data is attached to the end of this narrative report as Attachment A. The following is a summary of some key data elements.

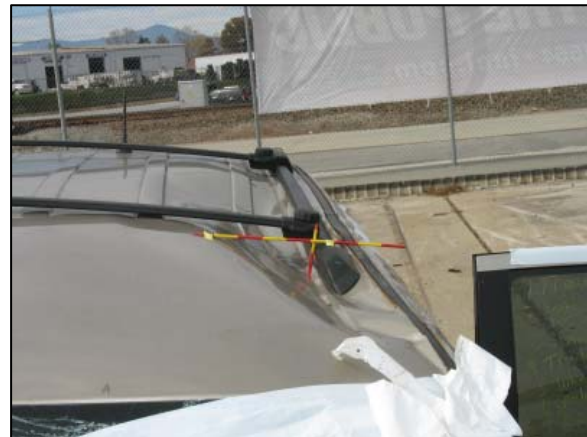
The Dodge rotated CCW after separation from the Ford and the right side wheel rims contacted the pavement. Both rim bead edges were abraded and a section of each rim edge was fractured. The vehicle then rolled over four-quarter turns (Event 2) coming to rest on its wheels. Surface abrasions from the rollover were identified on the right roof side, the roof rack, left roof side rail, the left door window frames and around the left wheel opening. There was no lateral shift of the roof structure. The roof deformed in a 185 cm (73 in) long V-shaped pattern inboard the left roof side rail. The maximum vertical deformation occurred within this pattern and was located in the left roof area adjacent to the B-pillar. The maximum vertical deformation measured 8.0 cm (3.1 in).

Figure 5: View of the deformed roof and the maximum vertical deformation adjacent to the B-pillar.

Figure 5 is a view of the roof deformation. The CDC of the damage was 00TDDO3.

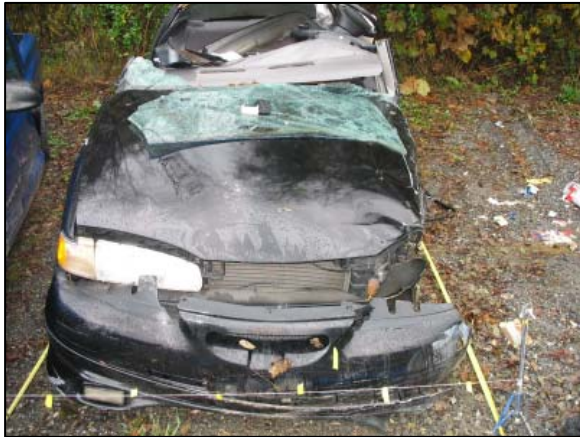
The Ford sustained moderate severity damage as a result of the frontal crash. **Figures 6 and 7** are the front and the left oblique view of the damaged vehicle. The initial direct contact damage began 56.0 cm (22.0 in) left of center and extended 15.0 cm (5.9 in) to the left corner. The offset impact involved the extreme left end of the bumper reinforcement. The bumper fascia and foam

Figure 6: Front view of the Ford.

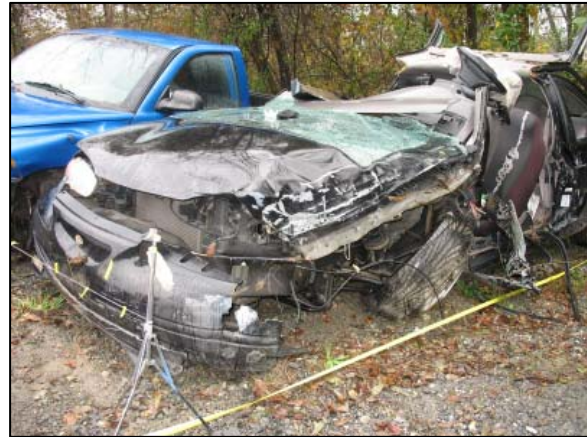
Figure 7: Left front oblique view of the Ford.

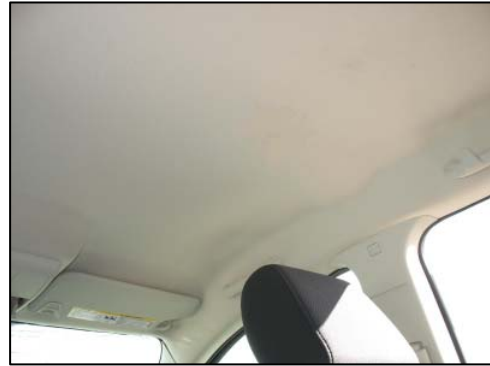
The interior damage to the Dodge consisted of the deployment of the CAC frontal air bags and vertical intrusion of the roof. There was no measureable longitudinal or lateral intrusion. The vertical intrusion of the left roof in Row 1 measured 3.0 cm (1.2 in). The vertical intrusion of the left roof rail measured 4.0 cm (1.6 in) in Row 2. The Row 1 roof intrusion measured 6.0 cm (2.4 in). This intrusion was located immediately inboard of the left B-pillar (**Figure 8**). There were no occupant contacts to the interior of the Dodge.

The Dodge was equipped with front seat-mounted side impact air bags and roll-sensing IC air bags. These air bags did not deploy during the crash sequence. **Figure 9** is an interior view of the right roof side rail and the location of the IC air bag.

Figure 8: Interior view of the right roof side rail and the location of the IC air bag.

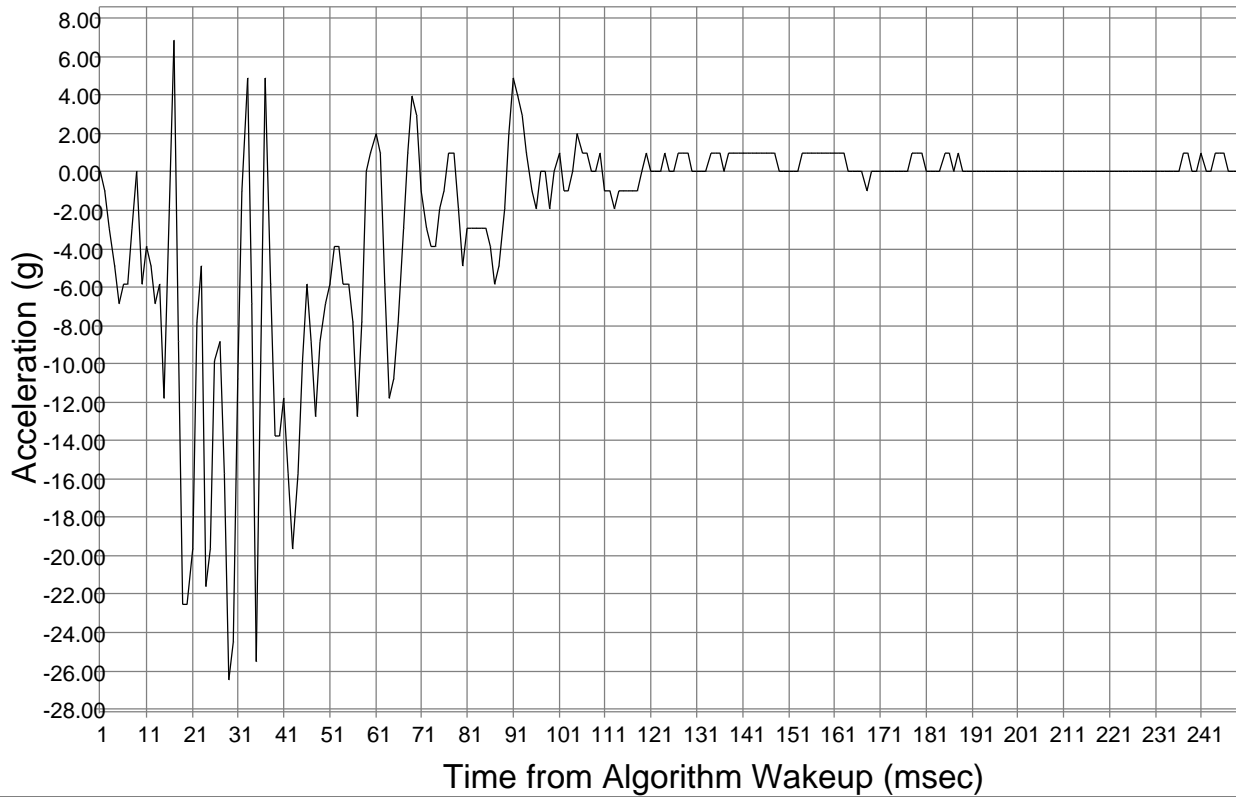
Longitudinal Crash Pulse (Event Record 1)

The recorded event was the frontal impact (Event 1) based on the recorded crash pulse. The maximum recorded longitudinal acceleration was -26.47g at 29 milliseconds after Algorithm

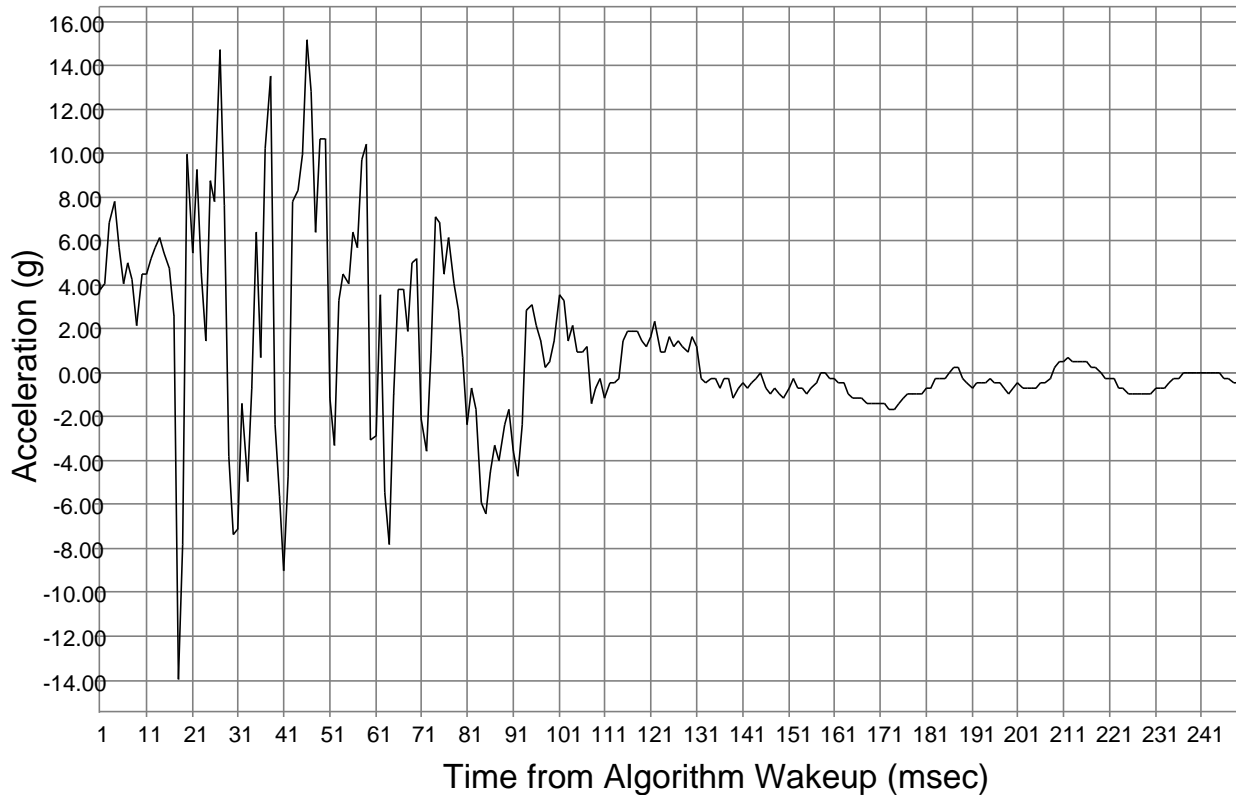
Lateral Crash Pulse (Event Record 1)

Wakeup (AW). The maximum recorded lateral acceleration was 15.15g at 46 milliseconds after AW. A reconstruction analysis of the crash pulse was conducted by the SCI investigator in order to determine the delta-V of the frontal event. The maximum longitudinal delta-V was -21.1 km/h (-13.1 mph) at 120 milliseconds after AW. The maximum lateral delta-V was 9.3 km/h (5.8 mph) at 132 milliseconds after AW. These values were consistent with the damage to the vehicle based on SCI field experience.

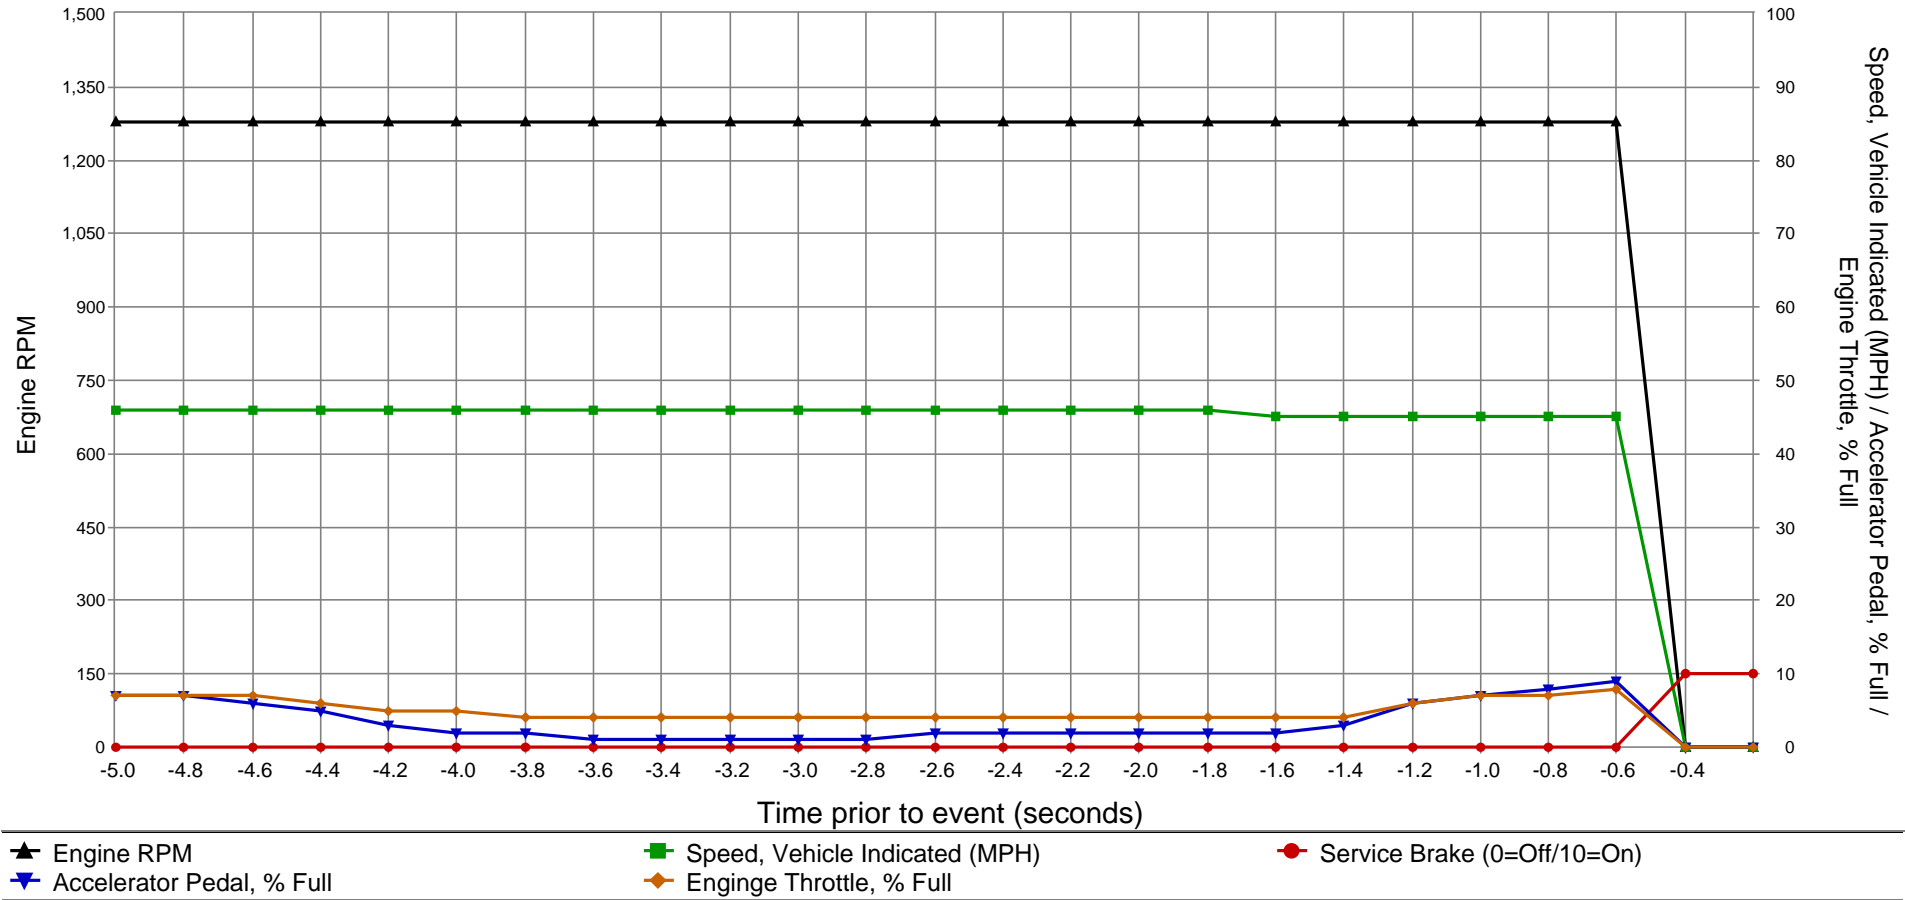
Pre-Crash Data (Event Record 1)

It is important to note that the recording of this event was interrupted by a potential loss of electrical power. The power loss was indicated by the *Vehicle Event Recorder Status* field in the Pre-Crash table. This parameter indicated a complete write of the buffered data to permanent memory did not occur. The power loss was a possible cause for the non-deployment of the IC air bags.

The imaged data indicated the vehicle's speed was 46 mph 5 seconds (-5 sec) prior to the crash. The recorded speed was consistent with the driver's statement. The steering wheel sensor indicated the driver was steering to the left, consistent with left curve of the crash site. There were no system faults prior to the loss of electrical power. The cruise control was "Off". The driver did not apply the brakes during the recorded pre-crash time frame. The recorded data contained no information regarding the rollover event.
