CALSPAN ON-SITE ROLLOVER CRASH INVESTIGATION

SCI CASE NO.: CA09078

VEHICLE: 2008 HONDA ACCORD EX-L

CRASH DATE: OCTOBER 2009

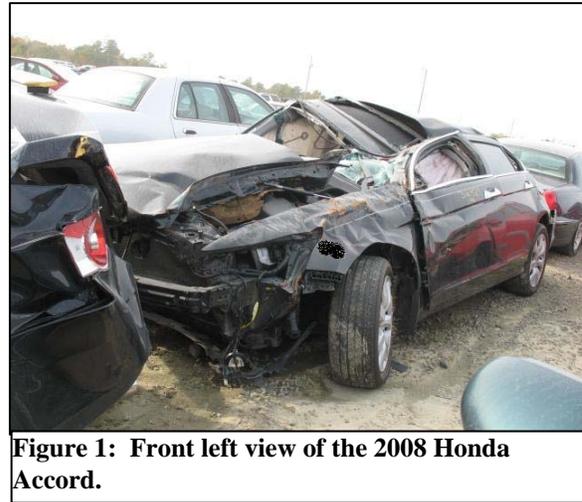
Figure 1: Front left view of the 2008 Honda Accord.

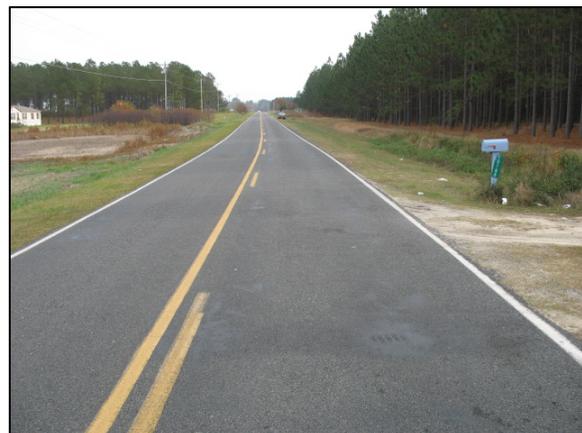
The restrained 30-year-old female driver of the Honda was operating the vehicle eastbound in a shallow left curve on the rural roadway at a driver estimated speed of 97-105 km/h (60-65 mph). It was raining heavily at the time of the crash. **Figure 2** depicts the Honda’s pre-crash trajectory. As the Honda entered the straight and level segment of roadway, the vehicle lost traction and initiated a CCW yaw. The Honda’s loss of traction was attributed to the vehicle’s relative speed in conjunction with the lack of

Figure 2: Pre-crash trajectory of the Honda.

adequate tire tread depth as this vehicle traveled through an area of standing water. The Honda traveled approximately 42 m (138 ft) and yawed approximately 50 degrees CCW through the travel lanes prior to departing the north side of the roadway. The Honda continued to yaw CCW as it crossed the north side ditch line.

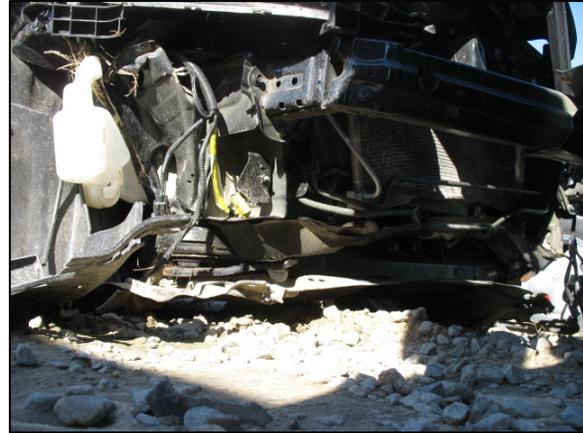
The exterior of the Honda sustained severe damage to the top plane and moderate-severity damage to the left and right planes as a result of this multiple impact crash. The front bumper fascia and front aspect of the undercarriage was damaged in the initial impact with the ditch's north side embankment. **Figure 3** depicts the deformation to the panel concealing the forward

aspect of the undercarriage. There was dirt and grass embedded into the undercarriage. The Collision Deformation Classification (CDC) assigned for the initial impact with the embankment was 00UFDW1

Figure 3: Undercarriage damage to the Honda, from lower right.

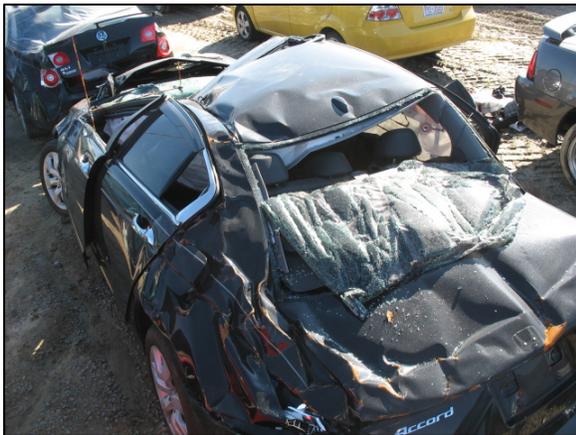
The rollover event resulted in two separate surface abrasion patterns on the left rear aspect of the roof, indicating that the Honda's top plane had contacted the ground on two separate occasions (**Figure 4**). The longitudinal direct contact damage to the top plane began at the leading edge of the hood and extended rearward 448.0 cm (176.4 in) to the rear of the trunk lid. Laterally, the direct contact damage extended 112.0 cm (44.1 in) between roof side rails. The maximum vertical crush measured 40 cm (15.7 in), which was located on the windshield header 21 cm (8.3 in) inboard of the left roof side rail. The maximum lateral crush was located at the junction of the windshield header and the left A-pillar, which measured 18 cm (7.1 in). During the rollover, the right rear wheel impacted the ground, resulting in deformation and separation of the suspension components that allowed for the wheel to be displaced under the vehicle. **Figure 5** depicts the maximum roof crush to the Honda. The CDC assigned for the rollover event was 00TDDO6.

Figure 4: Overhead view of the rollover damage to the Honda.

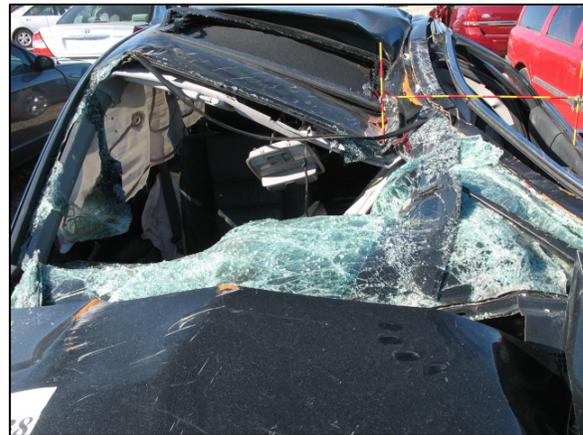
Figure 5: Vertical crush to the windshield header and left roof side rail.

The left roof side rail intruded laterally and vertically until it contacted the driver's head restraint located in a position 4.0 cm (1.6 in) above the seatback. The seatback was displaced longitudinally rearward in a deformed condition approximately 15 degrees aft of its original recline position. The left roof side rail compressed 5.0 cm (2.0 in) into the front left head restraint, which was also deformed from this intrusion. The intrusion to the Honda is listed on the following table:

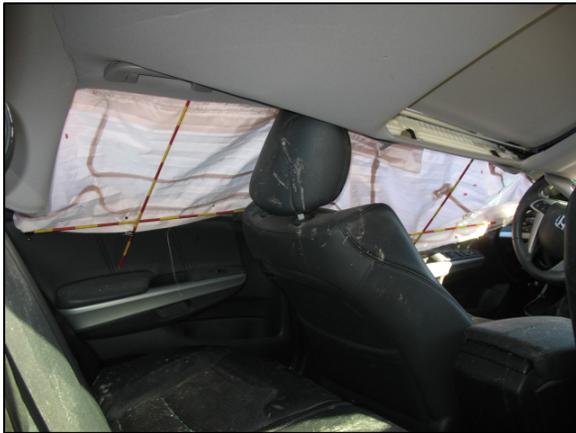
Figure 6 depicts the deployed left IC air bag. The left IC was labeled with the following nomenclature: 2420364 2006082701 250608GL31 S. **Figure 7** depicts the right IC air bag. The right IC was labeled with the following nomenclature: 2420364 2406082706 260608GL32 S.

Figure 6: Interior view of the deployed left IC air bag.

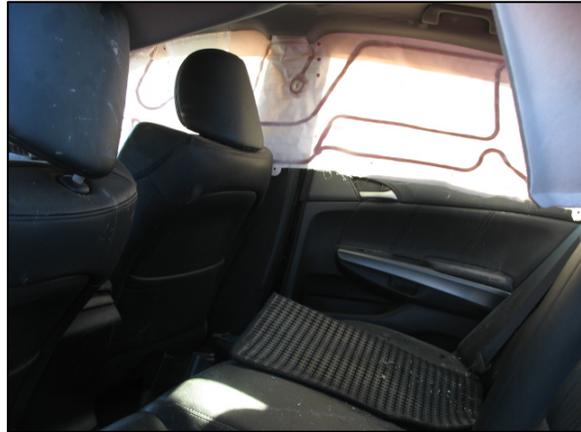
Figure 7: Interior view of the right IC air bag.

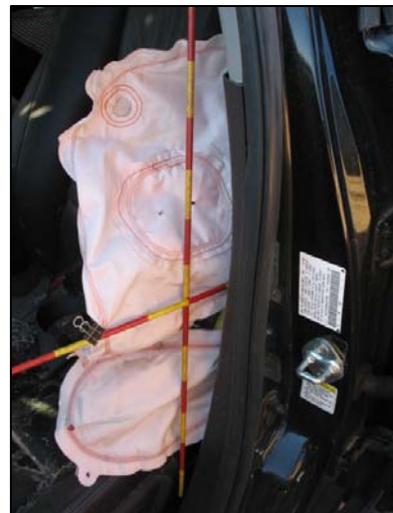
The side impact air bags deployed from panels in the outboard aspects of the front seatbacks. These panels measured 45.0 cm (17.7 in) in height. The seatback mounted air bags measured 28.0 cm (11 in) in width and 57 cm (22.4 in) in height in the deflated state. These side air bags contained one vent port located on the outboard aspect of forward most top corner. There was no damage or contact evidence on either side impact air bag. **Figure 8** depicts the left side impact air bag.

Figure 8: Left side impact air bag.

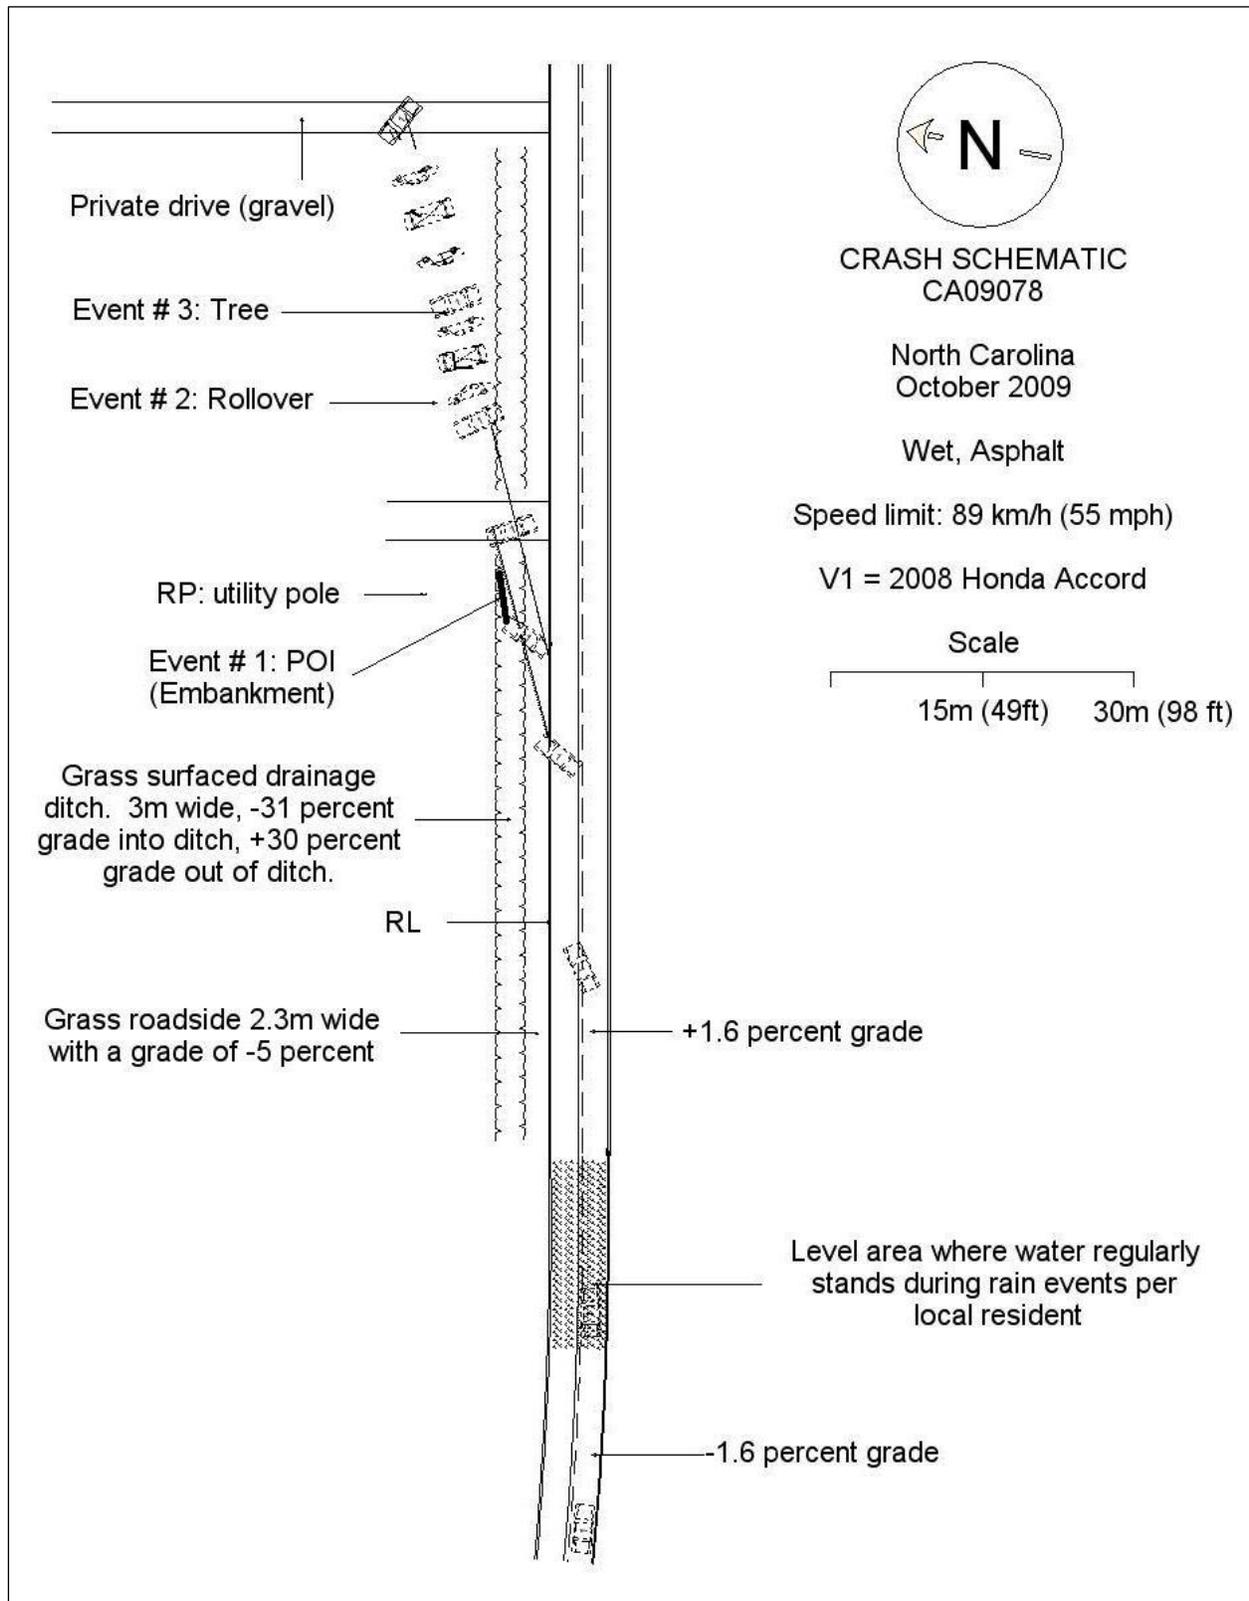
Figure 9: Crash Schematic

This crash occurred during the daylight hours of October 2009 on a two-lane east/west rural roadway. The environmental conditions at the time of the crash consisted of heavy rain showers. The wet roadway was comprised of two bituminous travel lanes that measured 2.9 m (9.5 ft) in width. The roadway was bordered by gravel and compacted soil shoulders that measured 2.4 m (7.9 ft) in width that sloped away from the travel lanes. The roadsides were grass surfaced and contained ditch lines that paralleled the roadway. The north roadside was 2.3 m (7.5 ft) in width with a negative grade of 4.9 percent. Located outboard of the north roadside was a ditch that was 3.0 m (9.8 ft) in width. The slopes of the ditch were a negative 31 percent entering the ditch and a positive grade of 30 percent exiting the ditch to the north. An overgrown driveway, surfaced with grass, was located 5.4 m (17.7 ft) east of the reference point and measured 3.8 m (12.5 ft) in width. A culvert pipe was located under the driveway. The pre-crash area of the roadway had a negative grade of 1.6 percent and included a curve to the left with a radius of curvature of 387 m (1269 ft). The grade transitioned to a level surface as the roadway straightened 56.2 m (184.4 ft) west of the reference point. Continuing along the Honda's direction of travel, the grade transitioned again to a positive grade of 1.6 percent. A local resident reported that the level area between the two grades collected standing water at times of heavy rain. This area of standing water was located 40-60 m (131-197 ft) west of the reference point, ending approximately 42 m (138 ft) west of the location in which the Honda departed the roadway. The posted speed limit in the area of the crash was 89 km/h (55 mph). A schematic of the crash is included at the end of this report as **Figure 9**.
