**CALSPAN ON-SITE POTENTIAL UNINTENDED ACCELERATION  
CRASH INVESTIGATION**

**SCI CASE NO: CA09083**

**VEHICLE: 2010 TOYOTA CAMRY  
LOCATION: NEW YORK  
CRASH DATE: NOVEMBER 2009**

1. Report No. CA09083		2. Government Accession No.		3. Recipient's Catalog No.	
4. Title and Subtitle Calspan On-Site Office of Defects Investigation Vehicle: 2010 Toyota Camry Location: State of New York			5. Report Date: February 2010

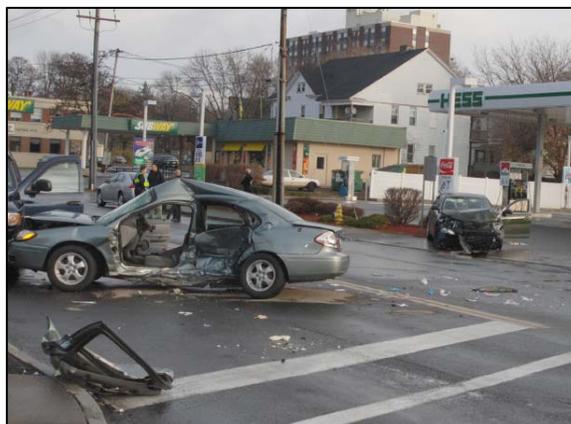
**Figure 1** is an on-scene police image of the crash site and the vehicles at final rest. The 56-

**Figure 1: On-scene police image of the crash site.**

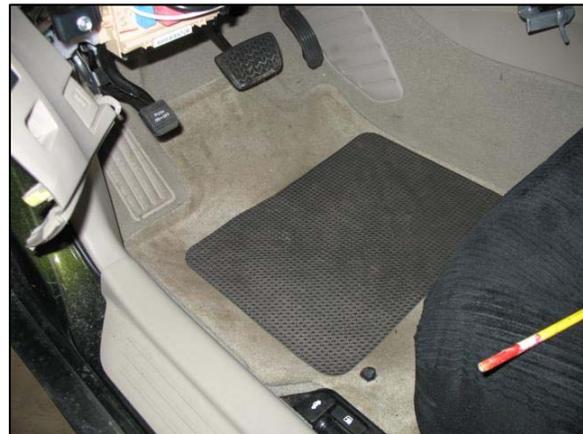
The Toyota was leased by the driver as a new vehicle approximately four months prior to this crash. There was no reported service history for this vehicle. The Toyota was equipped with the OEM carpeted floor mats that were secured to the vehicle with two hooks at the rear edge of the mat. Aftermarket rubber floor mats were positioned in all four outboard positions on top of the OEM carpeted mats (**Figure 3**). These aftermarket mats measured 43 cm x 31 cm (17.1 in x 12.1 in) and were 2 mm (3/32 in) thickness. These mats were very pliable and did not appear to obstruct the operation of the accelerator pedal.

**Figure 3: View of the aftermarket floor mat in the driver's foot well.**

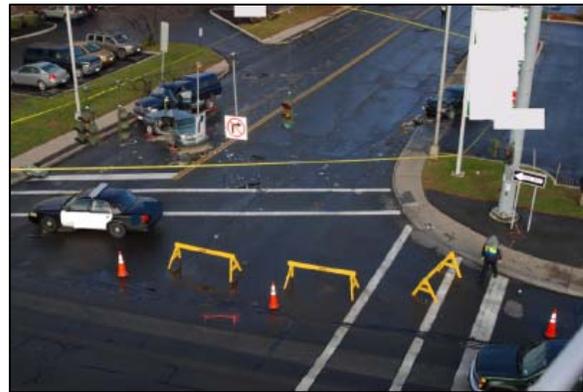
This two-vehicle intersection crash occurred during the afternoon hours of November 2009 in an urban setting. **Figure 4** is an overhead police image of the intersection and the final rest positions of the vehicles. At the time of the crash, the weather was cloudy and the asphalt road surface was wet. The crash occurred at the four-leg intersection of a 4-lane north/south road and a 4-lane, one-way westbound road. The total width of the north/south road measured 16.8 m (55.1 ft). The north and south traffic lanes were configured with two lanes in either direction that were separated by double-yellow center lines. The total width of the westbound road measured 15.6 m (51.2 ft). The westbound lanes were configured with a right turn only lane, two center-through lanes, and a left turn only lane. The intersection was controlled by standard (red/amber/green) overhead traffic signals that were operational at the time of the crash. The traffic light was green for the westbound traffic flow. The speed limit in the area of the crash was 48 km/h (30 mph). A schematic of the crash is attached to the end of this report as **Figure 19**.

**Figure 4: Overhead view of the crash site. (Image courtesy of the investigating police department.)**

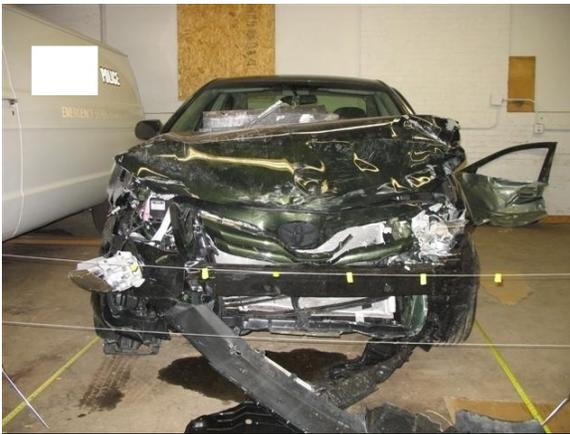
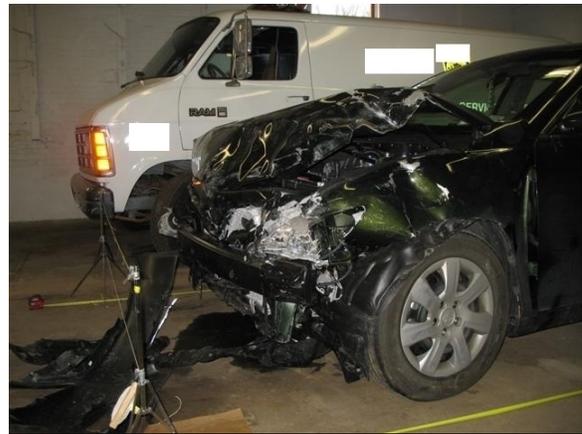
The Toyota sustained direct contact damage to its front plane that extended across the entire 157 cm (62 in) end width. **Figures 5 and 6** are front and left oblique views of the damage. The intersection impact resulted in a 28 cm (11 in) lateral displacement of the bumper reinforcement due to the 1 o'clock direction of the impact force. The front fascia and energy absorbing foam separated during the impact exposing the bumper reinforcement bar. The residual crush profile measured along the reinforcement bar was as follows: C1 = 29 cm (11.4 in), C2 = 26 cm (10.2 in), C3 = 23 cm (9.1 in), C4 = 18 cm (7.1 in), C5 = 17 cm (6.7 in), C6 = 7 cm (2.8 in). The maximum crush was located at C1. The hood buckled up and the forward aspects of both fenders were crushed. All the doors remained closed during the impact and were operational post-crash. The left wheelbase was reduced 4 cm (1.6 in). The right wheelbase was reduced 2 cm (0.9 in). The windshield and all the side glazing were intact. The Collision Deformation Classification was 01-FDEW2.

**Figure 5: View of the Toyota's frontal damage.**

**Figure 6: Oblique view of the Toyota's extent of crush.**

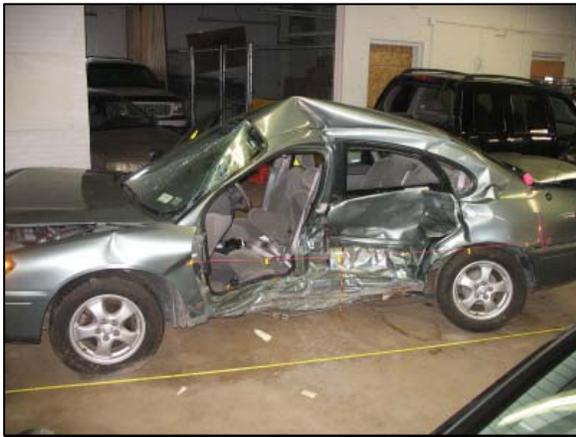
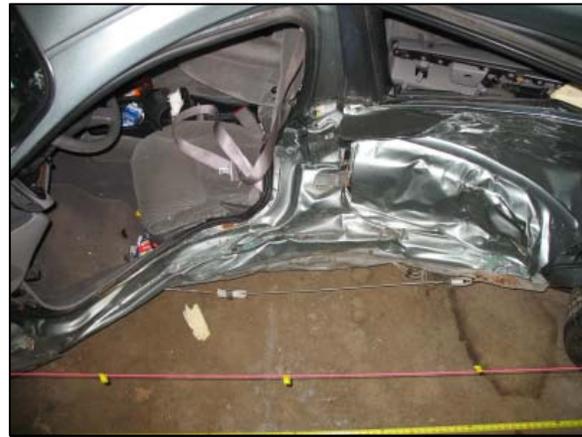
The left side of the Ford sustained severe impact damage as a result of the intersection crash. **Figures 7 and 8** are overall left side views of the vehicle depicting the extent of the damage. The direct contact damage began at the left A-pillar area, 50 cm (19.7 in) aft of the left front axle. The direct contact extended across the left side of the occupant compartment 202 cm (79.5 in) ending 4 cm forward of the left rear axle. The combined length of the direct and induced damage measured 235 cm (92.5 in). The residual crush profile was measured at the mid-door elevation and was as follows: C1 = 0, C2 = 24 cm (9.5 in), C3 = 74 cm (29.1 in), C4 = 75 cm (29.5 in), C5 = 46 cm (18.1 in), C6 = 0. The maximum lateral crush was located 11 cm (4.5 in) aft of the B-pillar and measured 75 cm (29.5 in). The Door Sill Differential (DSD) at that location was 32 cm (12.5 in). The center aspect of the roof was buckled up 36 cm (14.0 in). The sill and floor pan deformed and rolled vertically 24 cm (9.5 in) at the B-pillar. The left door was removed during the extrication of the driver. The left rear door was jammed closed. The right doors remained closed during the impact and were operational. The left wheelbase dimension was reduced 19 cm (7.6 in) and the right wheelbase lengthened 3 cm (1.1 in) due to body deformation. The CDC was 10-LPAW4.

**Figure 7: Left side impact damage of the Ford.**

**Figure 8: Overhead view depicting the Ford's extent of crush at the B-pillar.**

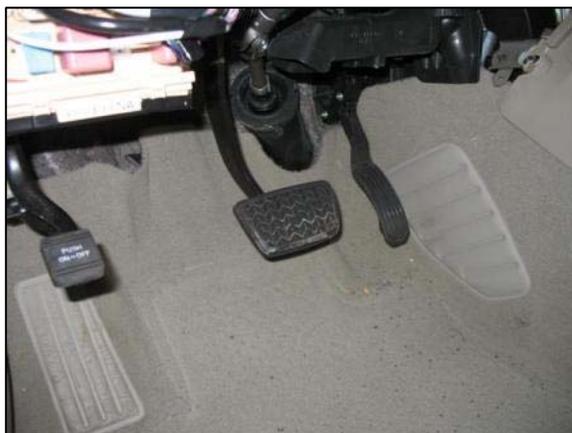
**Figure 9. Floor, toe pan and foot controls of the Toyota Camry.**

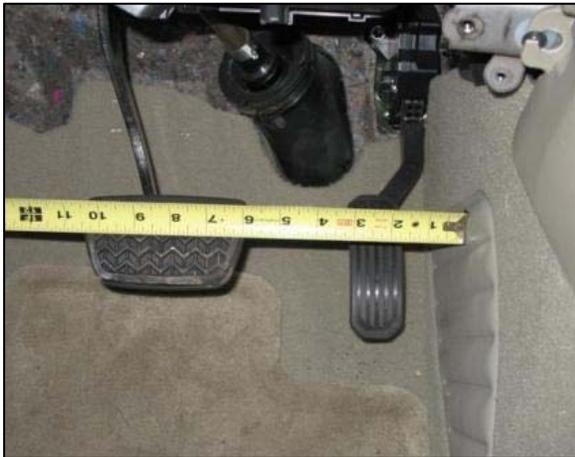
The brake pedal was rectangular in shape with a rubber pad that measured 7 cm (2.75 in) vertically, 11 cm (4.5 in) horizontally at the top aspect of the pedal and tapered to 10 cm (3.75 in) at the bottom aspect of the rubber pad. The pedal was welded to a steel arm that extended above the toe pan to the mounting point. The lateral offset between the brake pedal and the accelerator pedal was 7 cm (2.8 in) from the top of the brake pedal and 8 cm (3.25 in) at the bottom aspect of the brake pedal (**Figure 10**). The accelerator pedal was positioned at a lower point than the brake pedal with a 4 cm (1.5 in) height differential between the pedals (**Figure 11**). There was no damage or evidence of occupant foot loading/scuffing to the brake pedal.

**Figure 10. Lateral offset of the accelerator and brake pedals of the Toyota Camry.**

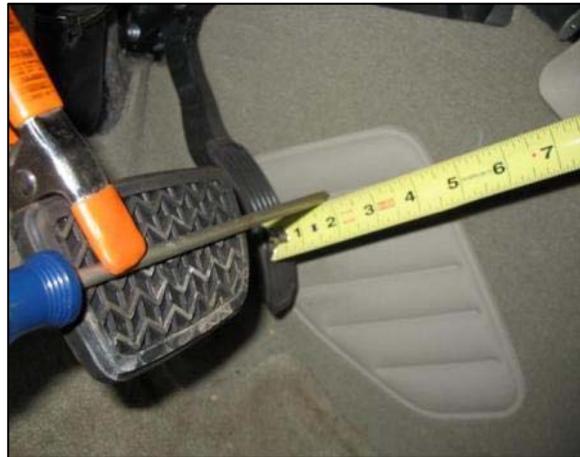
**Figure 11. Height differential between the foot controls of the Toyota Camry.**

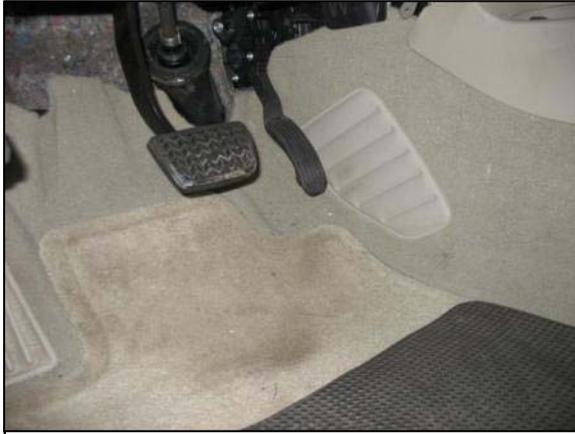
The Toyota was equipped with the OEM carpeted floor mats at the four outboard seat positions. The driver's OEM carpeted floor mat was factory cut around the travel distance of the accelerator pedal. With the accelerator pedal depressed to the full throttle position, the OEM carpeted mat did not interfere or capture the bottom of the pedal pad (**Figure 12**).

**Figure 12. Overall view of the OEM floor mat in relation to the foot pedals in the Toyota Camry.**

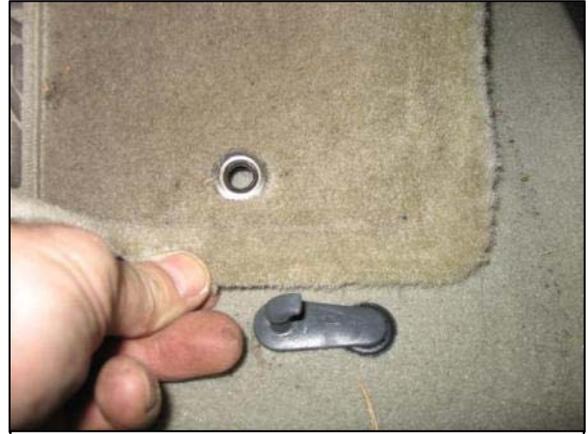
The OEM carpeted floor mat was held secure by two hooks installed in the aft aspect OEM base carpeting. These hooks were positioned on 36 cm (14 in) centers and extended through grommets in the OEM floor mat (**Figure 13**). The hooks extended above the level of the mat and were formed rearward to prevent the mat from moving forward. The left hook secured the floor mat 4 cm (1.75 in) inboard of the left edge of the mat and the right was 6 cm (2.4 in) inboard of the right aspect of the mat. Based on the SCI inspection of the OEM mats, the OEM hooks held the mat secure and in place to the carpeted floor of the Toyota.

**Figure 13. Positioning hooks of the OEM carpeted floor mats in the Toyota Camry.**

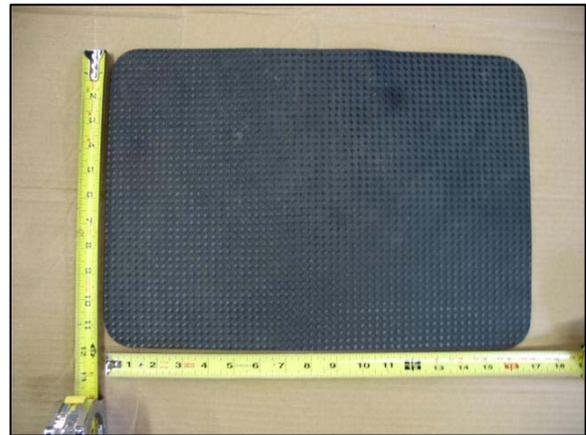
An aftermarket rubber/foam-like floor mat was placed over the OEM mats at all four positions and was in use at the time of the crash. These aftermarket mats were rectangular in shape and were 43 cm (17.1 in) in width and 31 cm (12.1 in) in height (**Figure 14**). The thickness of these mats was 2 mm (3/32 in). These mats were extremely pliable due to the thin construction and composition of the mats. During the SCI inspection, this mat was folded against the accelerator pedal in an attempt to capture the pedal in an open throttle position. The return tension of the accelerator pedal overrode the aftermarket mat on all attempts. The floor mat was not rigid enough for bottom edge entrapment to occur.

**Figure 14. Aftermarket floor mat from the Toyota Camry.**

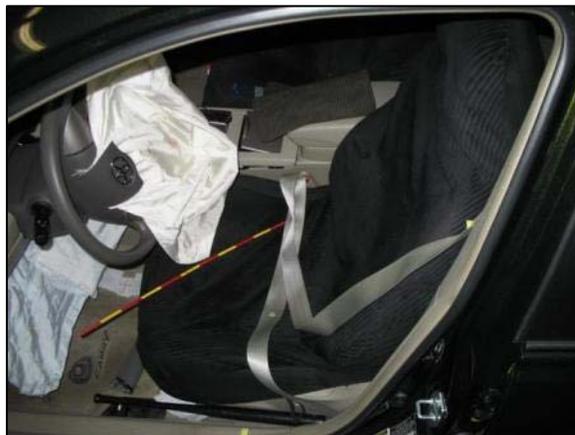
The Toyota was equipped with a CAC frontal air bag system for the driver and front right passenger positions. The system consisted of dual-stage frontal air bags, seat track positioning sensors, safety belt buckle and retractor pretensioners, safety belt buckle switches, and a front right occupant presence sensor. The manufacturer of the Toyota has certified that the vehicle is compliant to the advanced air bag requirements of Federal Motor Vehicle Safety Standard No. 208. In addition to the CAC frontal air bags, the Toyota was equipped with a driver's knee bolster air bag, seat back mounted side impact air bags, and roof side rail mounted Inflatable Curtain (IC) air bags. The frontal crash event triggered the deployment of the driver's frontal air bag and the knee bolster air bag and actuated the driver's retractor pretensioner (**Figure 15**).

**Figure 15. Deployed air bags in the Toyota Camry and the locked safety belt webbing due to pretensioner activation.**

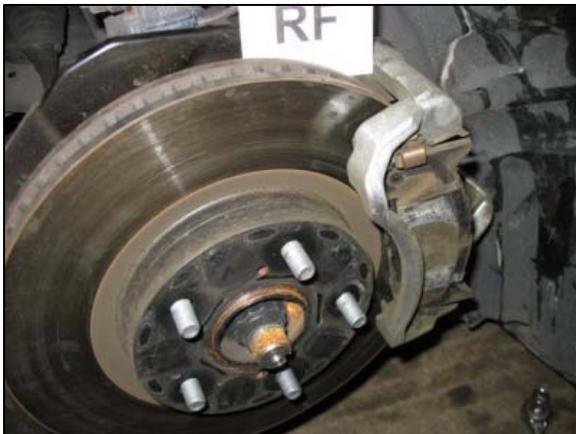
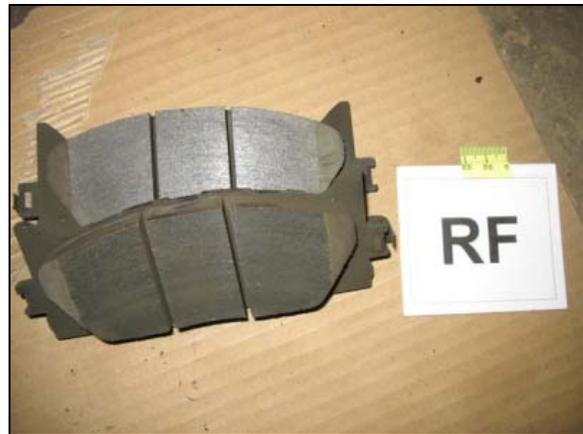
During the course of the SCI inspection, the Toyota’s brakes were inspected for signs of wear or heat stress. This inspection was conducted in order to ascertain if the brakes had been applied by the driver for an extended period during the pre-crash phase of the event in an attempt to stop the vehicle. In turn, each wheel was removed from the Toyota and the rotors and the brake pads were inspected. **Figures 16 and 17** are views of the right front rotor and the right front brake pads. The condition of these components was typical of the other three wheel positions. The

brake components did not display indications of extensive wear or evidence of overheating. The observations of the SCI brake inspection determined that the driver was not braking the vehicle for a prolonged, extended period of time. There was no physical evidence of pre-crash braking identified at the crash site during the police investigation.

**Figure 16: View of the condition of the Toyota's right front rotor.**

**Figure 17: View of the condition of the Toyota's right front brake pads.**

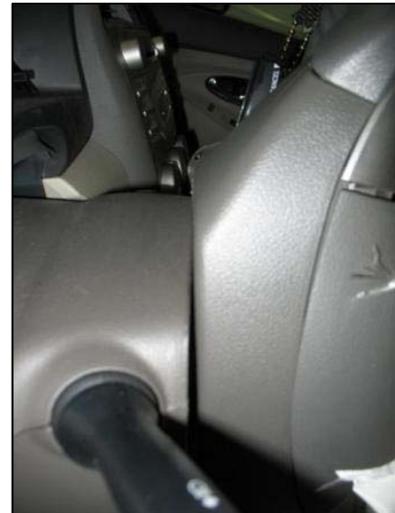
The driver continued to move forward as the belt compressed into her body and the load limiting retractor spooled out webbing to provide a ride down of the crash forces. Her head flexed forward as she engaged the deployed frontal air bag with her face and chest. The facial contact was evidenced by the subtle lipstick transfer of the center aspect of the air bag. Her torso compressed the air bag against the steering wheel rim. As a result, the steering wheel flange

deformed (**Figure 18**). Her loading force was transmitted through the air bag into the energy absorbing steering column. The column compressed and the shear capsules completely separated. The column subsequently dropped onto the top aspect of the knee bolster.

**Figure 18. Deformed steering wheel flange of the Toyota from driver loading.**
