Remote SCI/NASS Combination Side Air Bag Investigation
Dynamic Science, Inc. (DSI), Case Number 2010-74-127J
2010 Mazda 3
Nebraska
July 2010

1. Report No. 2010-74-127J	2. Government Accession No.		3. Recipient Catalog No.	
4. Title and Subtitle Remote SCI/NASS Combination Side Air Bag Investigation			5. Report Date January 3, 2011

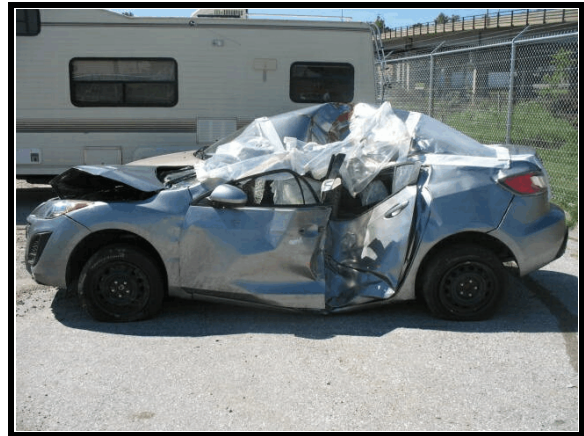
Figure 1. Subject vehicle, 2010 Mazda 3

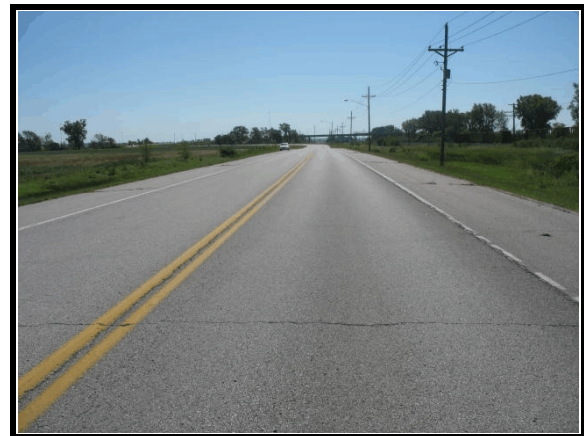
The crash site was the eastbound lane of a rural roadway (**Figure 2**). The roadway was configured with single east and westbound lanes that were separated by double solid yellow centerlines. The travel lanes were bordered by white fog lines and asphalt shoulders. The asphalt roadway was straight, level, and dry. The area beyond the shoulders was grass-covered, partially mowed, and contained areas of standing water. It was dark at the time of the crash and the street lights were illuminated. According to the nearest reporting station, the temperature was 25° C (77° F), the humidity was 69 percent, and the wind was from the south at 18.5 km/h (11.5 mph). The posted speed limit was 64 km/h (40 mph). A crash scene diagram is included at the end of this report as Attachment 1.

Figure 2. Eastbound travel lane

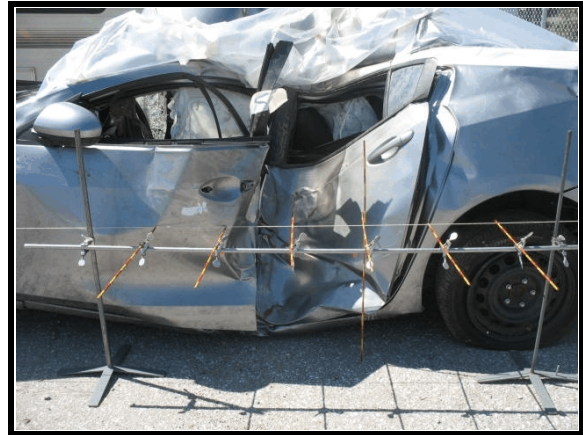
The Mazda sustained moderate damage left side damage from the impact with the wooden pole (**Figure 3**). The direct damage began 68.0 cm (26.7 in) forward of the rear axle and extended 49.0 cm (19.3 in) forward. The Field L began 16.0 cm (6.3 in) forward of the rear axle and extended forward 127.0 cm (50.0 in). Six crush measurements were taken at the mid-door level as follows: $C_1 = 0$ cm, $C_2 = 1.0$ cm (0.4 in), $C_3 = 11.0$ cm (4.3 in), $C_4 = 42.0$ cm (16.5 in), $C_5 = 15.0$ cm (5.9 in), $C_6 = 5.0$ cm (1.9 in). Maximum crush was located at C4. The Collision Deformation Classification (CDC) for Event 1 was 60LPAW5.

Figure 3. Left side pole damage

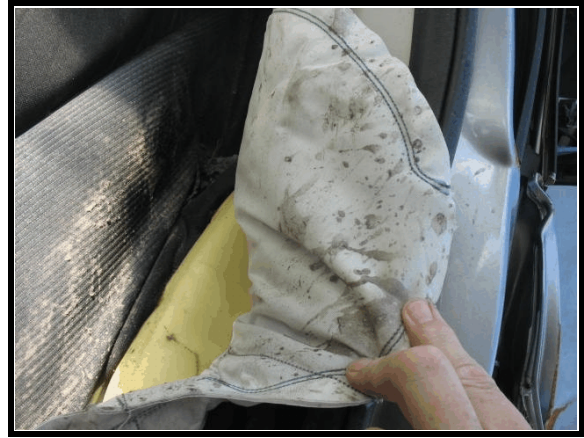
The left seat-mounted side air bag deployed at impact from the outboard aspect of the driver's seat back (**Figure 4**). The air bag was semicircular in shape. There was no damage reported to the air bag.

Figure 4. Left seat back mounted side air bag

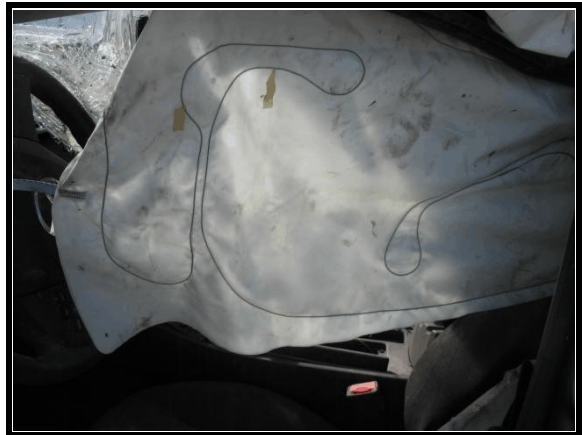
The left and right IC air bags deployed from the roof side rails above the front and rear rows (**Figure 5**). The IC air bags were rectangular in shape. The forward aspects of the bags were attached to the A-pillar by tethers that were approximately 30.0 cm (11.8 in) in length and the rear aspects were attached to the C-pillars. The longitudinal area of coverage began approximately 30.0 cm (11.8 in) aft of the A-pillar and extended to the C-pillar. The bag's vertical coverage began at the roof rail and extended below the window frame. The side window measured 13.0 cm (5.1 in) in height at the forward aspect, 39.0 cm (15.3 in) in height at the rear aspect, 92.0 cm (36.2 in) in length at the top, and 79.0 cm (31.1 in) in length at the bottom. The area of the side window not covered by the air bag was approximately 30.0 cm (11.8 in) in length and 32.0 cm (12.6 in) in height and encompassed approximately one-third of the window. At the time of the inspection, the forward tether had been cut. There was no evidence of occupant loading to the IC air bags.

Figure 5. Exterior view, left IC air bag
