On-Site Rollover Investigation
Dynamic Science, Inc. (DSI), Case Number DS10001
2008 Ford Escape Hybrid
California
November 2009

1. Report No. DS10001	2. Government Accession No.		3. Recipient Catalog No.	
4. Title and Subtitle On-Site Rollover Investigation			5. Report Date December 15, 2010

Dynamic Science, Inc.
Crash Investigation
Case Number: DS10001

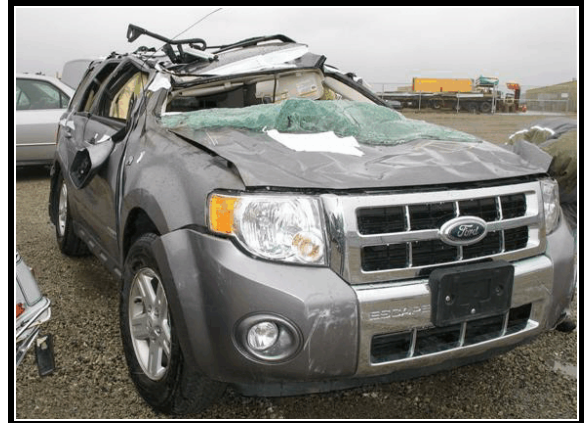
This investigation focused on a 2008 Ford Escape Hybrid that sustained multiple impacts and rolled over (**Figure 1**). This two-vehicle crash occurred in November 2009 at 1410 hours in an unincorporated area of California. The crash site was the four-leg intersection of a north/south roadway and an east/west roadway. The subject vehicle was being driven by a 37-year-old female. The other vehicle is a 2003 Chevrolet Cavalier that was being driven by a 23-year-old female. The Chevrolet was traveling north and slowed in preparation to turn left at the intersection. The Ford was traveling north directly behind the Chevrolet at an EDR-reported speed of 80.28 km/h (49.88 mph). The Chevrolet initiated a left turn and the driver of the Ford attempted to avoid impacting the Chevrolet by steering left. The right side of the Ford impacted the left front of the Chevrolet causing the driver of the Ford to lose control of her vehicle. The left and right IC air bags deployed during this side impact. The vehicle then departed the northbound roadway on the right side, impacted a mail box unit, overturned five quarter-turns, and came to rest on its left side in a ravine. The Chevrolet came to rest in the intersection.

Figure 1. Subject vehicle, 2008 Ford Escape Hybrid

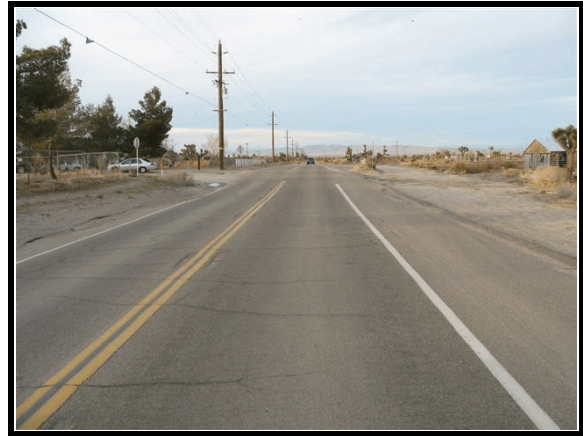
southbound travel lane that were separated by double yellow lines prior to the intersection (**Figure 2**). The asphalt roadway was straight and had an undulating profile. A hillcrest was located 82.9 m (272.0 ft) south of the intersection. At 60.9 m (200 ft) from the intersection the profile was a negative 5.4%, at 30.5 m (100.0 ft) the profile was a negative 2.9%, and at 15.2 m (50.0 ft) the profile was a negative 2%. At the intersection, the roadway began a positive grade and the profile was 1.5%. The posted speed limit was 89 km/h (55 mph). North of the intersection, the east edge of the roadway was delineated by a white stripe, followed by a 2.7 m (9.0 ft) asphalt shoulder, followed by a generally level area of dirt/gravel that terminated in a ravine that was located approximately 13.7 m (45.0 ft) from the road edge. The ravine was generally parallel with the roadway but had an irregular alignment and varying widths. The depth of the ravine ranged from 1.5m (5.0 ft) to 2.4 m (8.0 ft). East of the roadway there were three sets of group cluster mailbox units. The mailbox unit located furthest north measured 142.0 cm (55.9 in) in height and 143.0 cm (56.2 in) wide; it was supported by four 7.0 cm (2.8) diameter pipes that were embedded in a concrete base. The east/west intersecting roadways had an asphalt and dirt composition and were controlled by stop signs. The weather was clear and visibility in all directions was good.

Figure 2. Northbound approach

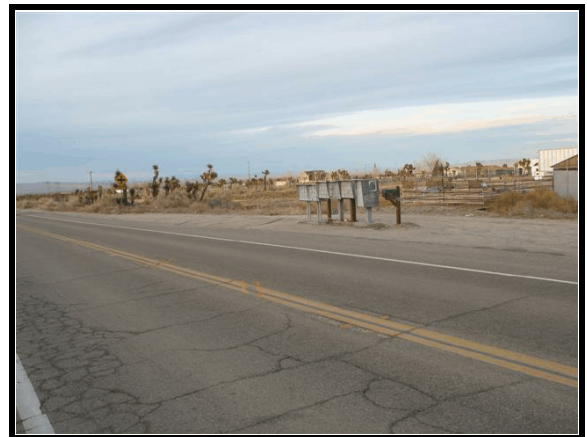
The right side of the Ford impacted the left front of the Chevrolet (Event 1), and the driver of the Ford lost control of her vehicle. The left and right IC air bags deployed and the driver's pretensioner actuated during this side impact. The EDR indicated that the driver began braking again. The Ford began a clockwise rotation, crossed the northbound travel lane, departed the northbound roadway on the right side (**Figure 3**) and impacted a metal mailbox unit (Event 2), and then began a left side leading rollover (Event 3). At one second prior to the rollover, the EDR reported that the vehicle speed was 25 km/h (16 mph). The Ford

Figure 3. Path to impact with mailbox unit

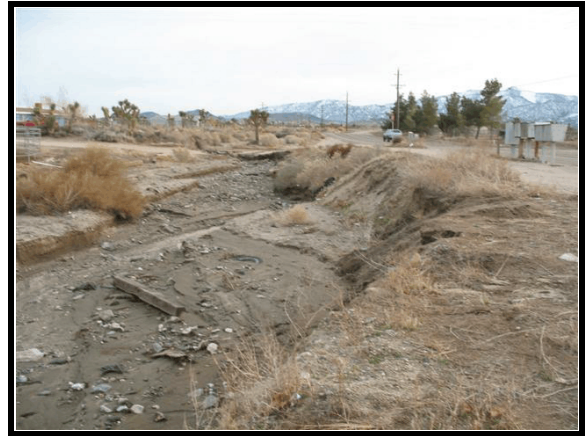
rolled five quarter-turns before coming to rest on its left side in the ravine (**Figure 4**). The Chevrolet came to rest facing north within the intersection.

Figure 4. Overview of final rest (south)

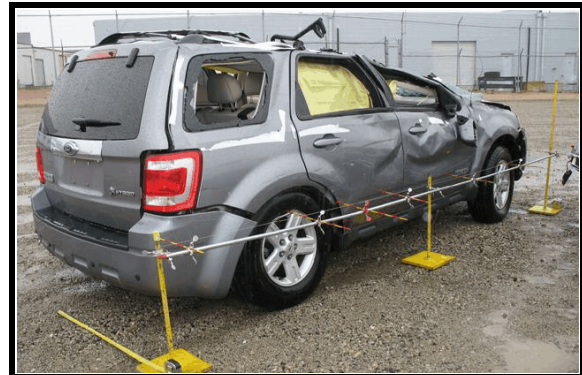
The Ford sustained direct and induced damage to the right side from the impact with the Chevrolet (**Figure 5**). The direct damage began at the left rear bumper corner and extended forward 412.0 cm (162.2 in). The Field L measurement was identical to the direct damage measurement. Six crush measurements were taken at the frame level as follows: $C_1 = 3.0$ cm (1.2 in), $C_2 = 0$ cm, $C_3 = 1.0$ cm (0.4 in), $C_4 = 2.0$ cm (0.8 in), $C_5 = 1.0$ cm (0.4 in), $C_6 = 1.0$ cm (0.4 in). Maximum crush was located 120.0 cm (47.2 in) forward of rear bumper corner and measured 5.0 cm (1.9 in). The Collision Deformation Classification (CDC) for Event 1 was 01RDES1.

Figure 5. Right side crush profile (Event 1)

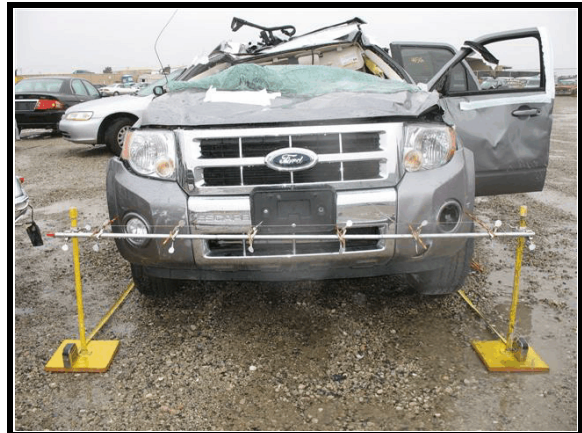
The Ford sustained minor front end damage from the impact with the mailboxes (**Figure 6**). The damage extended from bumper corner to bumper corner. Six crush measurements were taken at the bumper level as follows: $C_1 = 1.0$ cm (0.4 in), $C_2 = 1.0$ cm (0.4 in), $C_3 = 0$ cm, $C_4 = 0$ cm, $C_5 = 0$ cm, $C_6 = 0$ cm. Maximum crush was located at C1. The CDC for Event 2 was 12FDLW1.

Figure 6. Frontal damage

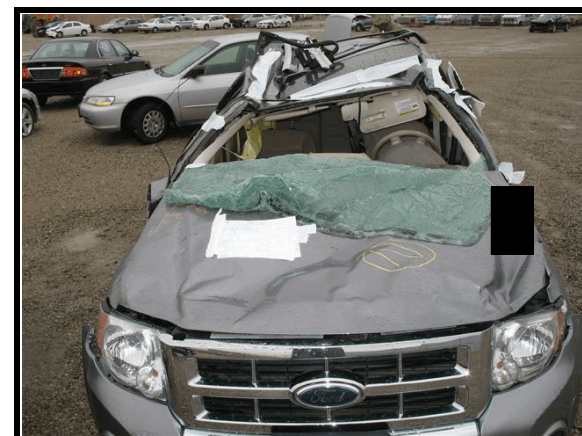
The Ford sustained moderate damage to the top plane during the rollover event (**Figure 7**). The direct damage to the top of the vehicle extended laterally from roof side rail to roof side rail and measured 142.0 cm (55.9 in). The damage extended from the backlight header forward 374.0 cm (147.2 in). The maximum vertical crush was located 53.0 cm (20.9 in) from the vehicle centerline at the right roof 3.0 cm (1.2 in) from the right A-pillar and measured 28.0 cm (11.0 in). The maximum lateral crush on the right roof side rail was located 127.0 cm (50.0 in) aft of the front axle and measured 5.0 cm (1.9 in). The CDC for Event 3 was 00TDDO4.

Figure 7. Top rollover damage (Event 3)

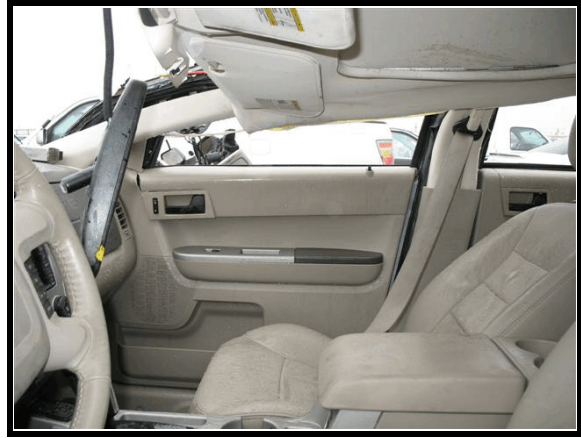
The Ford sustained moderate interior damage as a result of intrusions, occupant loading, and contact. Vertical intrusion was located in the front row at the right A-pillar, windshield header, roof, and left

A-pillar (**Figure 8**). Lateral intrusion was located in the front row at the roof side rail and B-pillar. Vertical intrusion was located in the second row at the roof. Evidence of occupant loading and contacts were documented to the driver's safety belt, the safety belt latch plate, the rear view mirror, and the left IC air bag.

Figure 8. Roof intrusion

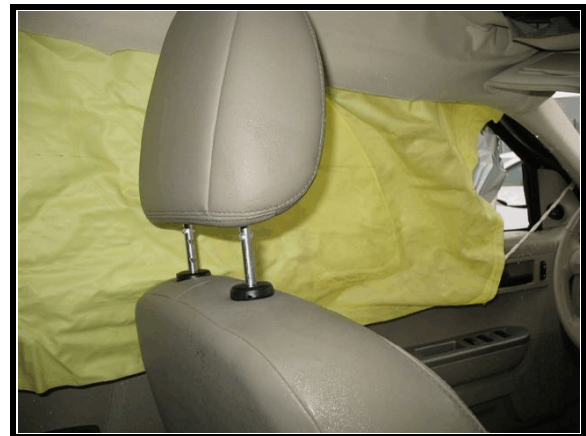
This vehicle's Supplemental Restraint System (SRS) included a Restraint Control Module (RCM), driver and passenger frontal air bags, seat-mounted side air bags for the front row, combination rollover/side impact IC air bags, and safety belt pretensioners for the front row. The Ford was a Certified Advanced 208-Compliant (CAC) vehicle and was equipped with advanced frontal air bags. The multi-stage air bags were certified by the manufacturer to be compliant with the advanced air bag requirements of Federal Motor Vehicle Safety Standard (FMVSS) No. 208. The driver's air bag was located within the steering wheel hub and the front right passenger air bag was located within the middle of the right instrument panel. During the side impact, the left and right IC air bags deployed (**Figure 9**). The frontal and seat-mounted side air bags did not deploy.

Figure 9. Left IC air bag

The left and right IC air bags deployed from modules in roof rails above the front and second rows. The IC air bags measured 138.0 cm (54.3 in) in length and 50.0 cm (19.7 in) in height. The bottom edge of the air bag was located 7.0 cm (2.8 in) below the side window frame. The air bags were configured without vent ports or internal tethers. The front of the air bag was attached to the A-pillar by a 38.0 cm (14.9 in) tether; the rear was attached to the C-pillar by a 6.0 cm (2.4 in) tether. There was 30.0 x 35.0 cm (11.8 x 13.8 in) area of window not covered.

The left IC air bag inboard panel revealed a skin oil/skin deposit covering an area measuring 46.0 cm (18.1 in) in length and 18.0 cm (7.0 in) in height. There was a vertical area of contact from the B-pillar that measured 33.0 cm (12.9 in) in height and 3.0 cm (1.2 in) in width. There was no damage to the outboard panel. There was no damage or contact to the right IC air bag.

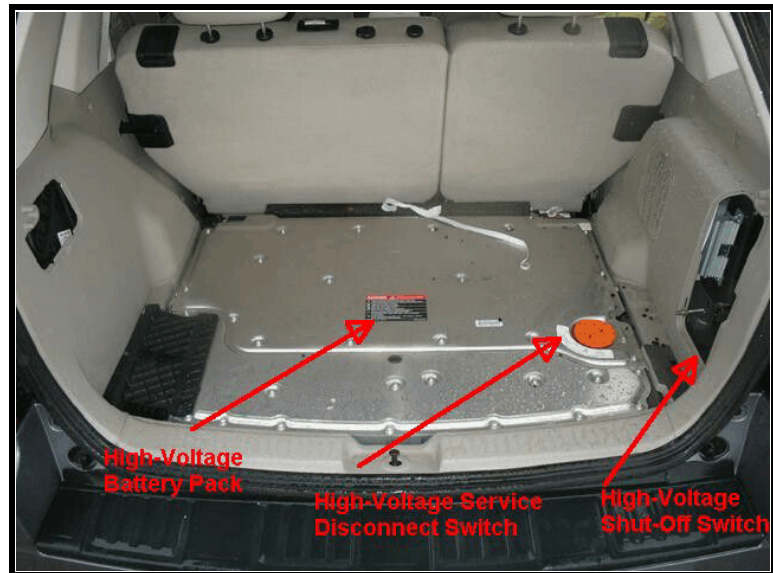
The high-voltage battery pack consists of 50 battery modules with each module comprised of 5 Nickel Metal-Hydrate (NiMH) 1.3-volt batteries welded together. The battery cells contain a base electrolyte consisting of potassium hydroxide as the dominant active ingredient. The total voltage of the battery pack is approximately 300 volts DC. The battery pack is mounted below the rear cargo floor, aft of the second row seat (**Figure 10**). The battery pack was mounted laterally in the vehicle and was concealed and protected by an aluminum cover that was bolted to the rear floor of the vehicle. The battery is electrically isolated from the rest of the vehicle when the key is OFF. When the key is turned ON, high voltage contactors inside the battery are closed to make the electricity available to the motor/generator and enable the vehicle to drive¹. There was an orange-colored service disconnect plug located on the right side of the battery. It was in the locked position at the time of the vehicle inspection.

Figure 10. High-Voltage Battery

- There were no indications of electrolyte spillage from the propulsion battery either outside or inside the passenger compartment.
- There was no movement of the battery module.
- The isolation test was not conducted. There were no indications of any arcing, fire or component meltdown.

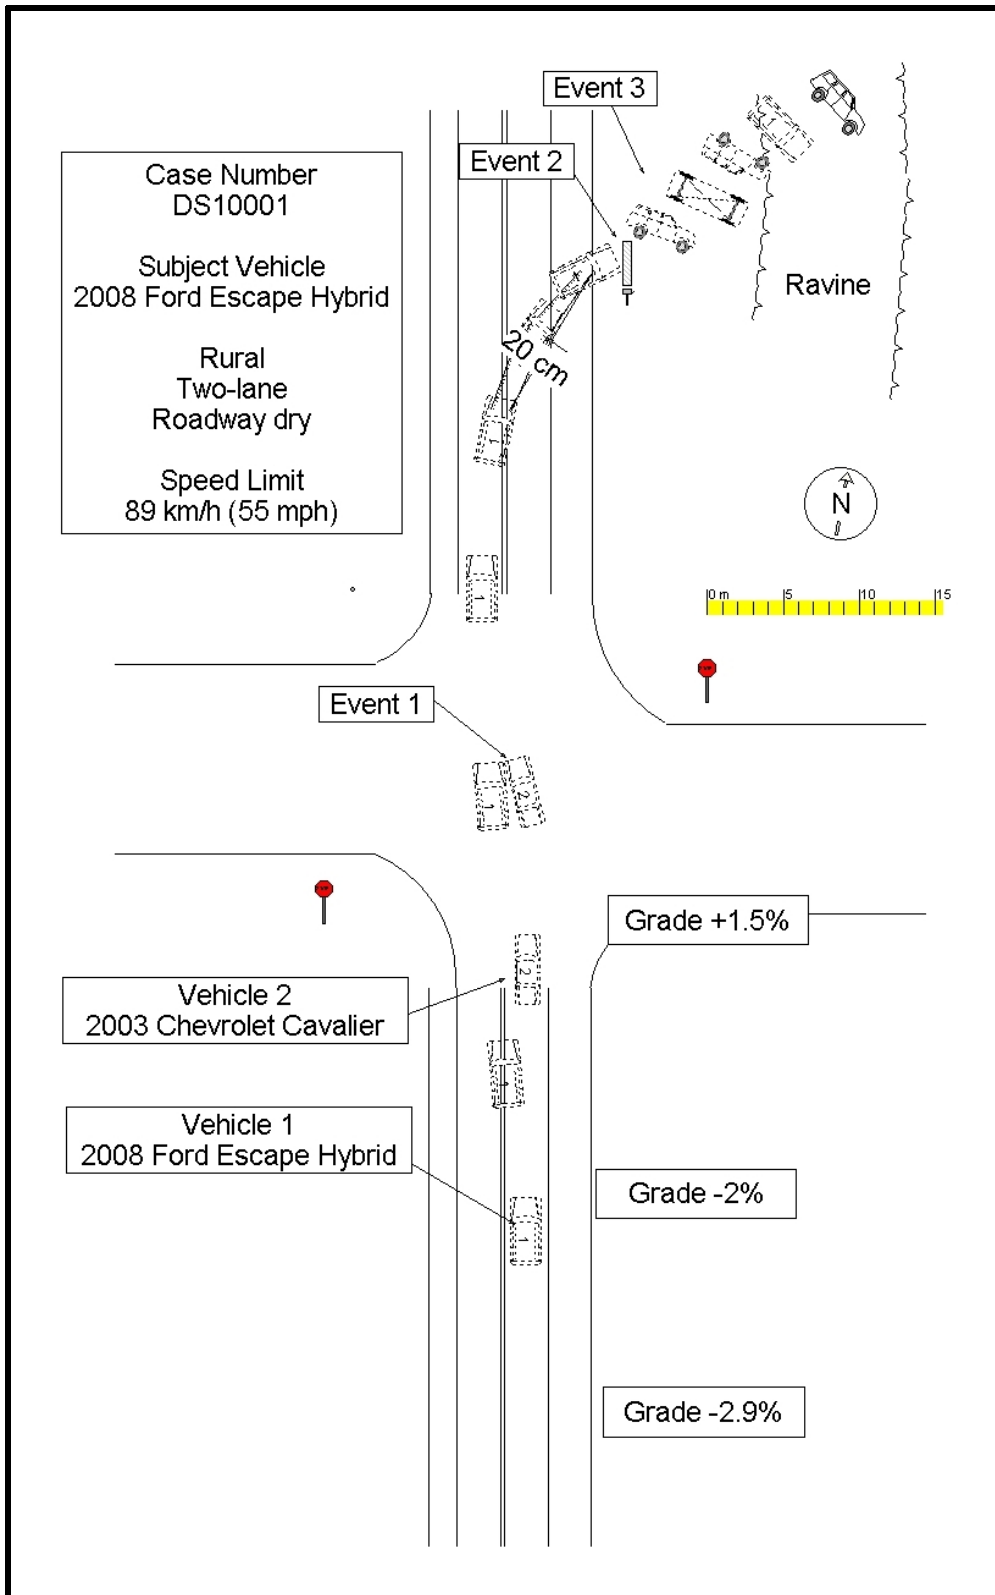
Attachment 1. Scene Diagram

After the initial impact with the Chevrolet, the Ford began a clockwise rotation. As the Ford departed the roadway, the front end impacted the mail box units. The clockwise rotation continued and as the left side tires engaged the ground the vehicle Ford tripped and began a left side leading rollover. The EDR recorded a rollover event with a rate of 152.5 degrees per second and a roll angle of 22.218 degrees. During the rollover, the Ford rolled across the level ground and then fell into the ravine. The Ford rolled five quarter-turns before coming to rest on its left side. The estimated distance from the trip point to final rest was 15 m (49 ft).
