ON-SITE ROLLOVER INVESTIGATION

CASE NUMBER - IN10002

VEHICLE - 2008 HUMMER H3

CRASH DATE - December 2009

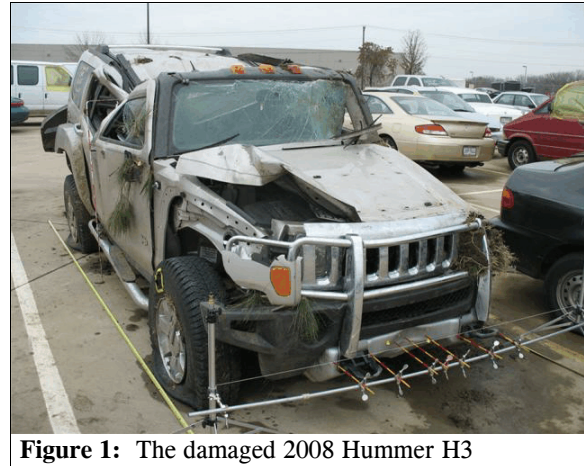
Figure 1: The damaged 2008 Hummer H3

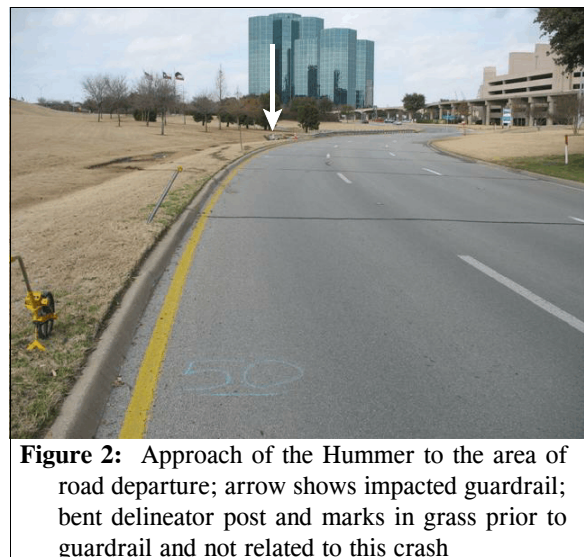
Pre-Crash: The unrestrained 48-year-old male driver of the Hummer was traveling northeast in the third lane from the right and was negotiating a right curve (**Figure 2**). The driver stated during the SCI interview that he lost control of the vehicle after traveling onto a patch of ice on the roadway. The driver did not apply the brakes in an attempt to avoid the crash.

Figure 2: Approach of the Hummer to the area of road departure; arrow shows impacted guardrail; bent delineator post and marks in grass prior to guardrail and not related to this crash

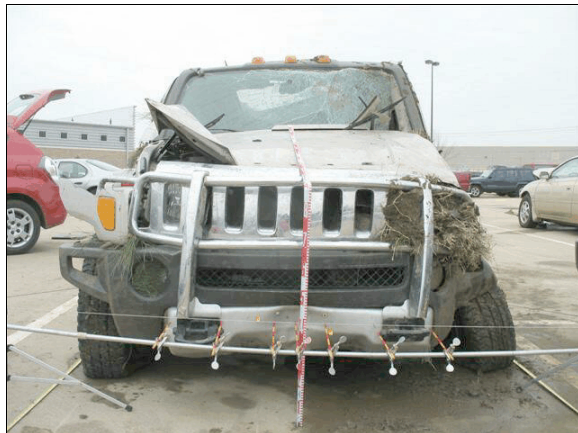
Figure 3: Damage on the front plane of the Hummer from the guardrail impact and rollover

Exterior Damage: The impact with the guardrail (event 1) involved the front plane of the Hummer. The direct damage involved the lower portion of the chrome brush guard and the bumper bar. There was overlapping damage from the rollover on the plastic bumper fascia on each corner of the bumper. The direct damage involved the full width of the bumper bar, 94 cm (37 in). The maximum residual crush was 6 cm (2.4 in) occurring 7 cm (2.8 in) left of C₄. There was no rigid structure below the plastic bumper fascia at the corners.

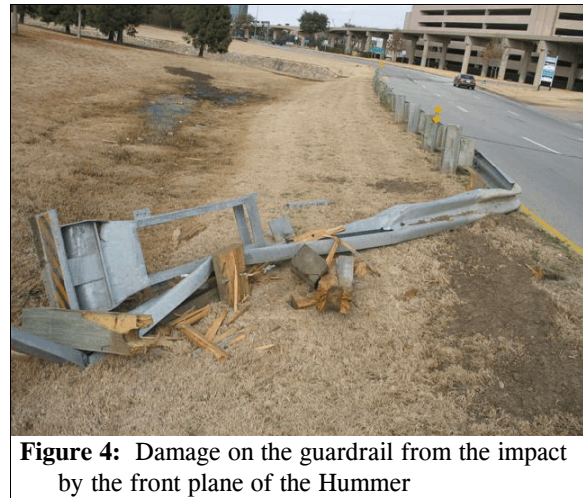
Crash: As the vehicle departed the left side of the road, the front plane (**Figure 3**) impacted a blocked-out W-beam metal guardrail (**Figure 4**, event 1). The guardrail was anchored in the ground by wood posts and three of them were broken by the impact. The vehicle continued through the guardrail and rolled over left side leading (event 2) as it became airborne. During the rollover, the left sill and undercarriage, the top plane, and the right fender impacted coniferous trees (events 3-5, respectively). The vehicle was equipped with rollover/side impact inflatable curtain (IC) air bag and both deployed during the crash. The vehicle came to final rest on its top plane heading southeast.

Figure 4: Damage on the guardrail from the impact by the front plane of the Hummer

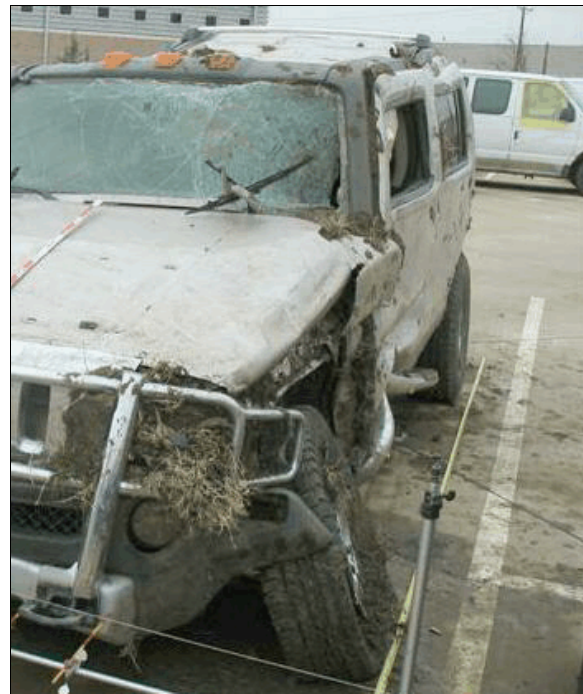
Figure 5: Mud deposits and damage on the front and left side plane from the rollover

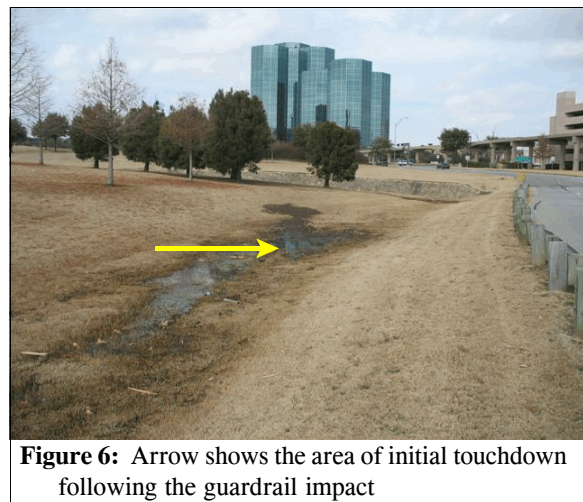
The rollover of the Hummer was initiated following the impact with the guardrail. As the vehicle traveled over the guardrail, it acted like a ramp and the vehicle became airborne and began to roll over left side leading. The vehicle traversed approximately 21 m (68.9 ft) from the initial guardrail impact and touched down on its left side (**Figure 5**) in a muddy area (**Figure 6**) and continued to rollover. During the rollover the sill and undercarriage below the left front door (**Figure 7**) impacted and broke a coniferous tree. The top plane (**Figure 8**) impacted a second tree, which was not broken by the impact. The vehicle’s right fender (**Figure 9**) impacted a third tree as the vehicle came to final rest (**Figure 10**) on its top plane heading southeast. Based on the crash scene physical evidence and the damage on the vehicle, it was estimated that the vehicle rolled over 10 quarter turns across a distance of approximately 45 m (147.6 ft).

Figure 6: Arrow shows the area of initial touchdown following the guardrail impact

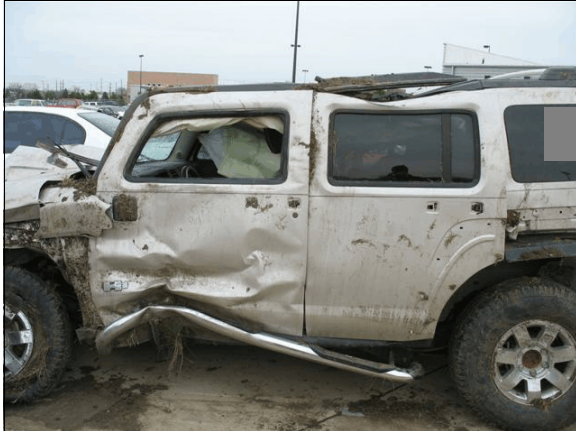
Figure 7: Damage on sill and undercarriage

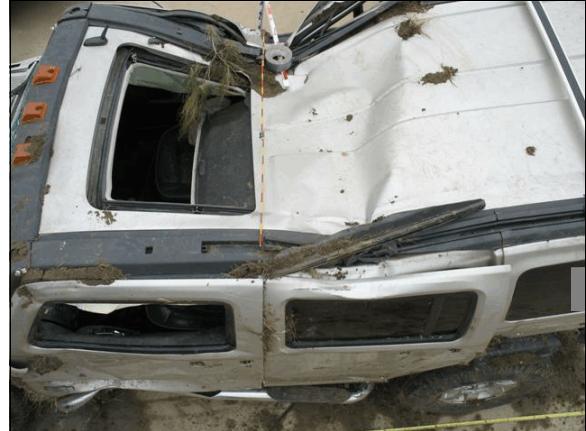
Figure 8: Damage to the top plane from impact with a pine tree during the rollover

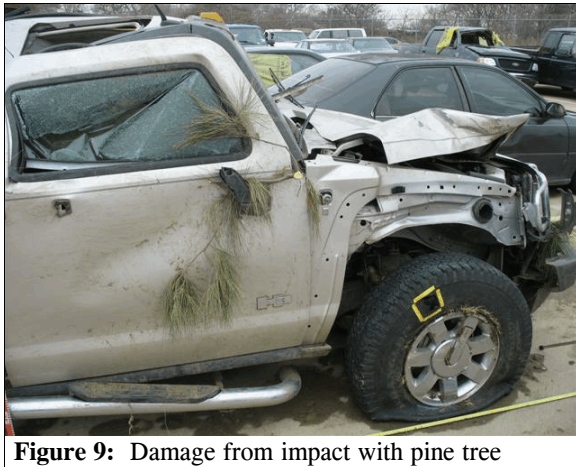
Figure 9: Damage from impact with pine tree

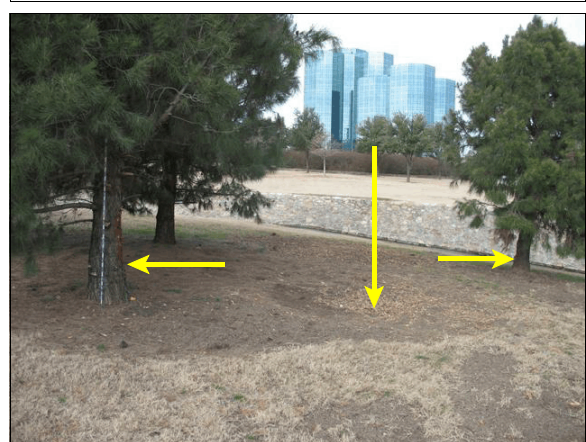
Figure 10: Arrow in center shows approximate location of tree that was broken when impacted by the Hummer's undercarriage; arrow on left shows tree impacted by top plane; arrow on right shows tree impacted by right fender as the Hummer came to final rest

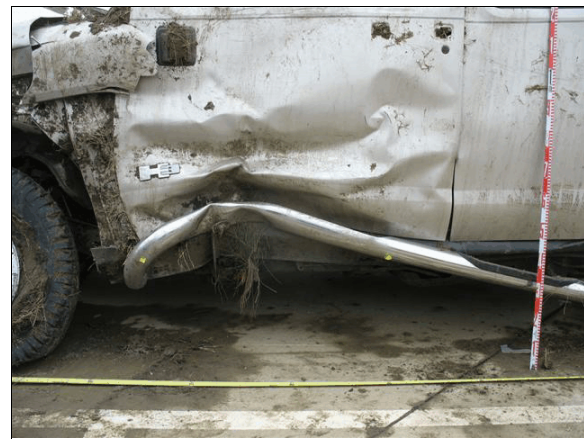
Figure 11: Damage on the left sill and undercarriage

The direct damage on the undercarriage from the tree impact (event 3) began 215 cm (84.6 in) forward of the left rear axle and was 78 cm (30.7 in) in length. The maximum crush on the undercarriage occurred at the left sill (Figure 11) and was approximately 10 cm (3.9 in).

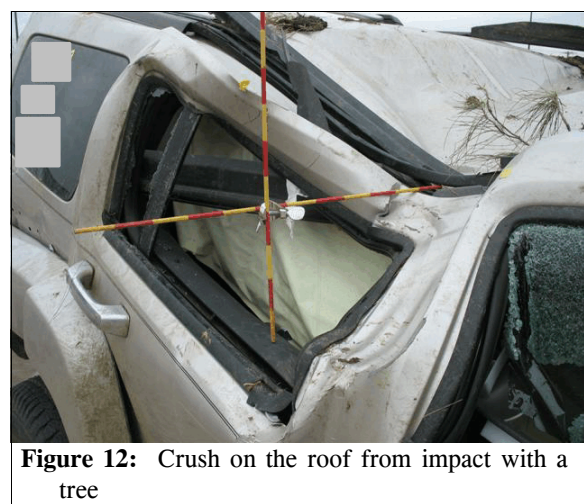
Figure 12: Crush on the roof from impact with a tree

The direct damage on the top plane from the tree impact (event 4) began 130 cm (51.2 in) forward of the left rear axle and extended across the full width of the top. The width of the direct damage was 43 cm (16.9 in). The maximum vertical and lateral crush as a result of this impact was 29 cm (11.4 in) and 12 cm (4.7 in), respectively, which occurred on the right roof side rail (Figure 12).

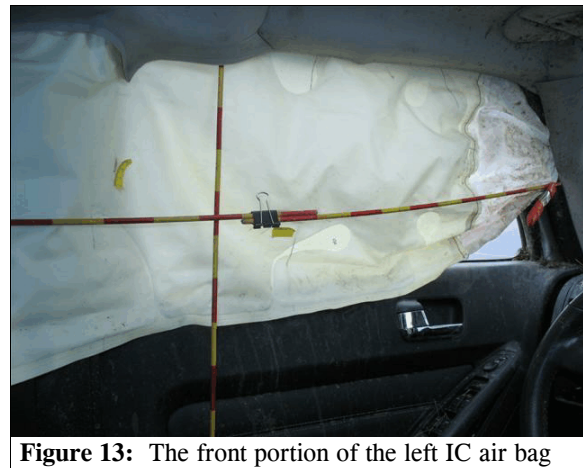
The IC air bags were located along the roof side rails inside the headliner (**Figure 13**) and extended from the A-pillar to the C-pillar. There were no visible vent ports. The deployed IC air bags were 160 cm (63 in) in width and 38 cm (14.9 inches) in height. They were attached at the A-pillars by a fabric panel that was 20 cm (7.9 in) in width. The IC air bags extended approximately 6 cm (2.4 in) below the beltline. The gap between the bottom of the IC air bag and the front of the window frame was approximately 15 cm (5.9 in) at the beltline. Inspection of the IC air bags revealed no discernable evidence of occupant contact or damage.

Figure 13: The front portion of the left IC air bag

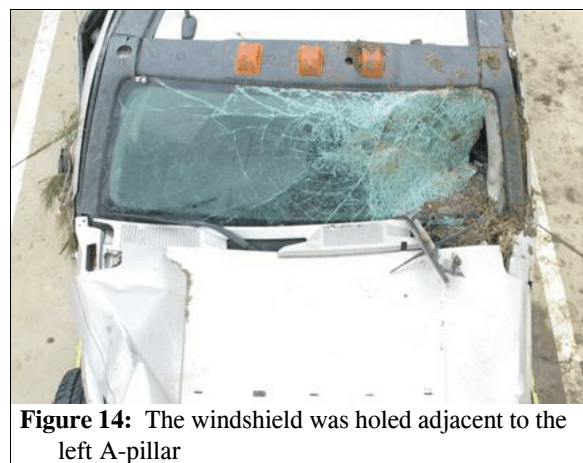
Figure 14: The windshield was holed adjacent to the left A-pillar

his head probably contacted the left A-pillar and passed partially out of the holed windshield. Due to the soiling of the interior by dirt and water, a specific occupant contact on the A-pillar was not discernable, but the A-pillar was judged to be the probable source of this injury since the driver's head passed out of the windshield adjacent to the A-pillar. He sustained a nonanatomic brain injury from the A-pillar contact and a partial avulsion of the right pinna, laceration on the left ear, laceration on the right parietal head, abrasion on the right cheek, and a laceration on the left cheek from the windshield. The driver sustained bilateral dislocation of the knees, a dislocated right elbow, and a fractured right fibula from contact with the instrument panel. He also sustained two fractures of the lateral malleolus from contact with the toe pan. The driver remained in the vehicle during the rollover. He was unsure how he exited the vehicle. The emergency medical technician records indicated that he extricated himself from the vehicle.
