**CALSPAN ON-SITE CERTIFIED ADVANCED 208-COMPLIANT  
VEHICLE CRASH INVESTIGATION**

**SCI CASE NO.: CA10002**

**VEHICLE: 2008 HONDA CIVIC LX**

**CRASH DATE: DECEMBER 2009**

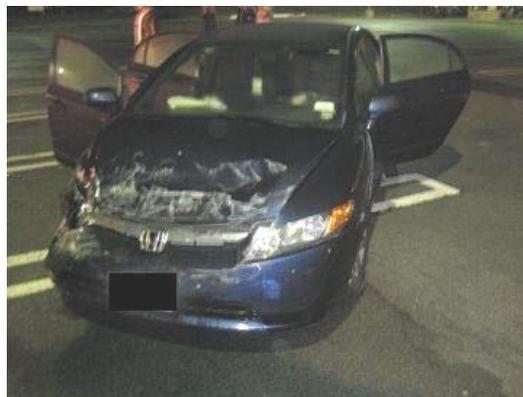
**Figure 1: On-scene image of the 2008 Honda Civic. Image supplied by the complainant.**

commercial-duty cargo van. The crash resulted in moderate-severity frontal damage to the Honda (**Figure 1**) and the deployment of the CAC frontal air bag system. The unrestrained front right passenger sustained a vertically oriented laceration of the forehead. She was transported from the scene of the crash to a local hospital where she was treated in the emergency room and released. The driver of the Honda complained of lower extremity pain and refused medical attention. The driver of the Ford was not injured.

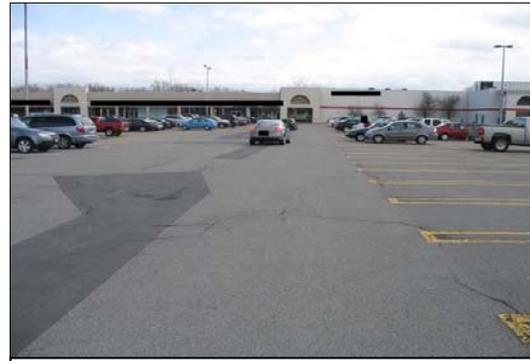
This two-vehicle crash occurred during nighttime hours in December, 2009. The crash occurred in a commercial parking lot that was delineated with parking spaces perpendicular to the driving aisle (**Figure 2**). Each driving aisle was configured for two-way traffic and was oriented in an east/west direction. The aisles measured 5.6 m (18.4 ft.) in width and were separated by a double row of parking spaces. The delineated parking spaces measured 2.8 m (9.2 ft.) in width. The weather conditions were overcast

**Figure 2: Overall view of the crash site looking east.**

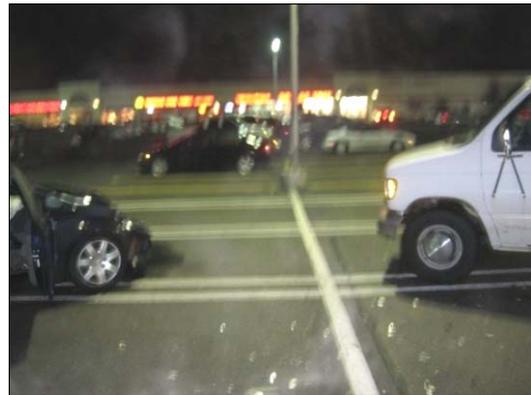
The vehicle momentum and impact configuration caused a counterclockwise rotation of the vehicles during separation. The impact and final rest locations were not documented by the police investigation. Based on the complainant-supplied on-scene image, the vehicles came to final rest in close proximity to each other in the empty parking stalls (**Figure 4**).

**Figure 4: On-scene image of the involved vehicles looking east. (Image supplied by the complainant.)**

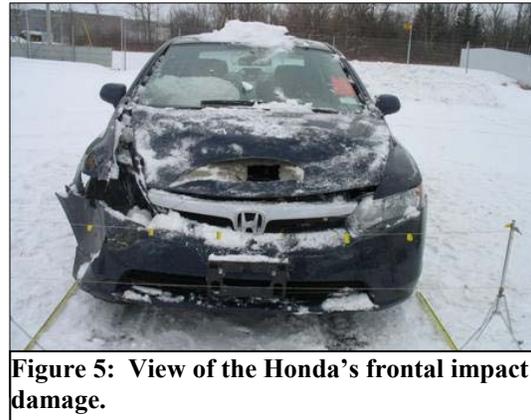
The Honda sustained moderate-severity frontal damage (**Figure 5**) from the impact event with the Ford. The direct contact damage began 55 cm (21.6 in) left of center and extended 135 cm (53.0 in) to the front right bumper corner. The damage involved the bumper fascia, grille, hood face, right front fender and right headlamp assembly. The contact damage consisted of laterally oriented abrasions to the painted surfaces and crush. The impact crushed the bumper beam to a residual depth of 8 cm (3.1 in) located at the right corner. The combined induced and direct contact damage extended the full 154 cm (47.0 in) end-width of the vehicle. The crush profile at bumper level was as follows: C1 = 3 cm (1.1 in), C2 = 3 cm (1.1 in), C3 = 4 cm (1.6 in), C4 = 5 cm (2.0 in), C5 = 5 cm (2.0 in), C6 = 8 cm (3.1 in). The Collision Deformation Classification (CDC) was 01FDEW1.

**Figure 5: View of the Honda's frontal impact damage.**

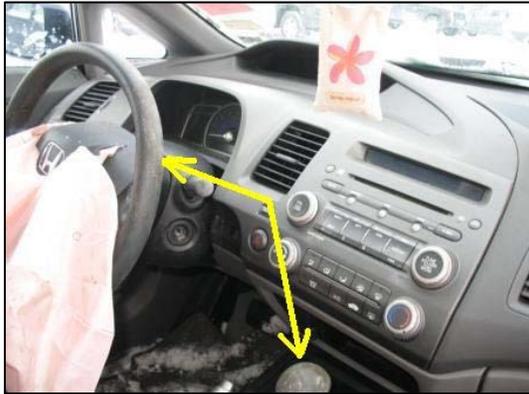
The interior of the Honda sustained minimal damage that was associated with air bag deployment and occupant contact/loading of the safety systems. The interior was not reduced in size by intrusion. The CAC air bag system deployed from the respective modules and the driver's retractor and buckle pretensioners actuated. The driver loaded the safety belt system evidenced by frictional abrasions at the latch plate and the D-ring. There was no displacement of the steering wheel rim or compression of the steering column. A probable (unknown) liquid drink or food item spilled and dried to a stain on the steering wheel rim and the top of the transmission shifter (**Figure 6**). The stain was located at the 2-3 o'clock position on the steering wheel rim.

**Figure 6: Stains to the steering wheel rim and shifter.**

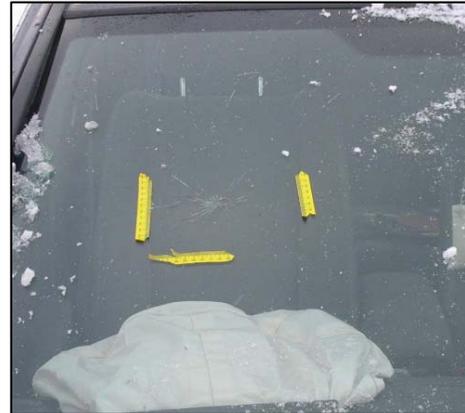
The unrestrained front right passenger loaded the deployed air bag and compressed the air bag against the windshield glazing. As a result, the exterior surface of the glazing fractured in a star-like pattern with diagonally oriented fractures located above (**Figure 7**). The interior surface of the windshield laminate was not fractured. This observation was consistent with the loading force that caused the fracture emanated from the occupant compartment and was directed forward. There was no evidence of air bag fabric transfers on the inside surface of the glazing or direct occupant contact to the windshield.

**Figure 7: Fracture/cracks of the right aspect of the windshield.**

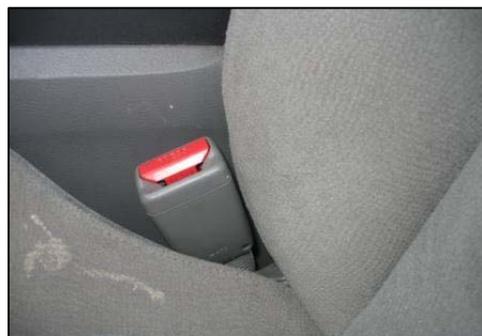
The residual position of front left safety belt buckle was 4 cm (1.75 in) below the top of the center console (**Figure 8**). A comparison measurement to the front right buckle revealed a height differential of 8 cm (3.0 in) associated with the actuation of the buckle pretensioner. Based on the actuation of the buckle and retractor pretensioners, and the loading evidence at the latch plate and D-ring, it was determined that the driver was restrained by the manual safety belt system at the time of the crash.

**Figure 8: View of the actuated driver's buckle pretensioner.**

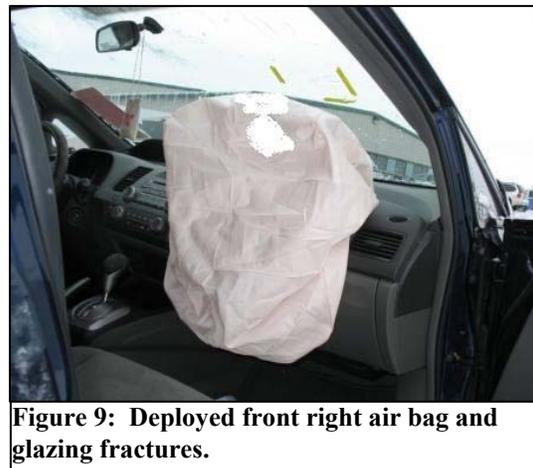
The front right air bag was mounted within the top right instrument panel and was concealed by two symmetrical H-configuration cover flaps. The forward cover flap was rectangular in shape and measured 27 cm x 8 cm (10.5 in x 3.25 in). The aft flap measured 27 cm x 6 cm (10.5 in x 2.5 in). The front right air bag was rectangular in shape and measured 37 cm x 66 cm, (14.5 in x 26 in), width by height in its deflated state. The air bag was not tethered and was vented by two lateral ports at the 3 and 9 o'clock positions; each port was 6 cm (2.5 in) in diameter. **Figure 9** is a view of the deployed front right air bag.

**Figure 9: Deployed front right air bag and glazing fractures.**

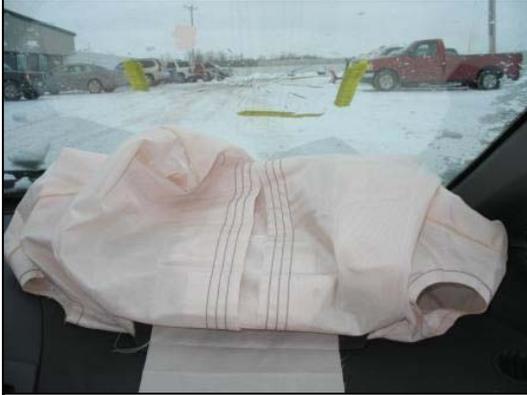
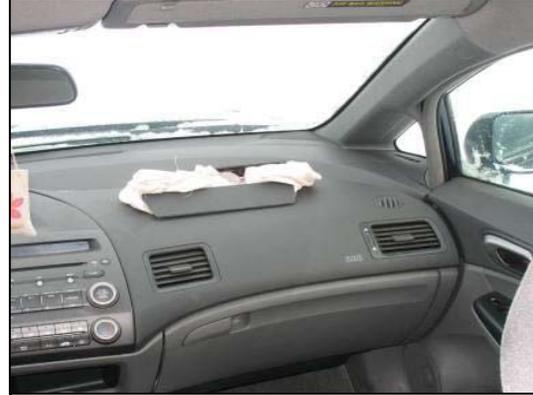
There was no damage or occupant contact evidence to either the air bag or the cover flaps. The flaps opened at the designated seams and the adjoining instrument panel was intact. An inspection of the front right air bag module, the cover flaps and its associated components in the instrument panel did not reveal any loose or separated components. The air bag appeared to have deployed as designed with all components and adjoining components intact. The inspection ruled out the possibility of a separated component or fragment associated with the air bag system causing the injury to the front right passenger as stated in the complainant's VOQ. **Figures 10 and 11** are of the front right air bag system.

**Figure 10: Location of the windshield fracture sites in relation to the deployed front right air bag.**

**Figure 11: View of the front right instrument panel sand the air bag module cover flaps.**

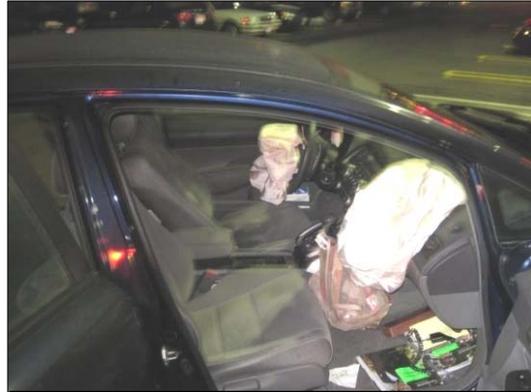
Although unconfirmed by interview data, the passenger was probably holding an object in her hands at the time of the crash. The on-scene images of the Honda showed a collection of school-type supplies on the front right floor of the vehicle. **Figure 12** is an on-scene image of the contents in the front right position of the Honda and the deployed air bag.

**Figure 12: On-scene image of the Honda Civic's deployed frontal CAC air bags and contents on the front right floor. Image supplied by the complainant.**
