On-Site Rollover Investigation  
Dynamic Science, Inc. (DSI), Case Number DS10003  
2008 GMC Yukon Denali  
Arizona  
December 2009

**Dynamic Science, Inc.**  
**Crash Investigation**  
**Case Number: DS10003**

The focus of this on-site investigation was the rollover dynamics of a 2008 GMC Yukon Denali involved in a side-impact crash. The GMC was equipped with an Electronic Stability Control (ESC) system designed to mitigate the chance of rollover, a rollover sensor, and combination side impact/rollover inflatable curtain (IC) air bags. Following the side impact with a 2007 GMC Sierra C1500, the Yukon initiated a left side leading one-quarter turn rollover. During the crash, the vehicle's IC air bags deployed.

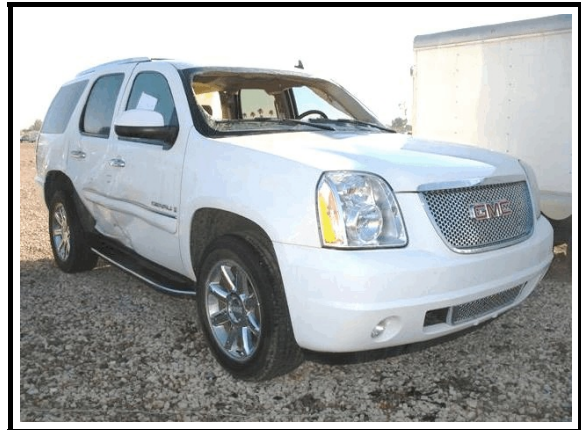
**Figure 1.** Subject vehicle, 2008 GMC Yukon Denali

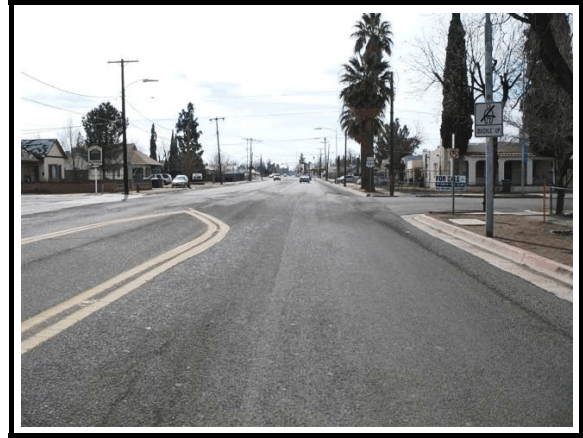
The crash occurred in a four-leg intersection consisting of an undivided east/west roadway and an undivided north/south roadway. (**Figure 2**). The intersection was controlled by stop signs for east- and westbound traffic. Conditions at the time of the crash were daylight and clear, and the roadway was dry.

**Figure 2.** Crash site, southbound approach

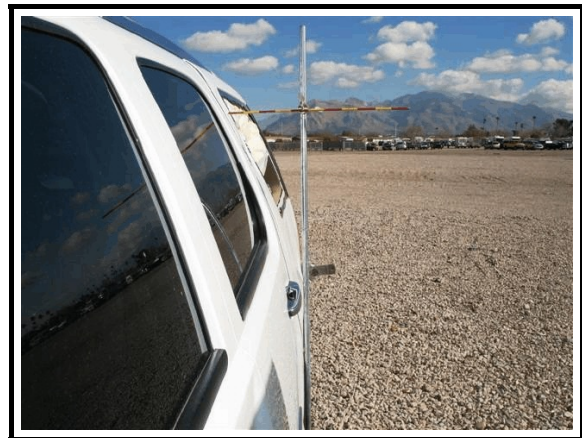
The Yukon sustained direct and induced damage to the right side resulting from the vehicle-to-vehicle impact and direct and induced damage to the left side from the rollover. Direct damage to the right side began 40.0 cm (15.7 in) aft of the rear axle, extended forward 254.0 cm (100.0 in), and ended 81.0 cm (31.9 in) aft of the front axle. The Field L was identical to the location of the direct damage. Six crush measurements were taken at mid-door level as follows:  $C_1 = 0$  cm,  $C_2 = 4.0$  cm (1.6 in),  $C_3 = 7.0$  cm (2.8 in),  $C_4 = 5.0$  cm (2.0 in),  $C_5 = 4.0$  cm (1.6 in),  $C_6 = 0$  cm. Maximum crush was located 58.0 cm (22.8 in) forward of the rear axle at  $C_3$ . The Collision Deformation Classification (CDC) for Event 1 was 02RZEW1.

**Figure 3.** Maximum lateral crush measurement

The vehicle-to-vehicle impact resulted in direct damage to the Yukon's right B- and C-pillars, and side doors. The height of maximum door crush measured 53.0 cm (20.9 in), the sill height measured 53.0 cm (20.9 in), and the Door Sill Differential (DSD) was 2.0 cm (0.8 in).

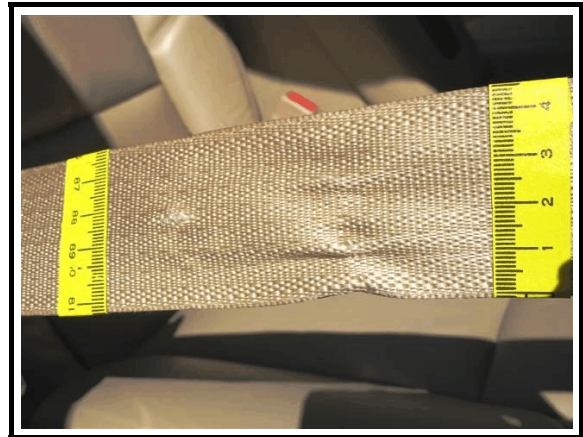
**Figure 4.** Damage to driver's safety belt webbing

The driver's safety belt D-ring was in the full-up position and the latch plate was scratched indicating historical usage. The safety belt retractor pretensioner had actuated during the crash and the safety belt was locked in the used position; the webbing measured 99.0 cm (39.0 in) in length in its post-crash state. The webbing exhibited a 5.0 x 9.0 cm (2.0 x 3.5 in) area of scuffs and stretch marks (**Figure 4**) beginning 30.0 cm (11.8 in) above the stop button. Based on the load marks on the safety belt webbing it was determined to have been used to restrain the driver during the crash.

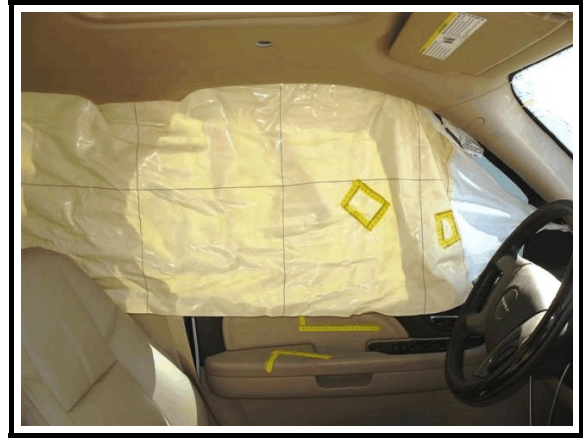
**Figure 5.** Left IC air bag

The left IC air bag deployed from the left roof side rail over the two passenger rows and the cargo area (**Figure 5**). It measured 270.0 cm (106.3 in) in length and 54.0 cm (21.3 in) in height, and covered the left side glass entirely. The air bag was configured without vent ports and was constructed with inflatable and non-inflatable sections. A 30.0 x 50.0 cm (11.8 x 19.7 in) sail and a 5.0 cm (2.0 in) tether attached the leading edge to the A-pillar and a 5.0 cm (2.0 in) tether attached the trailing edge to the C-pillar. A separate panel of the IC air bag covered the side glass in the cargo area.

The inboard panel of the left IC air bag exhibited a grease transfer and scuffs at the forward aspect. The grease transfer was determined to be a result of post-crash activities rather than an occupant loading. An area of scuffs measuring 3.0 x 4.0 cm (1.2 x 1.6 in) was located 45.0 cm (17.7 in) aft of the leading edge and 22.0 cm (8.7 in) above the bottom edge. The scuffs were consistent with occupant loading by the driver's left forearm which resulted in minor injuries. The outboard panel of the left IC air bag exhibited two abrasions at the rearward aspect where the air bag contacted the roadway.

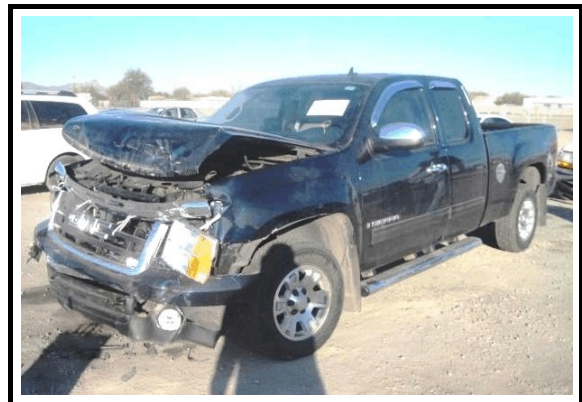
**Figure 6.** Other vehicle, 2007 GMC Sierra (auction facility photo)

Auction facility photographs showed the Sierra sustained direct and induced damage distributed across the front end from bumper corner to bumper corner and from the frame to the hood. Based on the photographs the estimated CDC for the Sierra was 10FDEW1.

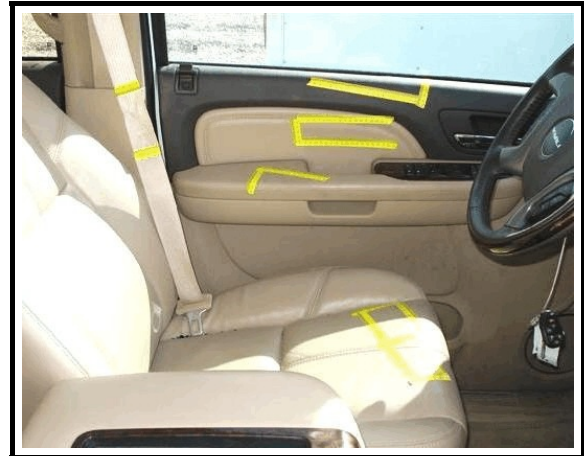
The driver did not observe the Sierra approaching prior to impact and did not attempt any evasive maneuvers. At impact, the driver of the Yukon was displaced right and slightly forward in response to the direction of force. His retractor pretensioner actuated and the vehicle's IC air bags deployed. His chest loaded the safety belt webbing and his thighs loaded the seat cushion depositing two fabric

transfers on its forward aspect (**Figure 7**).

During the left leading one-quarter turn rollover, the driver's left hip contacted the left armrest depositing a scuff measuring 3.0 x 8.0 cm (1.2 x 3.1 in). His left flank contacted the left door panel above the armrest depositing a scuff measuring 2.0 x 10.0 cm (0.8 x 3.9 in). The driver's left forearm loaded the left IC air bag and door panel below the side glass resulting in abrasions and contusions. A light-colored transfer measuring 2.0 x 17.0 cm (0.8 x 6.7 in) was deposited on the door panel as a result of occupant loading to the IC air bag and the air bag contacting the door panel.

**Figure 7.** Areas of occupant loading and contact evidence
