## ON-SITE SIDE IMPACT INFLATABLE OCCUPANT PROTECTION INVESTIGATION

CASE NUMBER - IN10004

LOCATION - MISSOURI

VEHICLE - 2009 FORD FOCUS SE

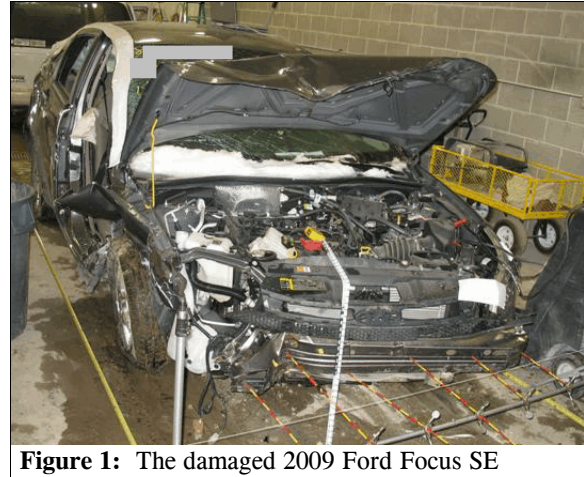
**Figure 1:** The damaged 2009 Ford Focus SE

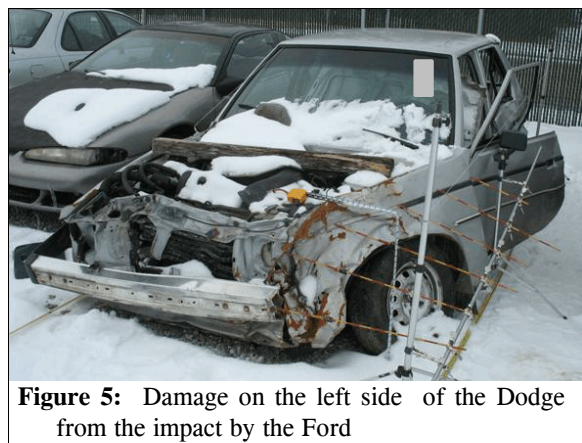
**Figure 5:** Damage on the left side of the Dodge from the impact by the Ford

**Exterior Damage:** The Dodge sustained damage on the left side during the first impact with the Ford. The front bumper and left fender were directly damaged. The direct damage ended 256 cm (100.8 in) forward of the left rear axle and extended forward along the side 73 cm (28.7 in). The crush measurements were taken at the mid-fender level and the maximum residual crush was 55 cm (21.7 in) occurring at C<sub>5</sub>. The table below presents the left side plane crush profile.

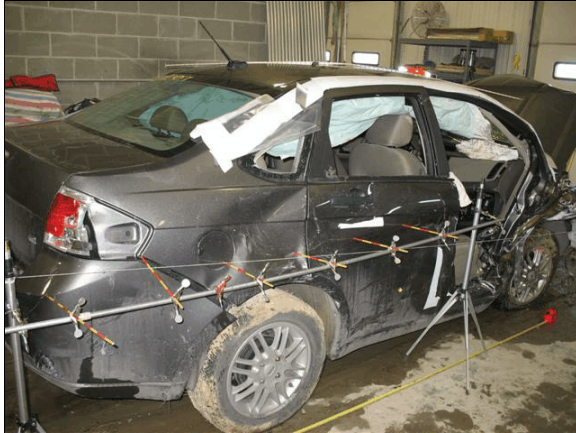
**Figure 6:** Damage on the right side of the Ford from impact with the left side of the Dodge

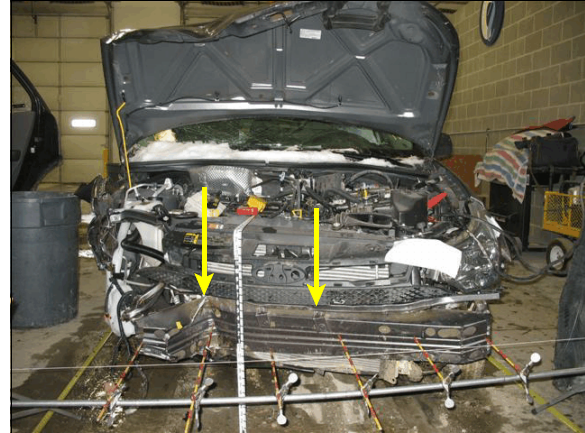
**Figure 7:** Arrow on right shows area of tree impact on the Ford for event 3; arrow on left shows damage from tree impact for event 5

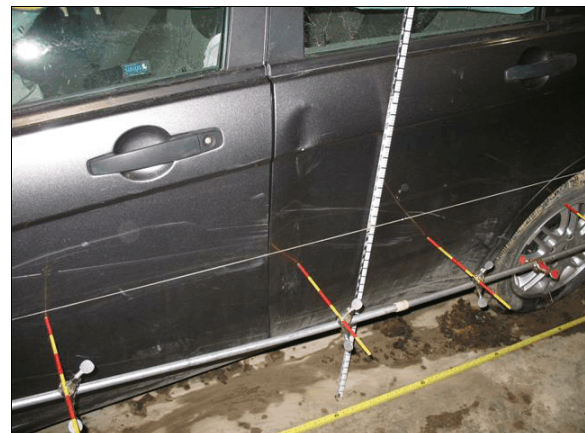
**Figure 9:** Sideswipe damage on the right side of the Ford from impact with a tree (event 4)

The vehicle sustained direct damage on the left fender and both left side doors during the impact with a tree (event 4). The direct damage ended 14 cm (5.5 in) forward of the left rear axle and extended 230 cm (90.1 in) forward along the left side. The crush measurements were taken at the mid-door level and the maximum residual crush was 3 cm (1.2 in) occurring at C<sub>3</sub>. The table below shows the left side crush profile.

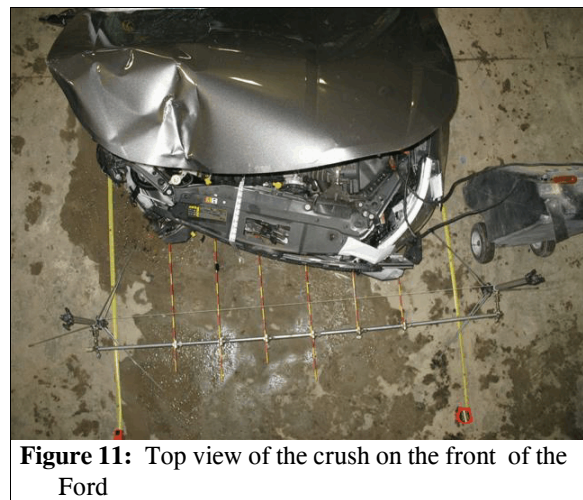
**Exterior Damage:** The Ford sustained front and right side damage during the impact with the Dodge. The front bumper fascia, fender, right front wheel, and right front door were directly damaged. The bumper bar was not engaged by this impact. The lateral distance from the side of the bumper fascia to the bumper bar was 17 cm (6.7 in). Since there was overlapping damage on the front from the impacts with the Dodge and two trees (events 1, 3, and 5), a specific crush profile for each impact could not be determined. However, the totality of the damage on the front was measured and the maximum residual crush was 36 cm (14.2 in) occurring 21 cm (8.3 in) left of the front right bumper corner (**Figure 11**). The majority of the crush on the front appeared to be related to event 5 [impact with a 19 cm (7.5 in) diameter oak tree].

**Figure 11:** Top view of the crush on the front of the Ford

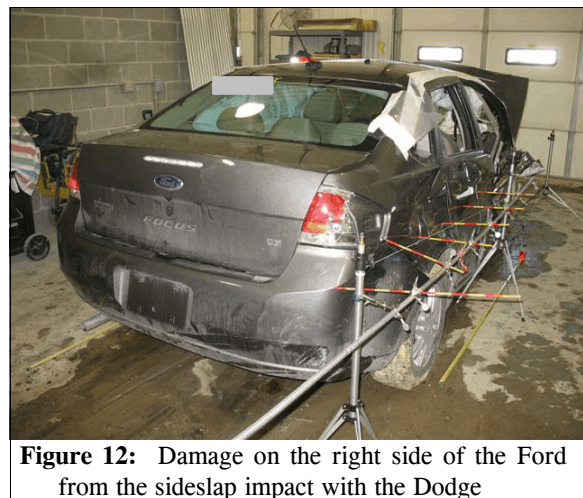
The Ford sustained direct damage on the right rear door and quarter panel (**Figure 12**) from the impact with the left side of the Dodge (event 2). The direct damage began 69 cm (27.2 in) forward of the right rear axle and extended 152 cm (59.8 in) rearward. The crush measurements were taken at the mid-door level and the maximum residual crush was 4 cm (1.6 in) occurring at both C<sub>3</sub> and C<sub>4</sub>. The table below shows the right side crush profile.

**Figure 12:** Damage on the right side of the Ford from the sideslap impact with the Dodge

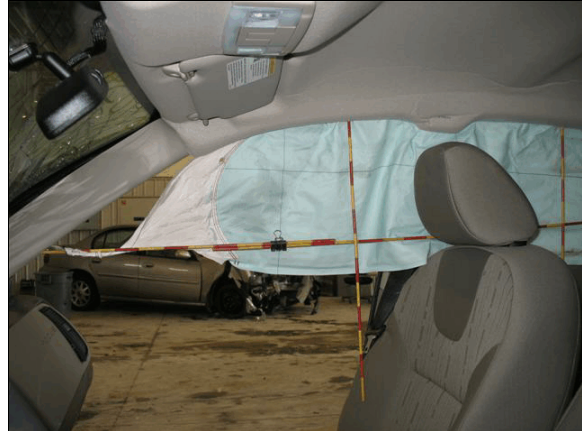
The IC air bags were located along the roof side rails inside the headliner (**Figure 15**) and extended from the A-pillar to the C-pillar. There were no external vent ports. The deployed IC air bags were 146 cm (57.4 in) in width. The height of each air bag was 34 cm (13.4 in) adjacent to the front row and 37 cm (14.6 in) adjacent to the second row. There was a non-inflatable fabric panel 15 cm in width located at the front of each IC air bag, which was attached to the A-pillar by a 19 cm (7.5 in) nylon rope. A 6 cm nylon rope attached the back of the IC air bag to the C-pillar. There was a gap above the nylon rope between the front of the fabric panel and the A-pillar that was 20 cm (7.9 in) in width at the rope and 22 cm (8.7 in) in height. There was no gap at the back of the IC air bag, which overlapped the C-pillar. The IC air bag extended vertically 1 cm (0.4 in) above the beltline adjacent to the front row and 2 cm (0.8 in) below the beltline adjacent to the second row. The inspection of the IC air bags revealed no discernable evidence of occupant contact and no damage. A dark scuff mark with vertical striations was located on the back portion of the left IC air bag and front portion of the right IC air bag, probably related to the deployment.

**Figure 15:** Front portion of the right IC air bag

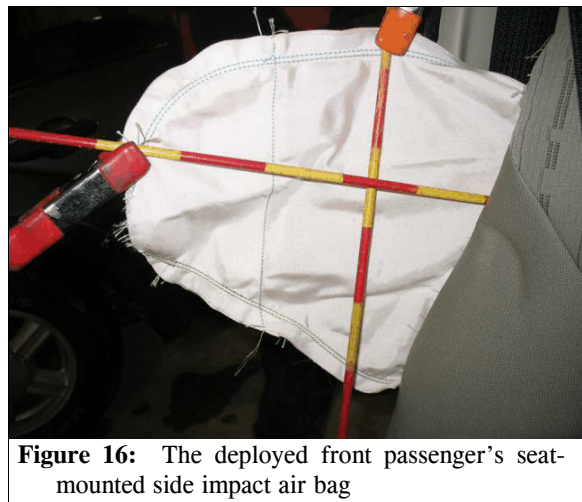
**Figure 16:** The deployed front passenger's seat-mounted side impact air bag

The front seat-mounted side impact air bags were located in the outboard side of the seat back and deployed through a tear-seam. Each deployed air bag (**Figure 16**) was 29 cm (11.4 in) in height and 23 cm (9.1 in) in width. What appeared to be a vent port 13 cm (5.1 in) in length was located on the leading edge of each air bag. There was no discernable evidence of occupant contact on either air bag and no damage.

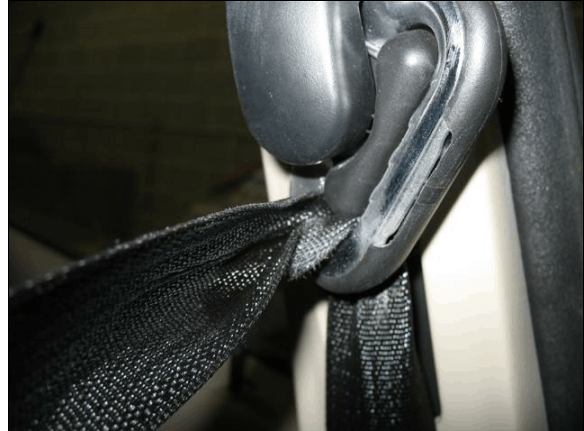
The inspection of the driver's safety belt assembly revealed that the belt webbing was bunched-up and entrapped in the D-ring (**Figure 17**). The belt webbing was stretched and the length of belt webbing extended out of the retractor was consistent with usage. The length of belt webbing as measured from the stop button to the D-ring was 150 cm (59.1 in). The pretensioner actuated and the length of the buckle stalk was reduced by 4 cm (1.6 in). This evidence was consistent with the driver's SCI interview statement that he was restrained. The EDR recorded the driver's safety belt as buckled.

**Figure 17:** The driver's belt webbing entrapped in the D-ring

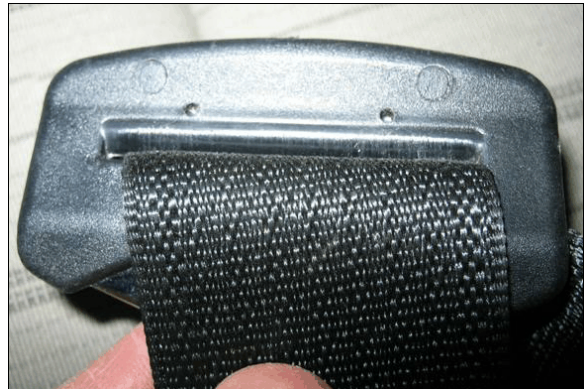
The inspection of the front right passenger's safety belt assembly revealed historical usage scratches on the latch plate and load abrasions on the latch plate belt guide (**Figure 18**). The pretensioner actuated and the length of the buckle stalk was reduced by 5 cm (2 in). The belt webbing also had a slight stretched appearance. This evidence was consistent with the driver's interview statement that the front right passenger was restrained. The EDR recorded the passenger's safety belt as buckled.

**Figure 18:** Load abrasions on the front passenger's latch plate belt guide
