CALSPAN REMOTE ROLLOVER CRASH INVESTIGATION

SCI CASE NO.: CA10006

VEHICLE: 2003 LINCOLN AVIATOR

CRASH DATE: JUNE 2008

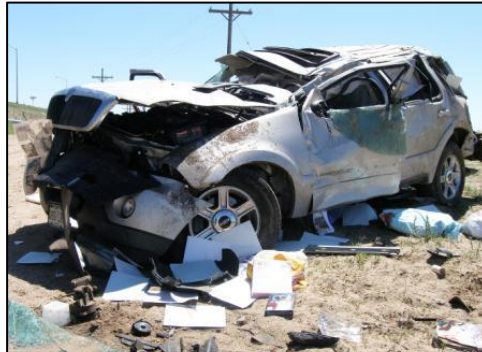
Figure 1. Image of the Lincoln at final rest. (Image courtesy of the investigating police agency.)

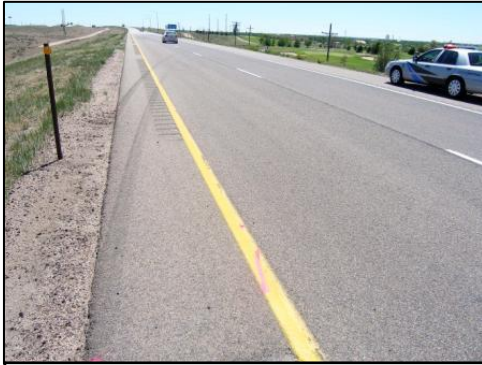
The driver of the Lincoln was traveling in a southerly direction in the left lane of the divided roadway at a police reported speed of 130 km/h (80 mph). The driver negotiated a sweeping left curve several hundred feet prior to the crash site. As she exited the curve, she allowed the vehicle to drift left across the rumble strips of the east shoulder and onto the dirt median surface for a distance of 36 m (118 ft) evidenced by the left front and left rear tire marks. During this trajectory, the driver initiated a right steering input that induced a clockwise (CW) yaw (**Figure 2**). The left rear area of the Lincoln sideswiped a delineator post that was located outboard of the shoulder.

Figure 2. Return to travel lanes following median departure.

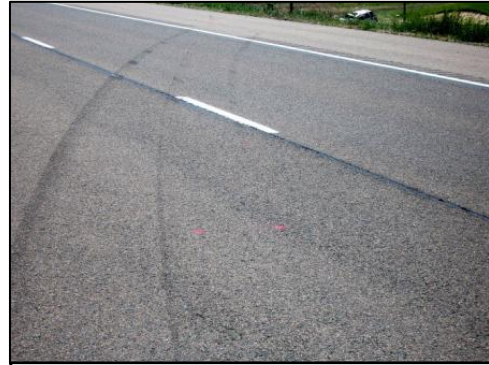
The Lincoln reentered the inboard shoulder and crossed the inboard southbound travel lane. The right front tire began to mark at the midpoint of the inboard travel lane and continued onto the outboard (right) shoulder. The Lincoln traveled a police reported distance of 43 m (140 ft) across the southbound travel lanes (**Figure 3**) during this CW yaw.

Figure 3. CW yaw across travel lanes.

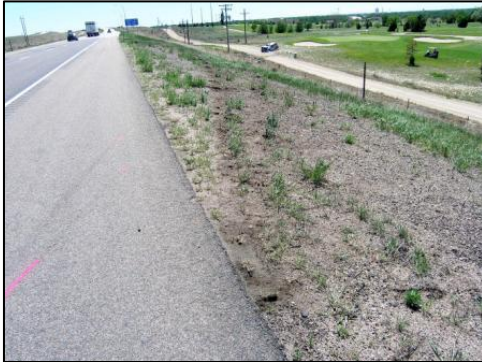
The driver counter steered left steering in an attempt to regain control of the Lincoln as it crossed the travel lanes. The left side tire marks merged as the vehicle entered the outboard shoulder. The left steering input reversed the vehicle's rotation (**Figure 4**) from CW to counterclockwise (CCW). The Lincoln continued to rotate CCW as it traversed the outboard shoulder and entered the dirt and grass roadside. The vehicle traveled a police reported distance of 21 m (69 ft) in the CCW yaw. The right side tires and wheels furrowed into the dirt surface as the Lincoln yawed approximately 40-50 degrees CCW.

Figure 4. Lincoln reverses rotation from CW to CCW.

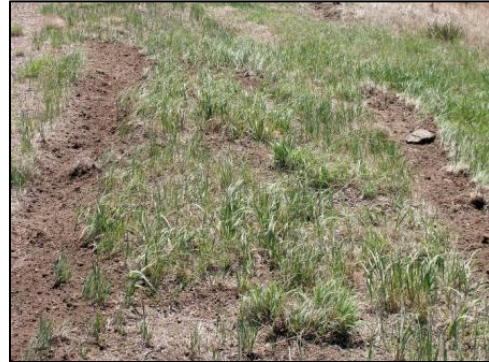
Figure 5. Right side tire furrows at trip point.

The furrowing of the right side tires (**Figure 5**) tripped the Lincoln into a right side leading rollover as its center of gravity continued down the negative sloped embankment that extended beyond the roadside. The rollover sensor deployed the IC air bags during the rollover. At the Lincoln rolled down the embankment, the frontal air bags deployed and the front safety belt buckle pretensioners actuated. The vehicle rolled a minimum of eight-quarter turns down the embankment and traveled through a wire fence before coming to rest in an upright position on the outboard edge of the dirt access road. The fence impact did not appear to alter the trajectory of the vehicle. The Lincoln came to rest 67 m (221 ft) from the initial trip point, facing in an easterly direction. The rollover was classified as a tripped/uninterrupted event.

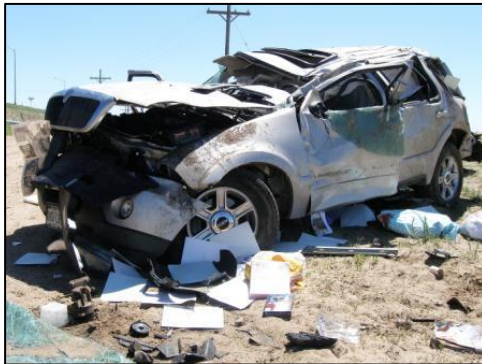
The exterior of the Lincoln sustained severe damage that was associated with the rollover. The rollover was initiated as a right side leading event. As the Lincoln continued to roll down the embankment, the rollover translated to an end-over type configuration. Maximum vertical crush was an estimated 30-36 cm (12-14 in) at the left A-pillar area with approximately 25 cm (10 in) of lateral displacement at the left A-pillar (**Figures 6 and 7**). The left B-pillar was displaced laterally approximately 15-20 cm (6-8 in). This left roof side rail area of the Lincoln probably deformed during the third-quarter turn, or later in the rollover event.

Figure 6. Front left view of the rollover damage.

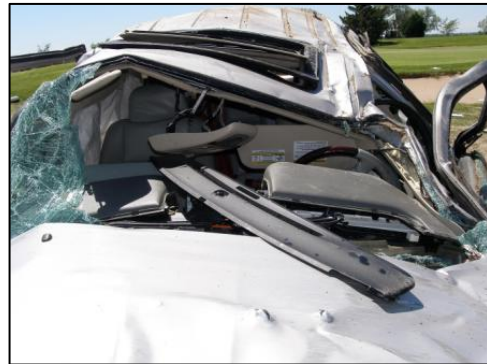
Figure 7. Vertical and lateral displacement at the left A-pillar area.

The interior of the Lincoln was significantly reduced in size by intrusion of the roof side rails and roof structure. Maximum intrusion was located at the left upper A-pillar and involved both vertical and lateral displacement. The roof at the left A-pillar location was deformed downward and displaced laterally, buckling the roof panel over the front right passenger position. The left B-pillar was displaced laterally into the driver's seat back. The B-pillar trim panel and the overhead console separated from their mounting points. The left D-pillar and the backlight header were displaced forward during the rollover. Intrusion into the second row seat positions appeared to be minimal.

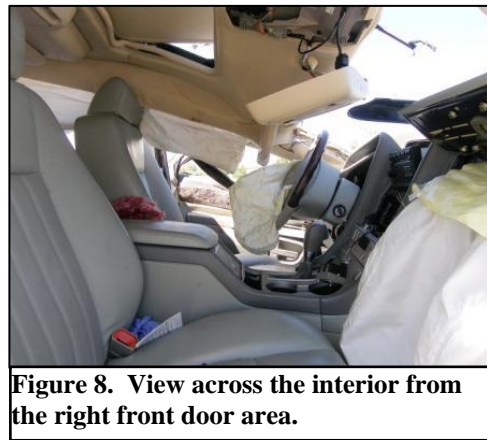
Figure 8. View across the interior from the right front door area.

Figure 8 is an overall view across the interior from the right front door area.

The lack of detailed interior images prohibited the identification of interior occupant contact points within the Lincoln. The driver was partially ejected through the left front window opening. Contact evidence that consisted of body fluid and tissue was present on the exterior surface of the left roof side rail and the deployed IC air bag. This contact evidence was also present on the inside surface of the left front laminate side glass.

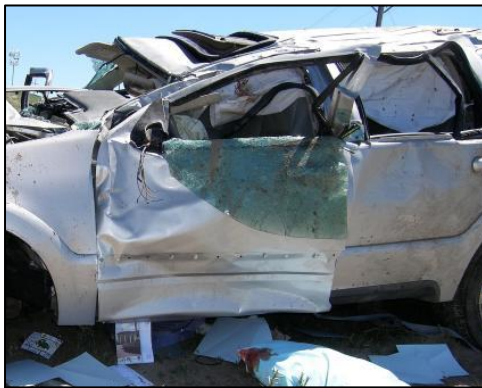
The on-scene images of the left IC air bag indicated the driver was partially ejected through the front left door window opening. The laminated side glass was cracked and out of place. The glazing remained attached to the track assembly and was lying on the side surface of the door panel. Body fluid associated with the partial ejection was present on the outside surface of the left IC at the midpoint of the door. The leading edge of the left IC was soiled and abraded from contact with ground during the rollover event. The left IC appeared to be captured between the intruding left B-pillar and the front left head restraint. The IC should have deployed prior to the displacement of the pillar; therefore the air bag was probably placed in this position during the extrication of the driver. The forward tether strap was separated from the air bag. It is unknown if this occurred during the rollover event or if the tether was cut during the extrication of the driver. **Figure 9** is an overall view of the deployed left IC air bag and the laminate side glazing.

Figure 9. Deployed left IC air bag and laminated side glazing.

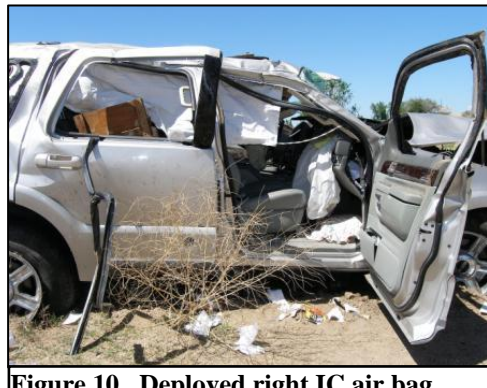
The right IC air bag did not appear to be damaged or displaced by the rollover event. The right forward tether remained intact (**Figure 10**).

Figure 10. Deployed right IC air bag.

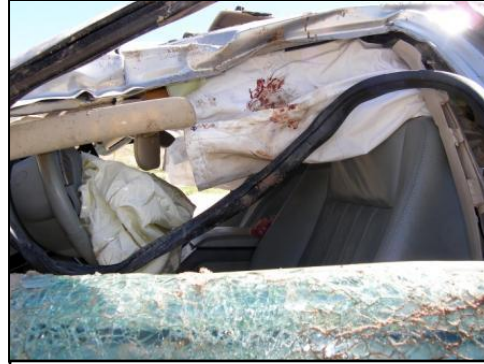
Based on the evidence to the vehicle, the driver was partially ejected from the vehicle. Specifically, her head traveled through the glazing opening and was captured between the ground and the midpoint of the left roof side rail. Body fluid was present on the outboard

aspect of the deployed IC air bag at the midpoint of the door area and aft of the leading edge of the IC (**Figure 11**). Body fluid was also present on the inside aspect of the side window glazing that remained attached to the track assembly, but was intact, cracked and out of place, lying against the door panel.

Figure 11. Driver contact evidence on the exterior of the left IC air bag and the left roof side rail.

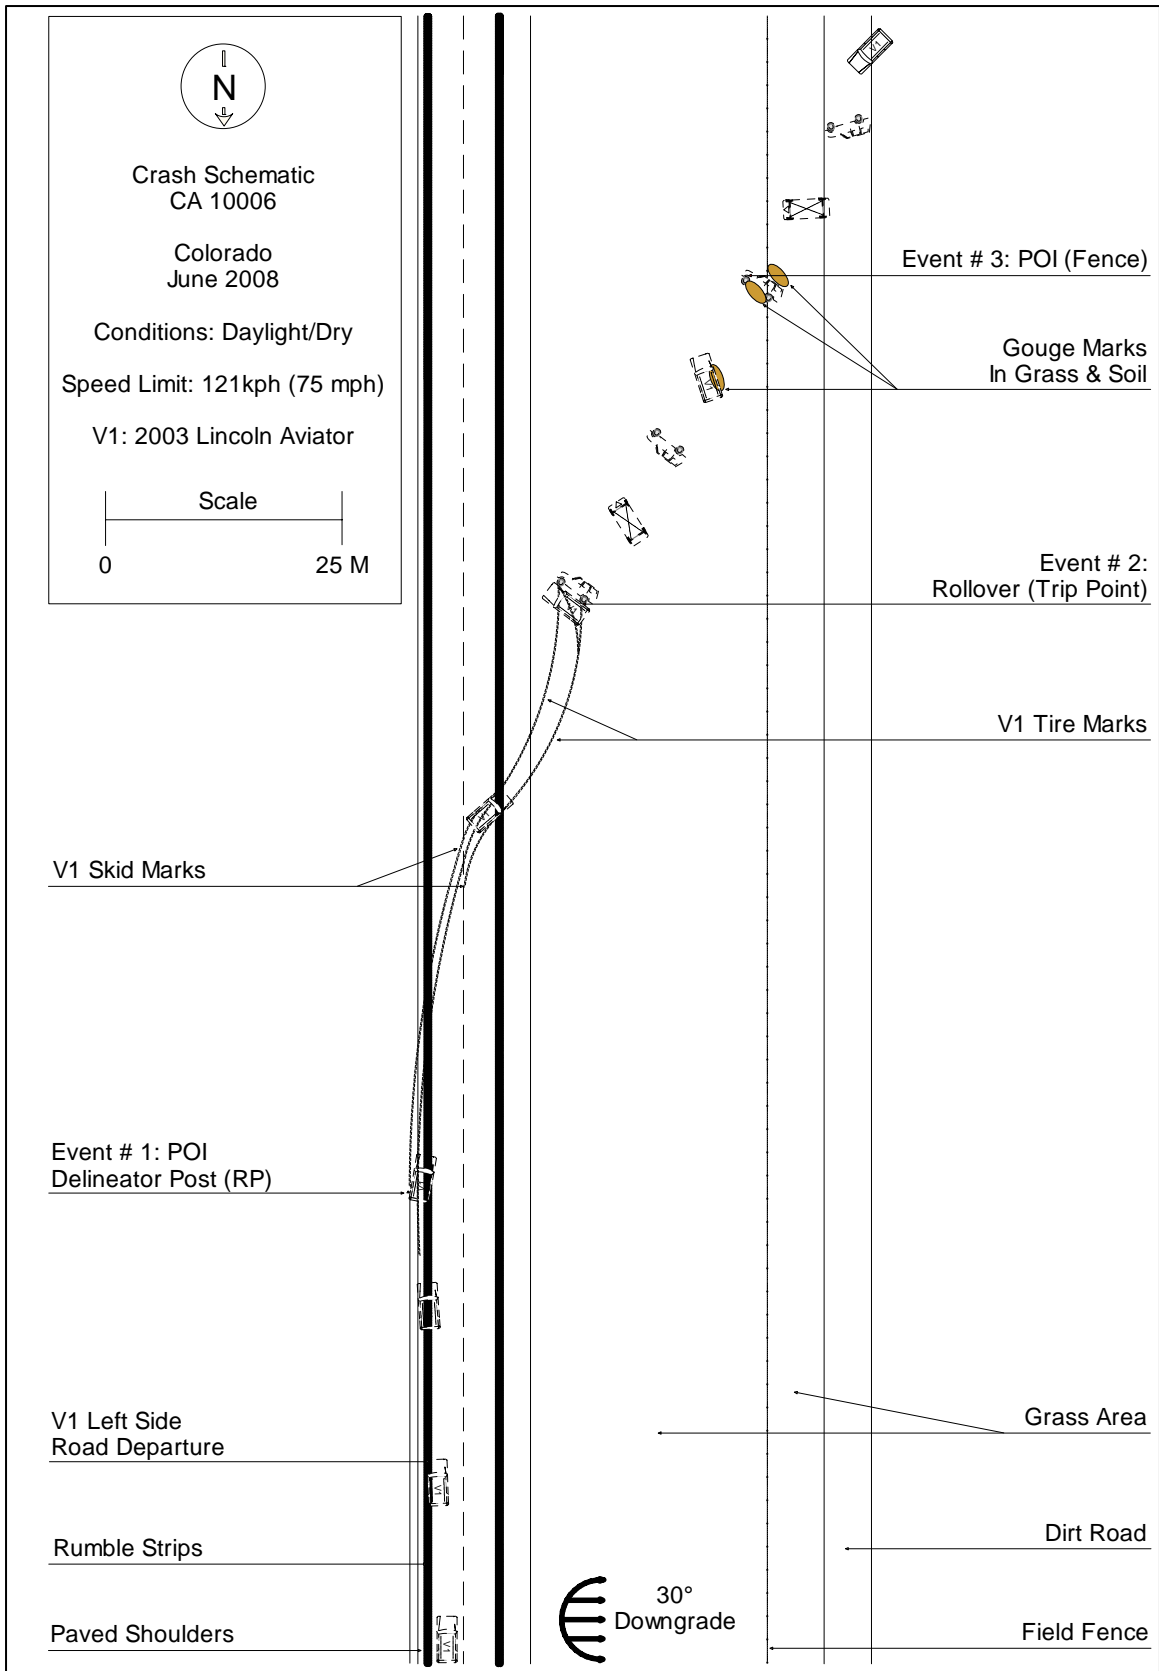
Figure 12. Crash Schematic

km/h (75 mph). At the time of the crash, atmospheric conditions were clear with dry road conditions. The crash schematic is attached to this report as **Figure 12**.
