**CALSPAN ON-SITE POTENTIAL UNINTENDED ACCELERATION
CRASH INVESTIGATION
SCI CASE NO.: CA10007**

VEHICLE: 2008 TOYOTA AVALON

LOCATION: GEORGIA

CRASH DATE: FEBRUARY 2010

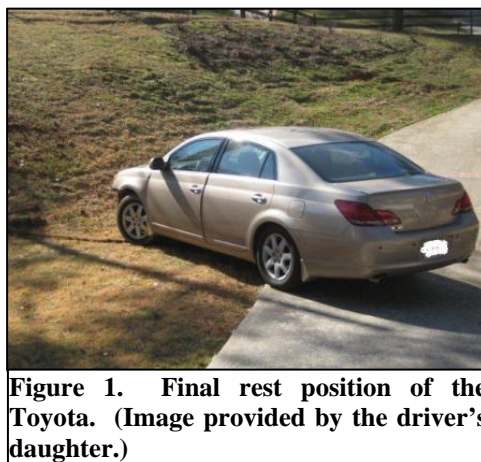
Figure 1. Final rest position of the Toyota. (Image provided by the driver's daughter.)

At rest, the Toyota was straddling the driveway and the lawn area with the engine running at idle (**Figure 1**). Acceleration tire marks across the concrete and grass surfaces evidenced the vehicle's backing trajectory. The driver was not injured in this crash. The Toyota was subsequently towed to a local dealership where it was retained for this investigation.

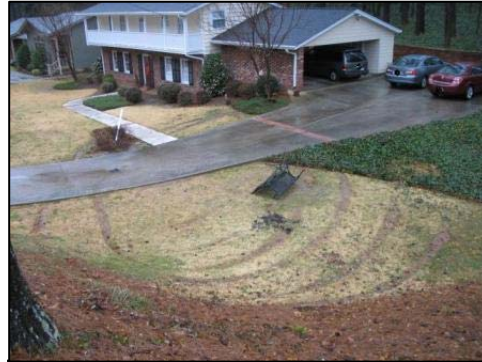
This alleged UA crash occurred at the residence of the driver during daylight hours. **Figure 2** is an overall view of the crash site. The backing crash originated in the attached side-loading carport to the single family residence. The carport was 5.9 m (19.4 ft) in width and 6.2 m (20.3 ft) in depth. The floor of the carport was concrete with a smooth surface. The concrete driveway was curved and extended to a maximum width of 7.8 m (25.6 ft) to the north of the carport. Both edges of the driveway tapered toward the centerline, east of the carport toward the street. The driveway was level in the area of the carport and sloped downward to the east and transitioned to an upward slope toward the cul-de-sac. The driveway grade was a negative 3 percent, measured at the east edge of the carport and increased to a negative 4.2 percent at a point 5.0 m (16.1 ft) east of the carport. In this area, the driveway tapered to a width of 4.9 m (16.1 ft).

Figure 2. Overall view of the crash site and the backing trajectory of the Toyota.

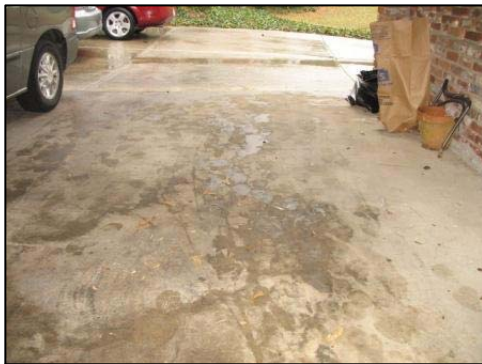
The Toyota exited the carport (**Figure 3**), traversed the width of the concrete driveway, and departed the north edge of the driveway into the ivy covered embankment (**Figure 4**). The physical evidence consisted of a right front acceleration tire mark that was 0.3 m (1.0 ft) in length on the north edge of the concrete driveway. The front tire marks continued in the ground ivy as the Toyota continued rearward. The front undercarriage of the Toyota bottomed-out in the ground ivy as the vehicle traversed the negative slope of the embankment. The compression of the ivy (similar to a gouge) was located approximately 1.0 m (3.3 ft) north of the driveway edge.

Figure 3. View of the backing trajectory of the Toyota from inside the carport.

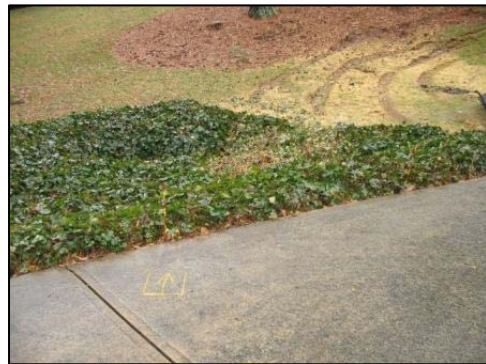
Figure 4. Departure from driveway onto the ivy and lawn areas.

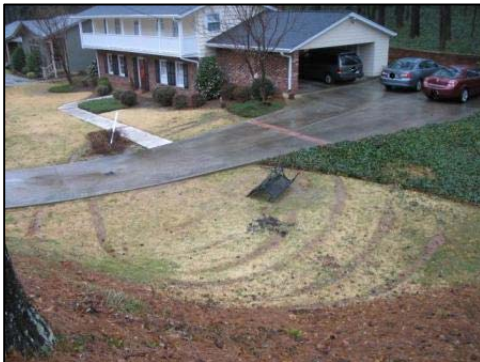
The Toyota continued rearward as it was redirected in a southerly direction. At this point, the Toyota traveled approximately 180 degrees on a CW arc (**Figure 5**). The diameter of this semi-circular trajectory was 11.3 m (37.1 ft). The vehicle crossed the

Figure 5. Overall view of the vehicle's backing trajectory and the associated physical evidence.

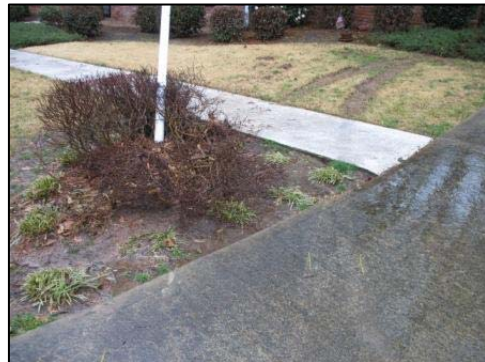
Figure 6. Acceleration tire marks across the driveway, sidewalk, and lawn areas.

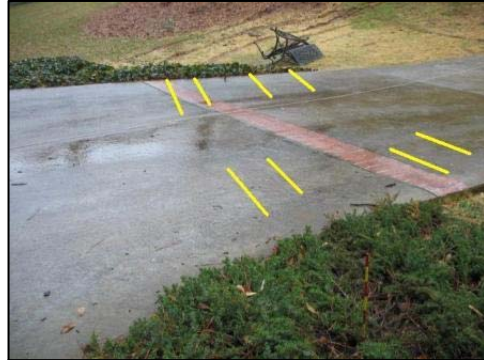
Figure 7. Acceleration tire marks across the driveway at the completion of 360 degrees of travel.

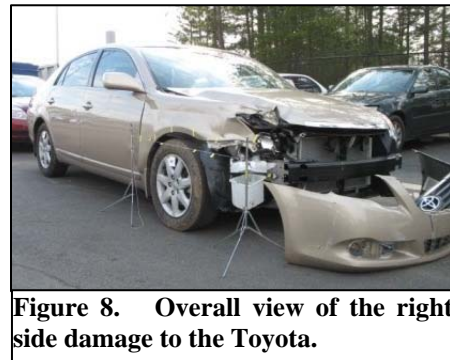
The 2008 Toyota Avalon sustained moderate severity damage from this multiple event crash (**Figure 8**). The initial impact event involved the right front fender impacting the lamp post at the driveway/sidewalk juncture. The damage was subsequently masked by the subsequent tree impact. The same area of the vehicle also impacted the garden bench that was positioned on the lawn area between the sidewalk and the carport.

Figure 8. Overall view of the right side damage to the Toyota.

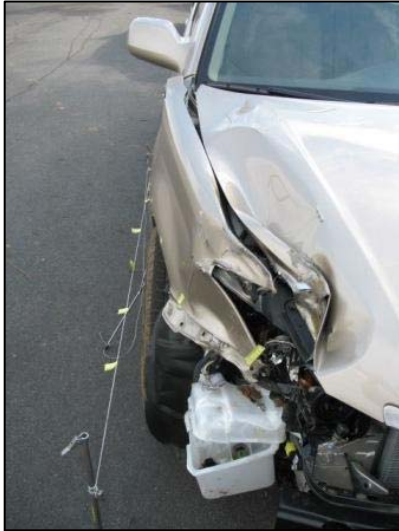
The impact with the 20.3 cm (8.0 in) diameter tree (Event 3) involved the right front fender, the right side of the front bumper fascia, and the right headlamp assembly. The direct contact damage on the right front fender began 47.6 cm (18.75 in) forward of the right front axle and extended 25.4 cm (10.0 in) forward to the leading edge of the fender. The impact crushed the fender to a maximum depth of 19.7 cm (7.75 in) located at the leading edge of the fender. The combined induced and direct contact damage length was 94.6 cm (37.25 in) and involved the full length of the fender. The documented residual crush profile was as follows: C1 = 0 cm, C2 = 1.9 cm (0.75 in), C3 = 3.8 cm (1.5 in), C4 = 8.1 cm (3.2 in), C5 = 9.5 cm (3.75 in), C6 = 19.7 cm (7.75 in).

The lateral impact force of the tree impact displaced the frontal structure minimally to the left resulting in binding of the left front door against the left front fender. The opening of the left front door at the scene produced damage to the trailing edge of the fender. The front bumper fascia and the grille separated from the frontal structure as a result of the tree impact. The fascia and grille came to rest on the lawn area between the sidewalk and the carport. **Figures 9 and 10** are views of the right front fender damage.

Figure 9. Lateral deformation of the right front fender area.

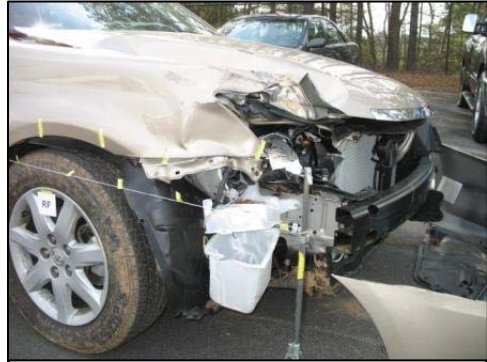
Figure 10. Tree impact damage to the right front fender area.

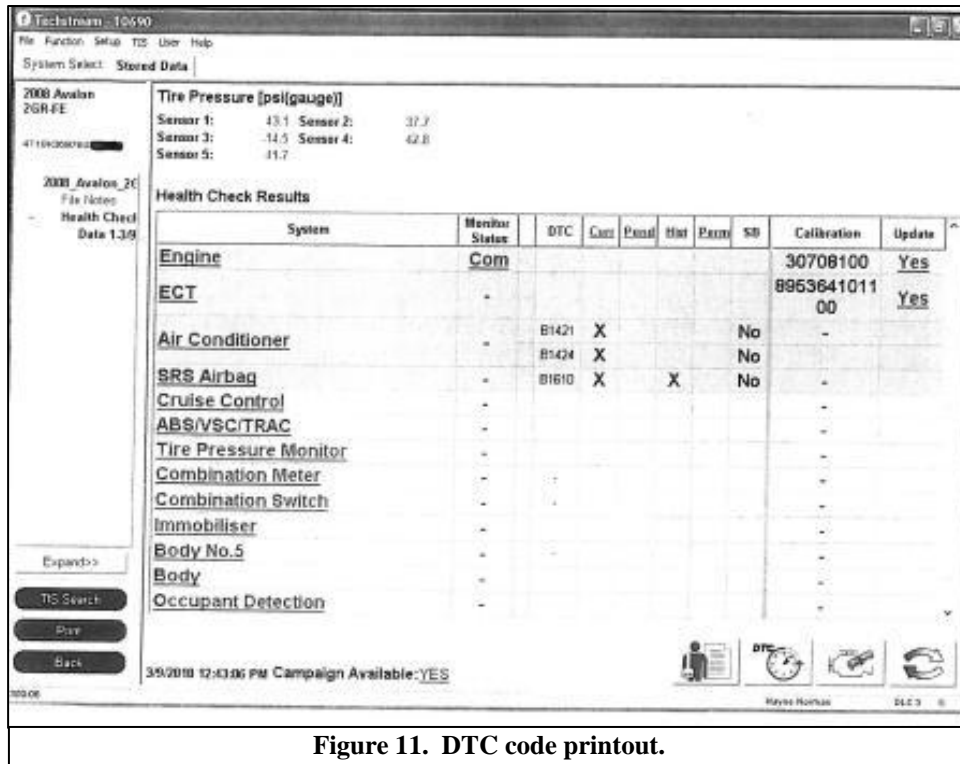
The Toyota retained three DTCs; two related to the automatic HVAC system and one related to the external air bag sensor located at the outboard aspect of the right front frame rail. The Toyota technician indicated that the air conditioner DTC codes depicted in **Figure 11** (B1421 and B1424) relate to the solar-sensing system reading artificial lighting in the service facility. The SRS air bag code B1610 indicated a probable fault with the external sensor that resulted from direct contact with the tree impact. It should be noted that the instrument panel air bag indicator light illuminated and remained on during the run-time of the vehicle at the time of the SCI inspection.

Figure 11. DTC code printout.

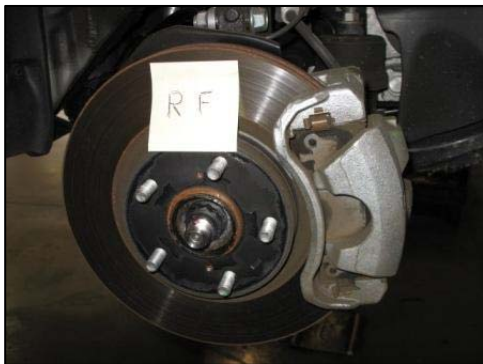
A preliminary inspection of the exterior condition of the Toyota was performed as the technician was positioning the lift arms. As the Toyota was raised on the lift, all four tires and wheels were visually inspected for evidence of damage; none was found. The brake caliper and rotors were viewed through the spokes of the alloy wheels and all four brake systems appeared to be free of damage and there was no evidence of prolonged heat due to braking.

The technician used a pneumatic impact wrench to remove the five lug nuts from the left front, right front and right rear wheels. The tire/wheels were removed from these positions and the brakes were again inspected. The technician used the pneumatic impact wrench to remove the 14 mm (socket size) caliper bolts from the right front and right rear brake assemblies. He removed the right side calipers and the brake pads. There was no evidence of wear to the OEM metallic brake pads or evidence of heat build-up due to prolonged braking. The right rear pads did exhibit subtle surface rust build-up attributed to nonuse that developed during the two weeks between the incident and the SCI inspection. **Figures 12 and 13** are views of the right front brake system.

Figure 12. Right front rotor and caliper.

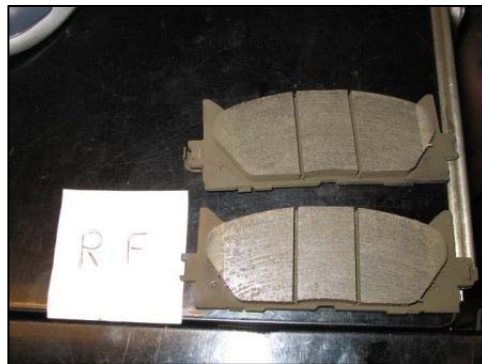
Figure 13. Right front brake pads.

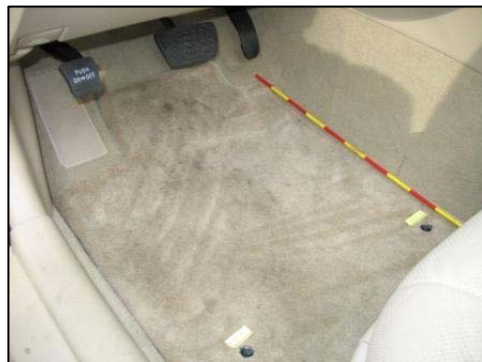
The 2008 Toyota Avalon was equipped with the OEM carpeted floor mats (**Figure 14**) that were dealer installed at the time of the new car delivery to the driver. The mats consisted of a beige carpet top surface bonded to a molded closed cell foam backing. The pliable backing was identified by the following number molded into the backing:

Figure 14. Position of the OEM carpeted floor mat.

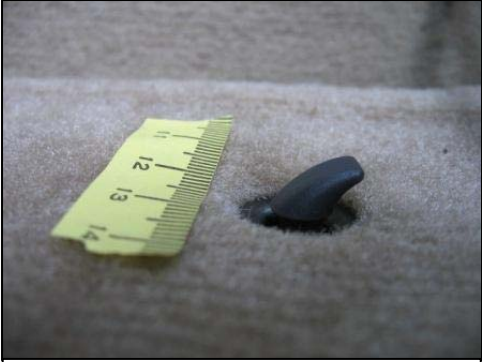
vehicle's carpet. The hooks were positioned through the grommets of the floor mat (**Figure 15**) and the mat was held secure without interference with the accelerator or brake pedals.

Figure 15. Hook protruding through the floor mat.

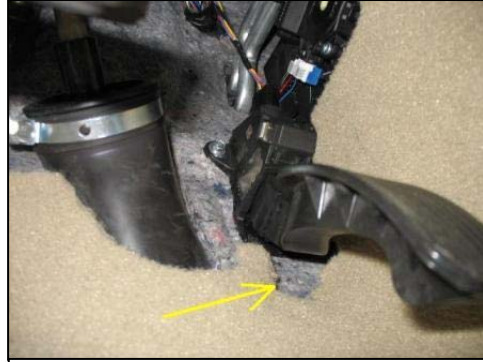
The OEM carpet was cut in a U-shaped pattern around the stalk of the accelerator pedal (**Figure 16**). There was no binding or interference of the carpet with the pedal.

Figure 16. OEM cutout of carpet behind accelerator pedal.

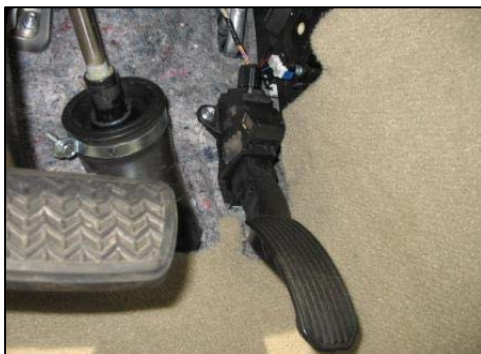
The Toyota Avalon was subject to both the Floor Mat recall (NHTSA Campaign No. 09V388000) and the Sticky Pedal recall (NHTSA Campaign No. 10V01700). The accelerator pedal was manufactured by CTS (**Figure 17**). The recall shim was installed in the pedal by the dealership on February 15, 2010. The crash occurred 10 days after the service. At the time of the SCI inspection, the pedal was repeatedly cycled to a full-throttle position and the pedal operated without binding and yielded strong return tension. The pedal was identified by the following nomenclature (**Figure 18**):

Figure 17. Overall view of the CTS accelerator pedal.

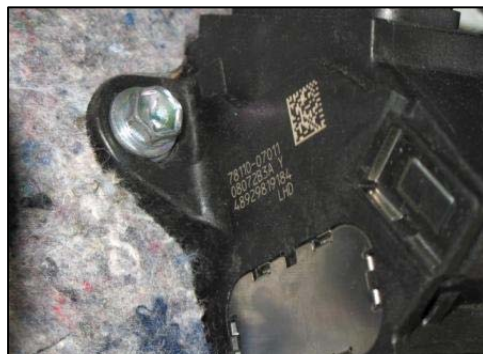
Figure 18. Identification numbers on the CTS pedal.

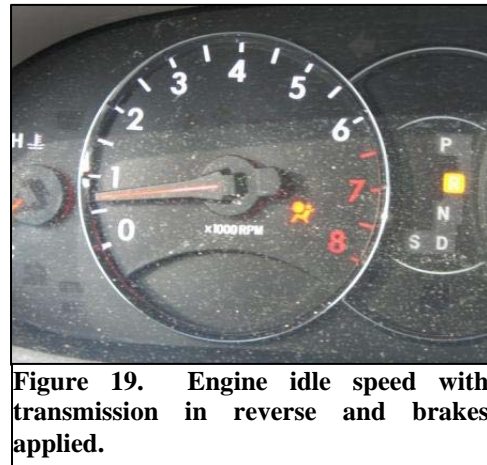
The SCI investigator conducted a test of the engine speed several hours following the above process using the vehicle's tachometer. The exterior ambient temperature at the time of this procedure was 22.7 degrees C (73.0 degrees F). With the transmission selector lever in the park position, the engine started immediately and ran at a fast idle of approximately 1200 Revolutions Per Minute (RPM). Within a 15-20 second period, the engine idle dropped to 1000 RPM, then to 900 RPM and to 800 PRM. At this idle speed, the brake pedal was depressed and the transmission was placed in reverse. The engine speed dropped to approximately 700 RPM (**Figure 19**). The transmission was placed in park and the engine returned to a normal idle speed.

Figure 19. Engine idle speed with transmission in reverse and brakes applied.

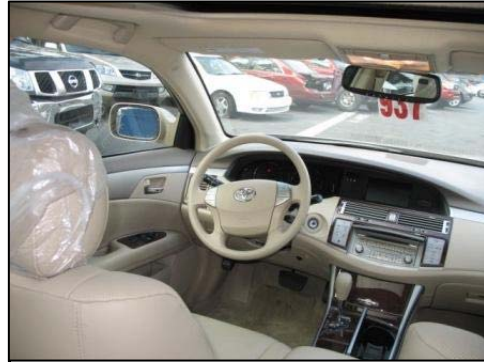
inspection. The driver stated she was restrained by the manual safety belt. The adjustable D-ring was in the full-up position. The driver was not wearing prescription eyeglasses or sunglasses at the time of the crash. She stated that her right foot was on the brake pedal as she shifted the transmission selector from park to reverse and maintained her foot position on the brake pedal as she began to back out of the carport. **Figure 20** is an overall view of the driver's position.

Figure 20. Overall view of the driver's position.
