ON-SITE SIDE IMPACT INFLATABLE OCCUPANT PROTECTION INVESTIGATION

CASE NUMBER - IN10007

VEHICLE - 2008 FORD ESCAPE XLT

CRASH DATE - December 2009

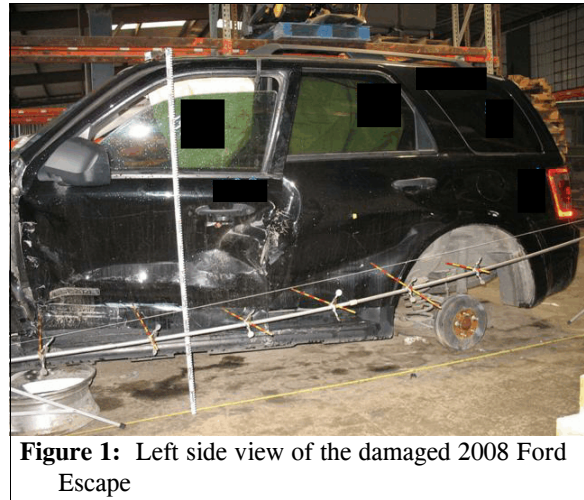
Figure 1: Left side view of the damaged 2008 Ford Escape

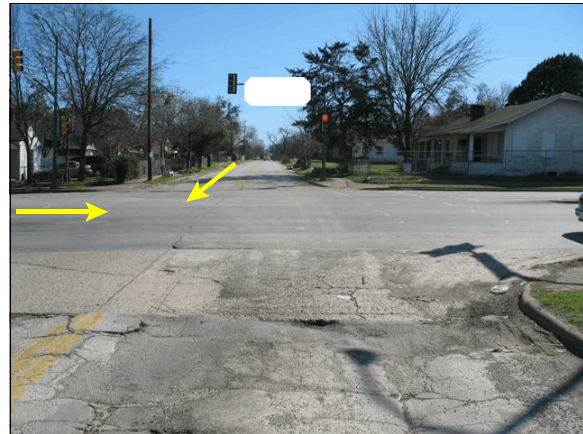
Figure 2: Approach of the Escape to the intersection; arrow on left shows approach of the Taurus; arrow on right shows approach of the Chevrolet

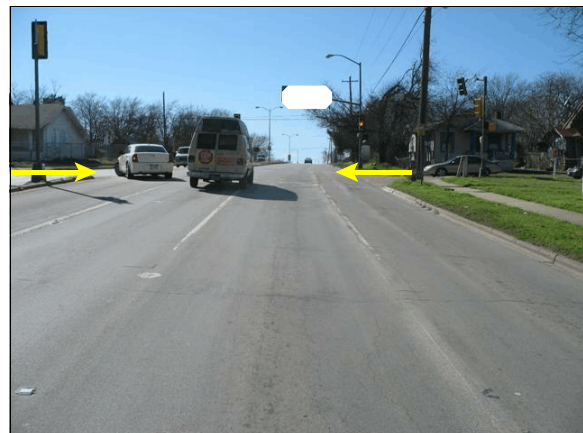
Figure 3: Approach of the Taurus; arrow on right shows the approach of the Escape; arrow on left shows the approach of the Chevrolet

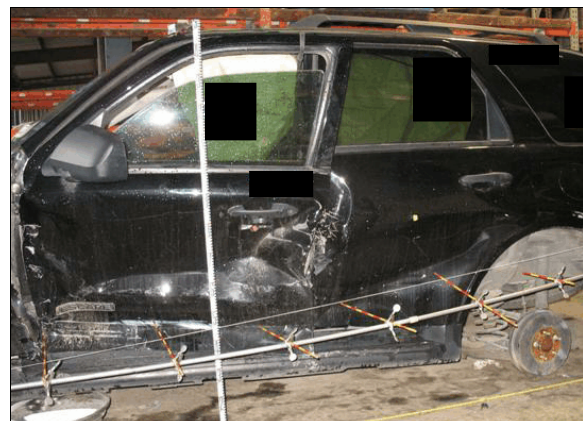
Figure 4: Damage on the left side plane of the Escape from the impact by the front plane of the Taurus

Exterior Damage: The Escape sustained left side plane damage during the impact with the Taurus. The direct damage involved the lower left A-pillar, the left front door, left B-pillar, and the left rear door. The direct damage began 63 cm (24.8 in) forward of the left rear axle and extended 137 cm (53.9 in) forward along the left side. The crush measurements were taken at the lower door level and the residual maximum crush was 20 cm (7.9 in) occurring at C₆. The vehicle's sill height was 43 cm (16.9 in) and the height of the maximum crush was 51 cm (20.1 in). The Door Sill Differential was 3 cm (1.2 in). The induced damage involved the left fender and left rear door. The table below presents the crush profile for the left side plane impact.

Damage Classification: The Collision Deformation Classifications (CDC) were 10LPEW3 (290 degrees) for the left side plane impact and 00RDAO2 for the rollover. The Missing Vehicle algorithm of the WinSMASH program calculated the Escape's total Delta V as 24 km/h (14.9 mph). The longitudinal and lateral velocity changes were -8.2 km/h (-5.1 mph) and 22.6 km/h (14 mph), respectively. Based on the damage sustained by the Escape, the results appeared reasonable. The severity of the damage from the rollover was minor.

The vehicle's passenger compartment sustained six intrusions, which resulted from the left side plane impact. The most severe intrusions into the driver's space involved the lower left A-pillar, the side panel forward of the A-pillar, and the forward lower quadrant of the left front door. Each of these components intruded 12 cm (4.7 in) laterally.

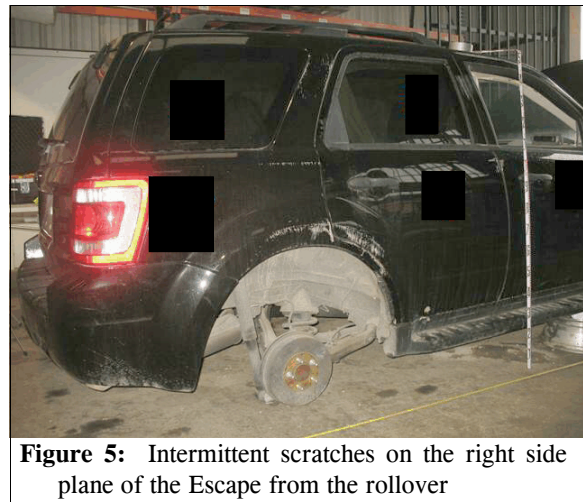
Figure 5: Intermittent scratches on the right side plane of the Escape from the rollover

The impact with the Taurus caused the Escape to roll over 1 quarter turn onto its right side. It was estimated that the vehicle traversed 2 m (6.6 ft) during the rollover.

The Escape sustained right side plane damage during the rollover. The direct damage began 259 cm (102 in) forward of the right rear axle and extended rearward 318 cm (125.2 in). The direct damage consisted of scratches and extended vertically in intermittent areas from the roof side rail to the sill. There was no lateral crush to the passenger compartment.

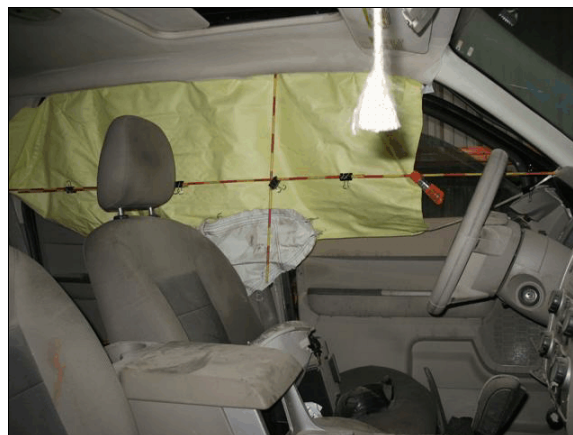
The left IC air bag was located along the roof side rail inside the headliner (**Figure 6**) and extended from the top of the A-pillar to the C-pillar. The deployed IC air bag was 145 cm (57.1 in) in width and 42 cm (16.5 inches) in height. It was attached at the lower A-pillar by a 43 cm (16.9 in) rope tether. The IC air bag extended 11 cm (4.3 in) below the beltline. The gap between the bottom of IC air bag and the A-pillar was 43 cm (16.9 in). There was no visible tether at the C-pillar. Inspection of the IC air bag revealed no discernable evidence of occupant contact and no damage. The right IC air bag was of the same dimensions and features.

Figure 6: The Escape's left side IC air bag and seat-mounted side impact air bag

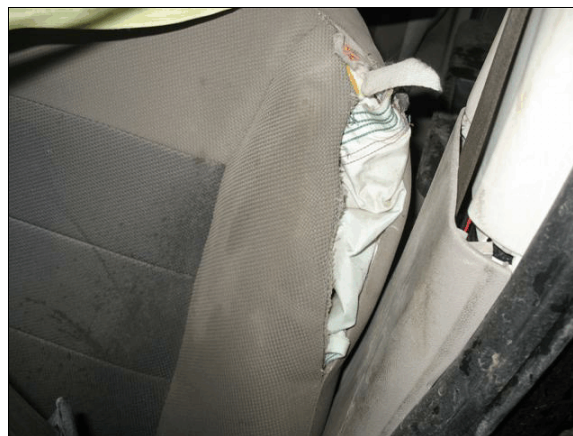
Figure 7: The Escape's left front seat back-mounted side impact deployed through a tear seam

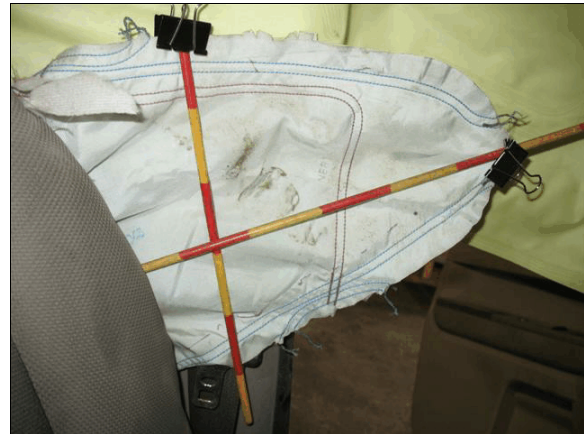
The driver's seat-mounted side impact air bag was located in the outboard side of the seat back and deployed through a tear seam (**Figure 7**). The deployed air bag (**Figure 8**) was 22 cm (8.7 in) in height at the seat back and 30 cm (11.8 in) in width. There was what appeared to be a vent port on the front edge of the air bag. Inspection of the deployed air bag revealed no damage and no discernable evidence of occupant

contact. The air bag had several areas of dirt or grease smears on it, probably from post-crash handling.

Figure 9: The deployed left front seat-mounted side impact air bag
