On-Site Side Air Bag Investigation
Dynamic Science, Inc. (DSI), Case Number DS10008
2005 Toyota Corolla LE
Arizona
January 2010

1. Report No. DS10008	2. Government Accession No.	3. Recipient Catalog No.	
4. Title and Subtitle On-Site Side Air Bag Investigation		5. Report Date October 12, 2010

14. Sponsoring Agency Code	
15. Supplemental Notes			
16. Abstract The focus of this investigation was the deployed side air bags in a 2005 Toyota Corolla LE involved in a crash and the serious injuries sustained by the vehicle's front right occupant. The single vehicle crash occurred on an undivided two-lane north/south roadway during January 2010 in the state of Arizona. The Toyota was being driven by a 23-year-old male and was occupied by a 23-year-old female front right passenger. While traveling southbound the driver lost control of the vehicle and it departed the roadway. The Toyota then impacted a raised curb, a metal utility pole, and a masonry wall. The vehicle was equipped with side impact inflatable curtain (IC) air bags and seat-mounted side air bags, and all four side air bags deployed during the crash. The driver of the Toyota sustained minor injuries and was transported to a l

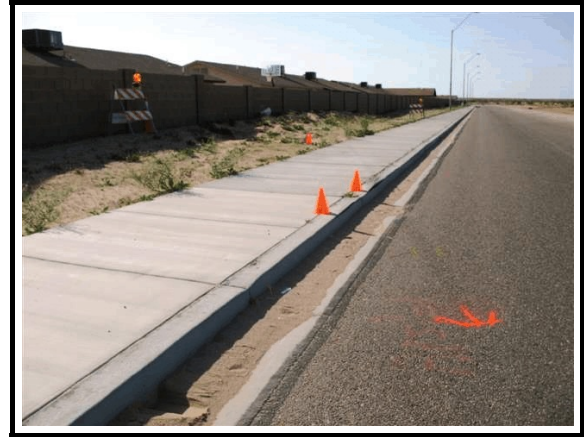
The crash sequence included six events. The Toyota's right front tire impacted the curb (Event 1) depositing a 76.0 cm (29.9 in) tire mark on the curb and a 2.7 m (9.0 ft) skid mark on the sidewalk. The left front tire impacted the curb (Event 2) depositing a 62.0 cm (24.4 in) tire mark on the curb. The right rear tire impacted the curb (Event 3) depositing a 1.6 m (5.2 ft) tire mark on the curb and a 4.7 m (15.4 ft) skid mark on the sidewalk. The Toyota then traveled in a right side leading yaw for 10.0 m (32.8 ft) on the sidewalk and then the right side of the vehicle impacted the breakaway luminaire utility pole (Event 4) (**Figure 3**). The impact displaced the pole from its base and fractured it into two sections. The vehicle's seat-mounted side air bags and IC air bags probably deployed during the pole impact.

Figure 3. Area of impact showing tire skid mark in foreground, curb impact in mid-ground, and pole impact in background

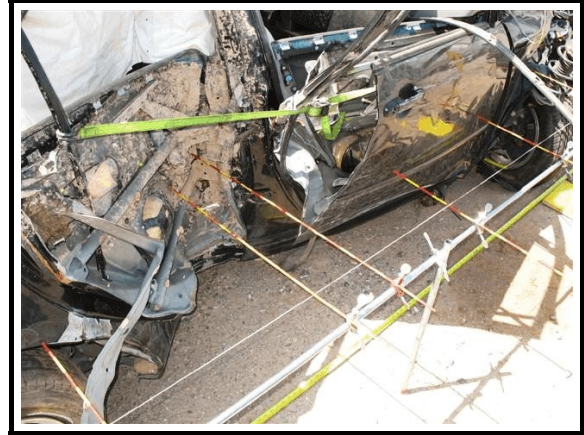
Figure 4. Right side crush profile for pole impact (Event 4)

Event 4 was a pole impact to the vehicle's right side passenger sector and direct damage began 75.0 cm (29.5 in) forward of the rear axle and extended forward 26 cm (10.2 in). The Field L began 30.0 cm (11.8 in) aft of the rear axle, extended 276.0 cm (108.7 in) forward, and ended 23.0 cm (9.1 in) aft of the front axle (**Figure 4**). Vertically, the deformation extended from the sill to the roof. Six crush measurements were taken at mid-door level as follows: $C_1 = 7.0$ cm (2.8 in), $C_2 = 4.0$ cm (1.6 in), $C_3 = 41.0$ cm (16.1 in), $C_4 = 0$ cm, $C_5 = 1.0$ cm (0.4 in), $C_6 = 11.0$ cm (4.3 in). Maximum crush was located 96.0 cm (37.8 in) forward of the rear axle between C_3 and C_4 and measured 46.0 cm (18.1 in). The CDC for Event 4 was 03RPAN3.

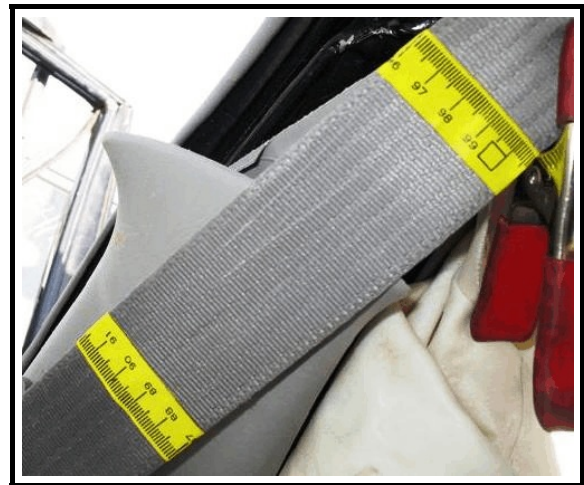
Figure 5. Front right occupant's safety belt webbing showing load marks

The front row passenger's safety belt D-ring was in the full-up position and the latch plate was scratched indicating historical usage. The safety belt webbing was cut during extrication activities at 90.0 cm (35.4 in) above the lower anchorage. The webbing showed scuff marks in a 10.0 cm (3.9 in) sector beginning 46.0 cm (18.1 in) above the lower anchorage and stretch marks in a 10.0 cm (3.9 in) sector (**Figure 5**) beginning 72.0 cm (28.3 in) above the lower anchorage. The latch plate was found inserted in the buckle and it showed scuff marks where the webbing was routed. The D-ring also showed scuff marks where the webbing was routed. Based on the vehicle inspection it was determined that the front right safety belt was used to restrain the occupant during the crash.

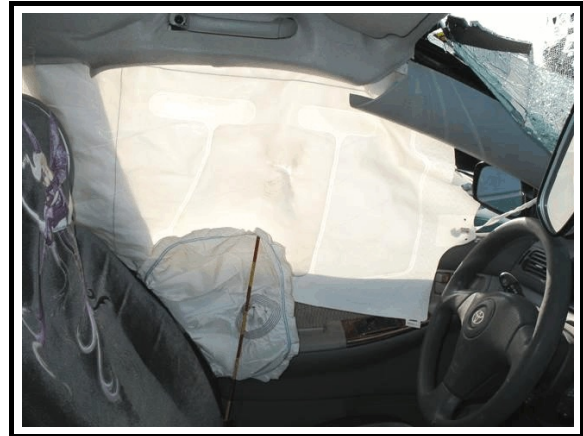
Figure 6. Left IC air bag and seat-mounted side air bag

The left IC air bag deployed from the left roof side rail over the front (**Figure 6**) and second rows. The IC air bag measured 160.0 cm (63.0 in) in length and 42.0 cm (16.5 in) in height. The deployed air bag covered the vehicle's left rear side glass in its entirety and the left front side glass beginning 15.0 cm (5.9 in) aft of the forward aspect. The IC air bag was configured with an exterior tether measuring 26.0 cm (10.2 in) in length that connected the air bag's forward aspect to the A-pillar.

The left IC air bag's inboard panel showed skin oil transfers and scuff marks located within an area measuring 15.0 cm (5.9 in) square at the forward lower aspect. Based on the driver's kinematics and medical records, it was determined the transfers and scuff marks were possibly deposited by the driver's forearm and left hand, which sustained abrasion injuries.

The air bag's outboard panel showed a tear measuring 18.0 cm (7.1 in) in length and a brown-colored scuff mark that was located 34.0 cm (13.4 in) aft of the leading edge and 17.0 cm (6.7 in) above the bottom edge. Based on the type of damage to the air bag and the color of the scuff mark it was determined the outboard panel of the left IC air bag was contacted by masonry blocks during the second wall impact (Event 6).

The left seat-mounted side air bag deployed from the outboard aspect of the driver's seat back. The air bag was oval in shape measuring 42.0 cm (16.5 in) in height and 28.0 cm (11.0 in) in width. It covered the door panel's rear upper quadrant including the armrest. The seat-mounted side air bag showed no damage or load marks and was unremarkable.

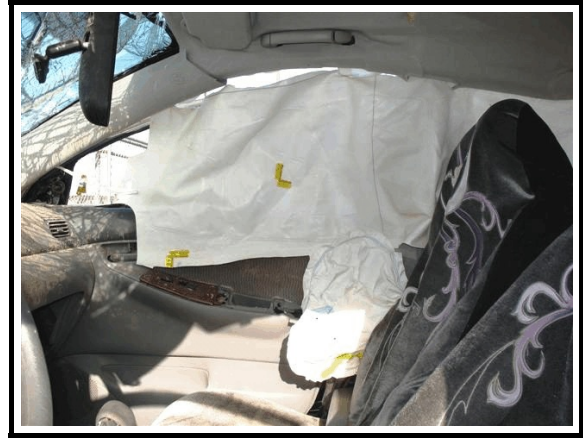
The right IC air bag deployed from the right roof side rail and showed damage resulting from occupant loading and extrication activities. The air bag including the tether was cut at the upper aspect beginning at the leading edge and ending at the B-pillar. The air bag showed a scuff mark on the inboard panel measuring 2.0 cm (0.8 in) and located 23.0 cm (9.1 in) from the top and 43.0 cm

(16.9 in) aft of the leading edge. A second scuff mark measuring 1.0 x 2.0 cm (0.4 x 0.8 in) was located at the bottom edge and 10.0 cm (3.9 in) aft of the leading edge. The outboard panel of the right IC air bag showed dirt deposits and was otherwise unremarkable.

The right seat-mounted side air bag deployed from the front left seat back and showed damage on the inboard panel. A tear and two scuff marks each measuring 2.0 cm (0.8 in) in length were located beginning 3.0 cm (1.2 in) from the bottom edge. The source of the damage was determined to be occupant loading by the right hip of the front right occupant. **Figure 7** shows the deployed right seat-mounted side air bag and right IC air bag in their post-inflated state with occupant loading evidence highlighted.

Figure 7. Right seat-mounted side air bag and right IC air bag
