ON-SITE OFFICE OF DEFECTS INVESTIGATION POTENTIAL UNINTENDED ACCELERATION INVESTIGATION

CASE NUMBER - IN10009

VEHICLE - 2007 LEXUS ES-350

CRASH DATE - March 2010

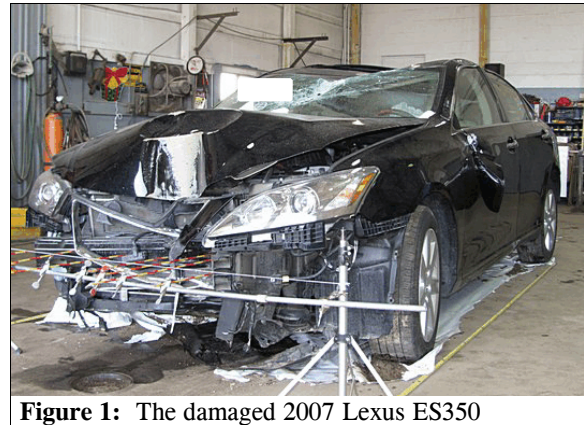
Figure 1: The damaged 2007 Lexus ES350

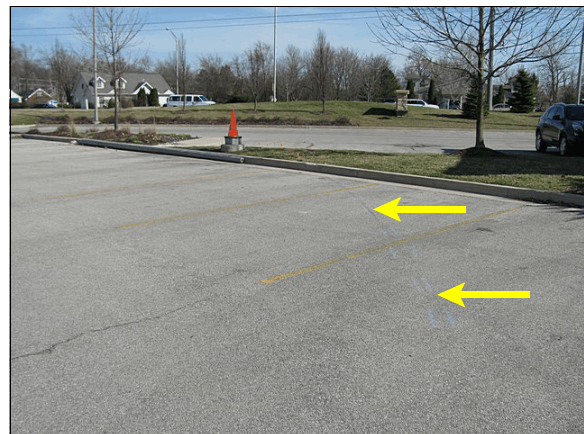
Figure 6: Approach to impacts with curb and concrete light pole; arrows show right front tire mark

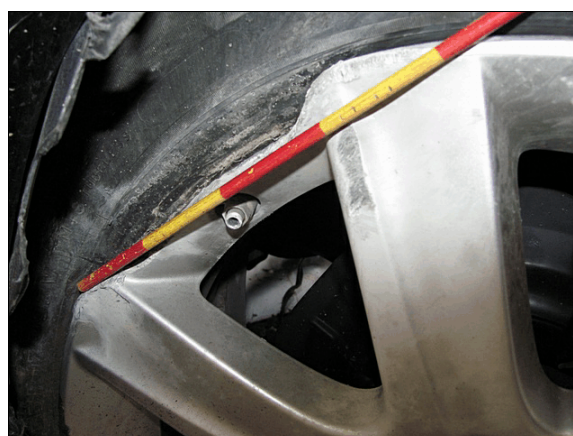
Crash: The right front wheel of the Lexus (**Figure 7**) impacted a 15 cm (6 in) high concrete curb (event 1). The Lexus traveled over the curb and traversed 2 m (5.9 ft) where the front plane (**Figure 8**) impacted a 21 cm (8.3 in) diameter concrete light pole (event 2). The force direction on the Lexus from this impact was within the 12 o'clock sector and the impact force was sufficient to trigger deployment of the driver's frontal and knee air bags. The EDR reported this as a "Low" stage deployment, which occurred 35 ms following the impact trigger. The pole impact was immediately followed by a left front wheel impact on the curb (event 3). The impact on the concrete pole broke it off near the base and it impacted the top plane of the Lexus (event 4, **Figure 9**). The concrete pole also impacted the side of the left roof side rail, A-pillar, and fender (event 5) as it fell off the vehicle. The Lexus came to final rest partially on a sidewalk and a flower bed heading southeast. The vehicle traveled a total distance of 8.8 m (28.9 ft) from the initial impact with the curb to its final rest position.

Figure 7: Damage on right front rim from curb impact

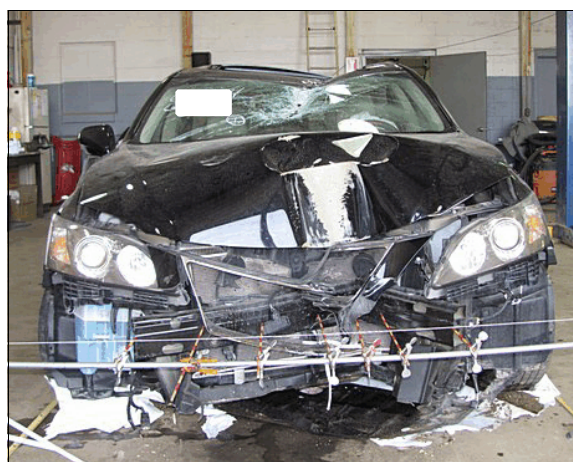
Figure 8: Damage on front plane of Lexus from impact with concrete light pole

Exterior Damage: Both front wheels sustained damage from the curb impacts. The left front wheel rim was dented and the right front wheel rim was broken. The front bumper and hood of the Lexus sustained direct damage from the impact with the concrete light pole. The direct damage began 78 cm (30.7 in) left of the right corner of the bumper fascia and was 24 cm (9.4 in) in length. The crush measurements were taken on the bumper bar and the maximum residual crush was 33 cm (13 in) occurring 9 cm (3.5 in) left of C₂. The bumper, hood and grille sustained induced damage. The table below presents the front crush profile.

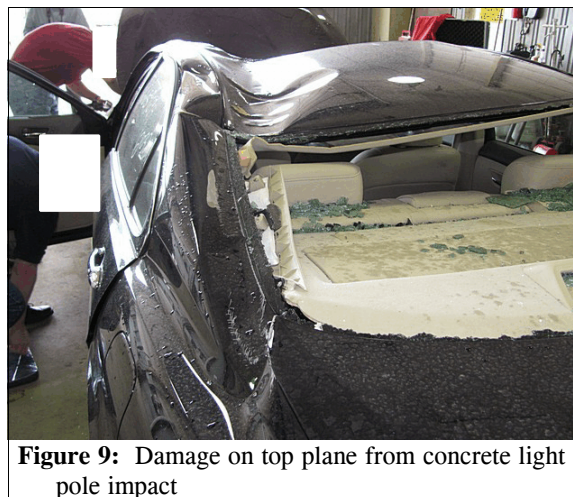
Figure 9: Damage on top plane from concrete light pole impact

The direct damage on the top plane from the concrete light pole impact began near the front of the hood on the approximate centerline of the vehicle. It extended 427 cm (168 in) along a diagonal onto the windshield, roof, left C-pillar and left quarter panel. The direct damage width at its widest point was 22 cm (8.7 in). The maximum crush on the top plane was 11 cm (4.3 in).

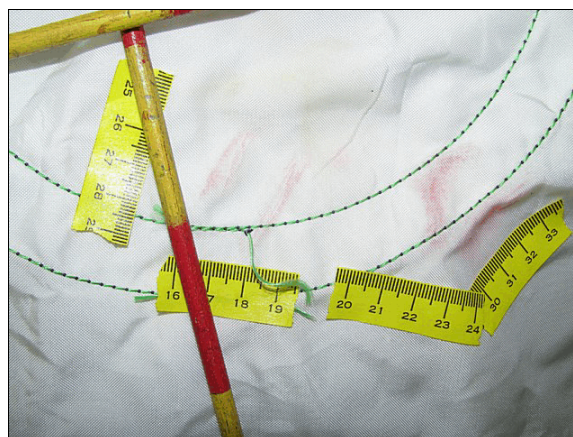
Vehicle Interior: The inspection of the interior of the Lexus revealed a transfer of lip stick and make-up on the driver's frontal air bag (**Figure 10**). There was no other discernable evidence of occupant contact. There was no deformation of the steering wheel or compression of the energy absorbing steering column.

Figure 10: Lip stick and make-up transfer on driver's frontal air bag of the Lexus

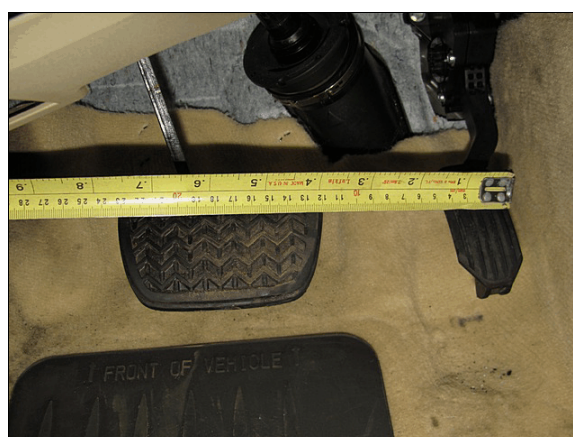
The initial status of the Denso accelerator pedal, floor mat, and brake pedal at the time of the SCI inspection are shown in **Figures 11** and **12**. The driver's floor mat was secured by the floor mat attachment clips and was not free to move. The floor mat appeared to be in nearly new condition. The product identification on the back of the floor mat was PT908-33100 Driver/Front TPE 789-1. The carpet under the accelerator pedal was smooth and flat against the floor and toe pan. There was a black transfer and impression on the carpet directly below the end of the accelerator pedal (**Figure 13**). The imprint was 19 mm in length and was the same shape and size as the back of the accelerator pedal (**Figures**

Figure 11: The initial status at inspection of the accelerator pedal, front of the floor mat, and brake pedal of the Lexus

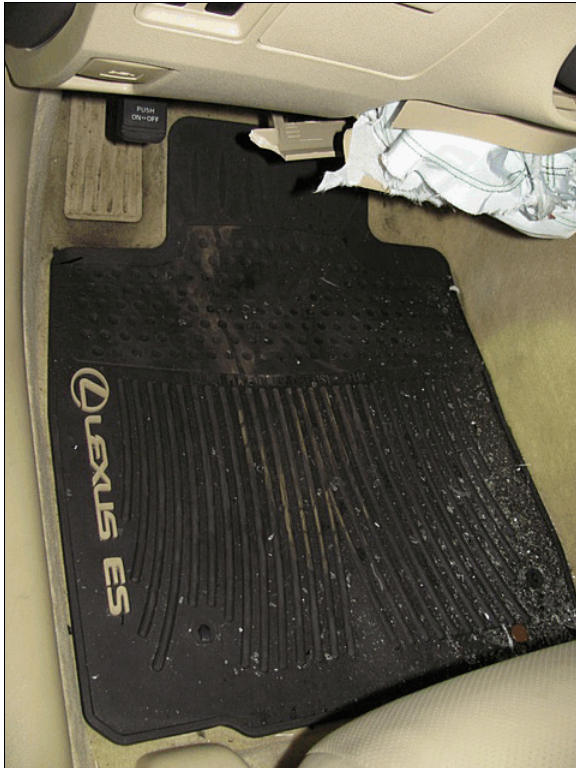
Figure 12: Initial status at inspection of the left front floor mat of the Lexus

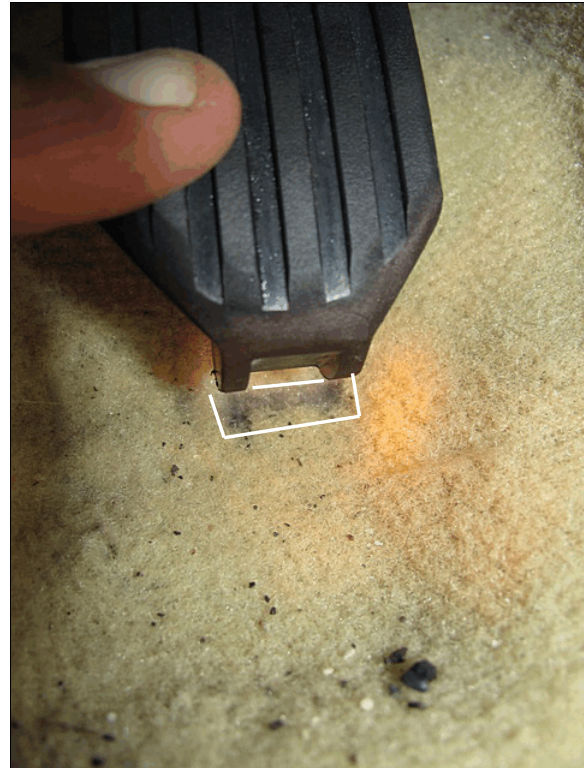
Figure 13: Accelerator pedal and black transfer on carpet (outlined in white) of the Lexus

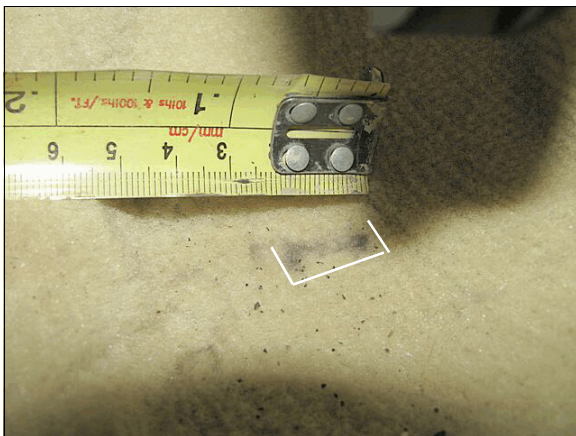
14 and 15). The accelerator pedal functioned smoothly and did not bind. **Figure 16** shows the Denso accelerator pedal mechanism housing. Inspection of the left front and right rear brake rotors and pads showed no evidence of overheating (**Figures 17 and 18**).

Figure 14: Black transfer and impression on carpet from back of accelerator pedal end

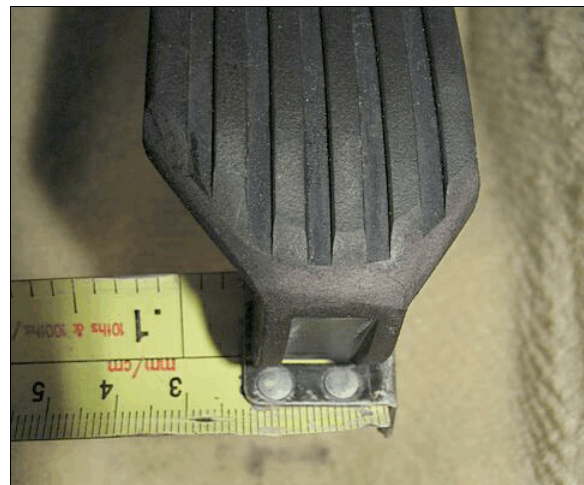
Figure 15: End of accelerator pedal

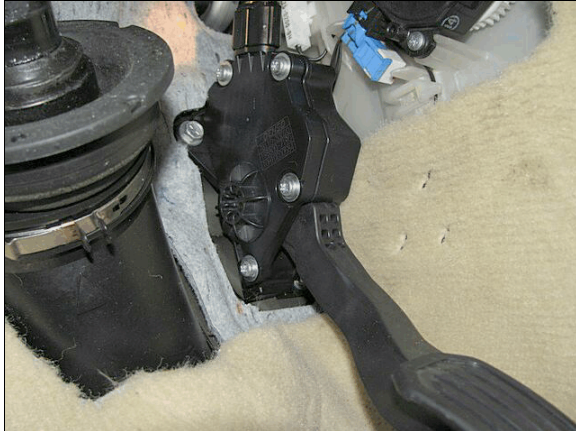
Figure 16: The accelerator pedal mechanism housing of the Lexus

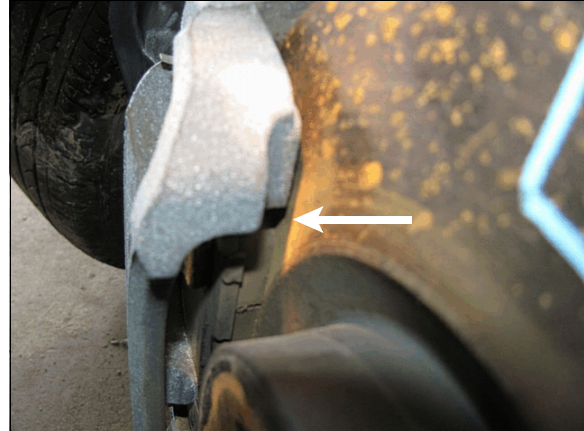
Figure 17: Left rear brake rotor, caliper, and brake pad (arrow) of the Lexus

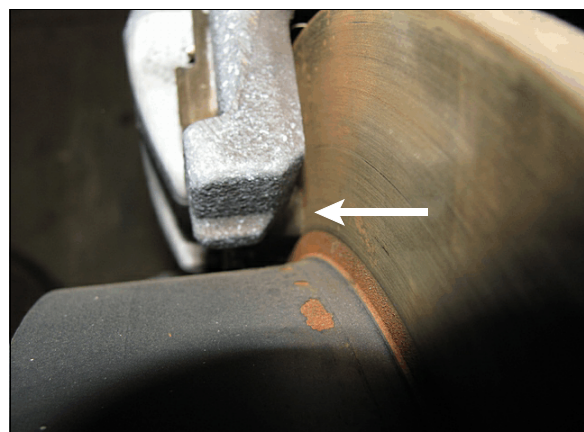
Figure 18: Right rear brake rotor, caliper, and brake pad (arrow) of the Lexus
