Remote Potential Unintended Acceleration Investigation
Special Crash Investigation (SCI)/Office of Defects Investigation (ODI)
Dynamic Science, Inc. (DSI), Case Number DS10011
2007 Toyota Tundra
Washington
October 2007

1. Report No. DS10011	2. Government Accession No.		3. Recipient Catalog No.	
4. Title and Subtitle Remote Potential Unintended Acceleration Investigation		5. Report Date November 12, 2010

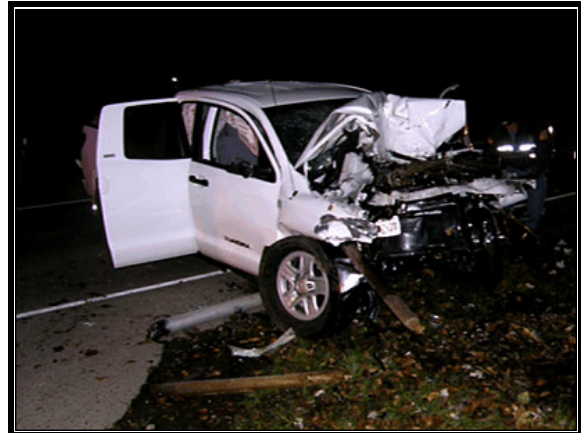
This remote investigation was initiated in response to the report of a driver fatality related to the alleged unintended acceleration of a 2007 Toyota Tundra (**Figure 1**). The restrained 29-year-old driver departed on the right side of a two-lane roadway, impacted wooden fence posts, a phone/cable box, and a large oak tree. The driver was transported from the scene with serious head and torso injuries and died at the hospital 14 hours post-crash.

Figure 1. 2007 Toyota Tundra (police photo)

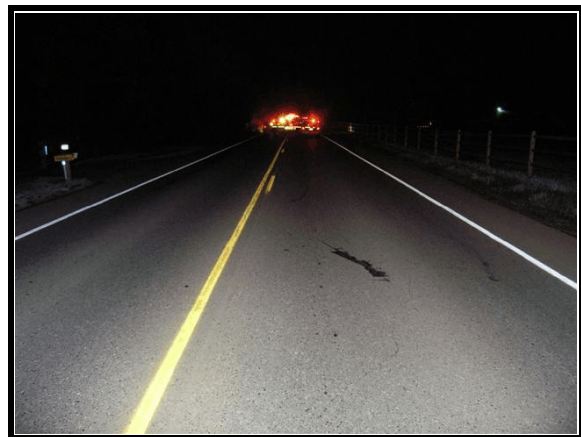
Figure 2. Approach to area of roadway departure, eastbound view (police photo)

The crash site was a two-lane east/west roadway (**Figure 2**). The lanes were divided by a solid yellow line for westbound traffic and a dashed yellow line for eastbound traffic. The roadway was bordered on both sides by white fog lines and asphalt shoulders. The right edge of the roadway was bordered by a grass shoulder and a three-rail wooden fence. The fence was located approximately 2.7 m (9.0 ft) from the roadway edge. A metal phone/cable box was located near the fence west of a north/south private driveway. The posted speed limit was 72 km/h (45 mph).

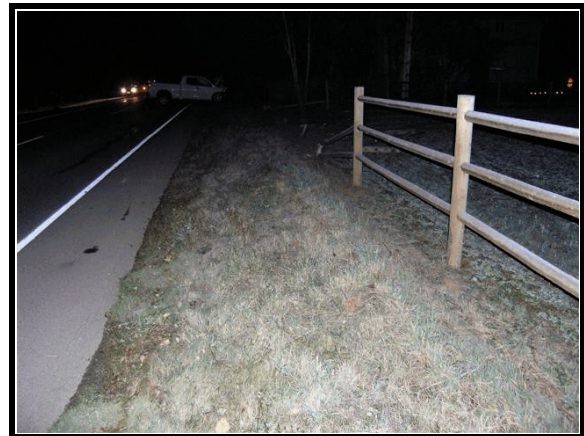
Based on the EDR-reported speed and roadway departure point, the Toyota traveled for 1.3 seconds off the road before impacting and displacing three sections of the wooden fence and wooden posts (**Figure 3**). The impact resulted in the deployment of the driver's frontal air bag and right inflatable curtain (IC) air bag in the

Figure 3. Area of impact with fence (Event 1)

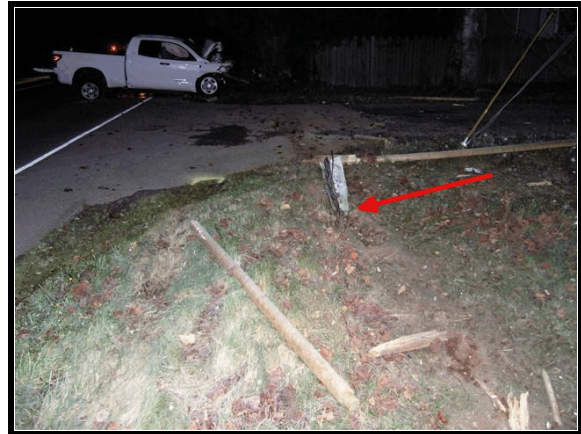
Figure 4. Impact with phone/cable box (Event 2)

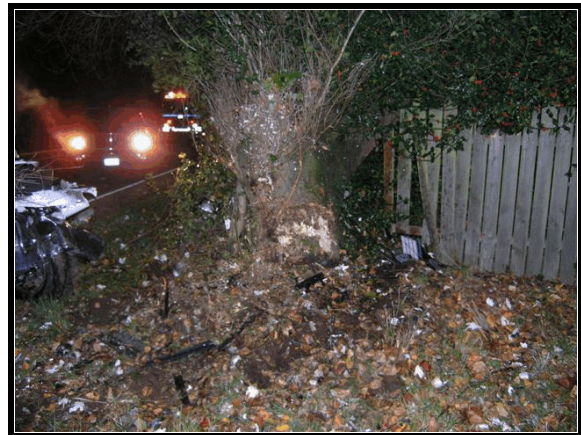
Toyota. The Toyota continued forward and impacted a phone/cable box (**Figure 4**), crossed a private driveway, and then impacted a large tree (**Figure 5**). The Standard algorithm of the WinSMASH program computed a Total Delta-V of 107.0 km/h (66.5 mph)¹ for the tree impact, based on the estimated crush to the front bumper. This should be considered a borderline reconstruction because of the high speed and the crush estimation.

Figure 5. Impact with tree (Event 3)

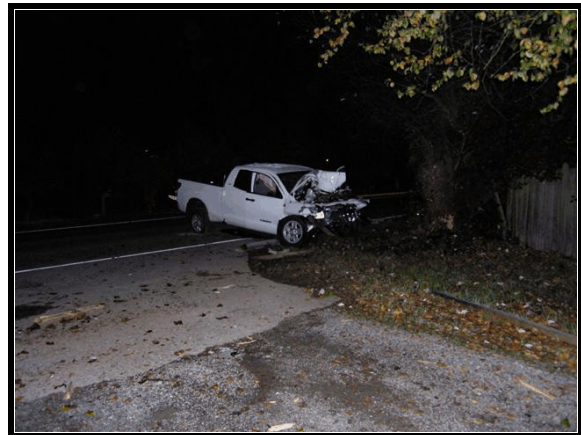
The Toyota rotated 90 degrees in a clockwise direction and came to rest on its wheels facing south with its rear wheels in the eastbound travel lane (**Figure 6**). During the crash the spare tire and drive shaft were displaced from the vehicle. The tire came to rest on the north side of the roadway and the drive shaft came to rest on the right side of the vehicle.

Figure 6. Final rest (looking northeast)

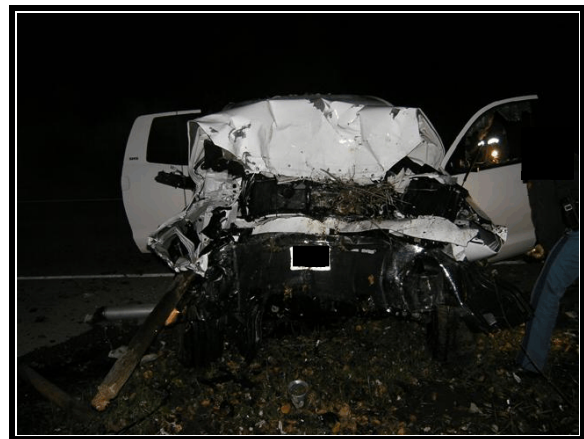
The Toyota sustained major front end damage from the impacts with the wooden fence posts, phone/cable box, and tree (**Figure 7**). The damage from the fence posts and phone/cable box was masked by the damage from the tree. There was a wooden fence rail embedded into the front right of the vehicle under the headlight casing into the fender. The drive shaft was displaced from the vehicle and was laying on the ground to the right of the vehicle at final rest. The spare tire was displaced from the vehicle and came to rest on the north side of the roadway. Based on the final appearance of the damage the estimated Collision Deformation Classification (CDC) for all three impacts was 12FDEW5. Six crush measurements were estimated at the bumper level as follows: $C_1 = 39$ cm (15 in), $C_2 = 68$ cm (27 in), $C_3 = 103$ cm

Figure 7. Frontal damage (police photo)

(41 in), $C_4 = 103$ cm (41 in), $C_5 = 68$ cm (27 in), $C_6 = 21$ cm (8 in). The partial CDCs for the fence post and phone/cable box impacts were 12F9999 and 12F9999, respectively.

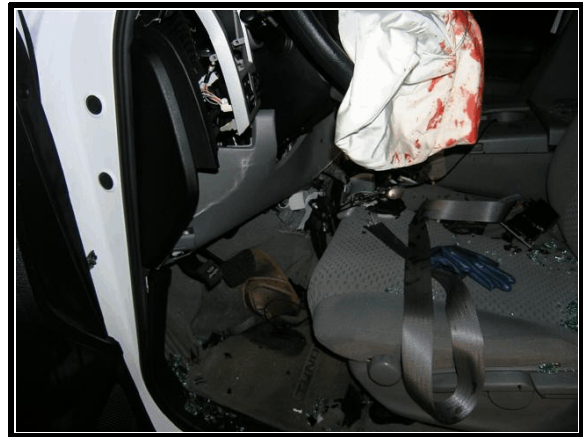
Figure 8 is an interior view of the driver's foot controls and floor mat as photographed by the police shortly after the crash. An original equipment manufacturer (OEM) floor mat was installed in the vehicle but it could not be determined if the mat was held in place by the retaining clips. The floor mat consisted of a carpeted top side with TUNDRA embossed on the face and a textured rubber under side. The floor mat was contoured to fit within the left floor pan. Cut-outs at the upper left and right corners of the floor mat allowed space for the dead pedal and the accelerator, respectively. It does not appear that the mat reached the foot controls or impeded their movement.

Figure 8. Floor and foot controls (police photo)

The accelerator pedal assembly appears to have been displaced rearward and to the left by intrusion to the toe pan/center console area. According to the police report, the gas pedal had broken away and wedged between the instrument panel and the driver's seat. Based on a metal tab visible in a police photo showing the pedal arm, it is likely that the pedal was manufactured by CTS. The accelerator pedal pad was not visible in any of the police photos. There were no reports that the pedals were manipulated by police for functionality.
