On-Site Side Air Bag Investigation
Dynamic Science, Inc. (DSI), Case Number DS10012
2006 Buick LaCrosse
Arizona
March 2010

1. Report No. DS10012	2. Government Accession No.	3. Recipient Catalog No.	
4. Title and Subtitle On-Site Side Air Bag Investigation		5. Report Date October 28, 2010

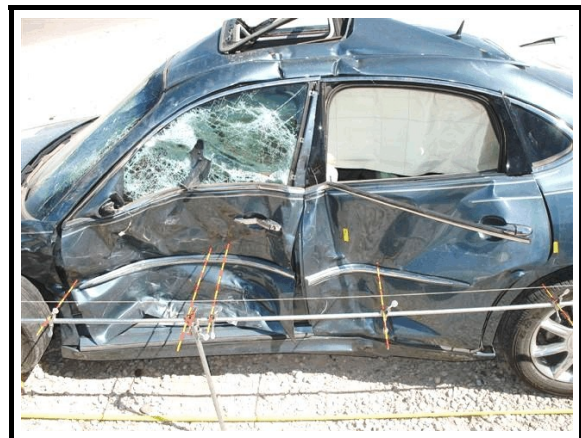
The Buick sustained direct and induced damage to the left side and induced damage to the top plane. The left front rim sustained direct damage and the tire was flattened. The left side view mirror was fractured and displaced from the side panel. The direct damage to the left side began 98.0 cm (38.6 in) forward of the left rear axle, extended forward 218.0 cm (85.8 in), and ended 44.0 cm (17.3 in) forward of the left front axle. The direct damage extended from the lower door panels to 12.0 cm (4.7 in) above the belt line on the B-pillar. The Field L began 22.0 cm (8.7 in) forward of the left rear axle, extended 318.0 cm (125.2 in) forward, and ended 68.0 cm (26.8 in) forward of the left front axle (**Figure 4**).

Figure 4. Left side crush documentation showing maximum crush to front left door panel.

Six crush measurements were taken at mid-door level as follows: $C_1 = 0$ cm, $C_2 = 23.0$ cm (9.1 in), $C_3 = 38.0$ cm (15.0 in), $C_4 = 23.0$ cm (9.1 in), $C_5 = 6.0$ cm (2.4 in), $C_6 = 0$ cm. Maximum crush was located 156.0 cm (61.4 in) forward of the rear axle at the left front door panel between C_3 and C_4 and measured 39.0 cm (15.4 in). The Collision Deformation Classification (CDC) for Event 1 was 10LYAW3.

The impact resulted in direct damage to the Buick's left A-pillar and B-pillar and left side doors. The height of maximum door crush to the left front door panel measured 69.0 cm (27.2 in), the sill height measured 28.0 cm (11.0 in), and the Door Sill Differential (DSD) was 23.0 cm (9.1 in).

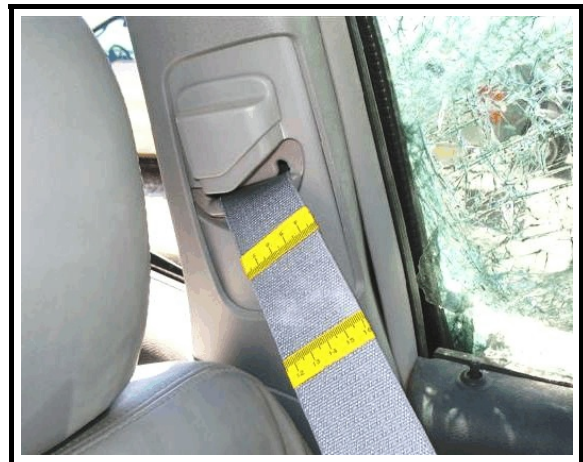
The driver's safety belt D-ring anchorage was set between the middle and full-up positions and the latch plate was scratched, indicating historical usage. The safety belt buckle pretensioner had actuated at impact and the stalk had compressed 2.0 cm (0.8 in) from its original length. The safety belt webbing was loaded by the driver and showed scuff marks measuring 5.0 x 5.0 cm (2.0 x 2.0 in) beginning 92.0 cm (36.2 in) above the stop button near the D-ring anchorage (**Figure 5**). Based on the vehicle inspection it was determined that the front left safety belt was used to restrain the driver during the crash.

Figure 5. Driver's safety belt webbing showing occupant loading evidence

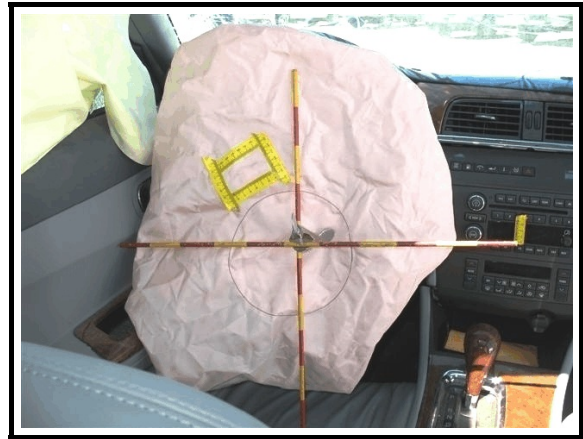
Figure 6. Driver's frontal air bag showing occupant loading to upper left quadrant

The Buick's advanced dual-stage frontal air bags were designed to deploy in two stages according to impact severity. Based on the EDR report the left frontal air bag deployed at the 1st stage. The left frontal air bag deployed from the steering wheel hub through an I-configured cover flap. The air bag was circular in shape and measured 67.0 cm (26.4 in) in diameter from seam to seam. It was configured with two vent ports on the back panel and two internal tethers attached to the center of the front panel. A skin oil transfer measuring 2.0 x 4.0 cm (0.8 x 1.6 in) was located 10.0 cm (3.9 in) from the center of the front panel in the upper left quadrant (**Figure 6**) indicating occupant loading during the crash.

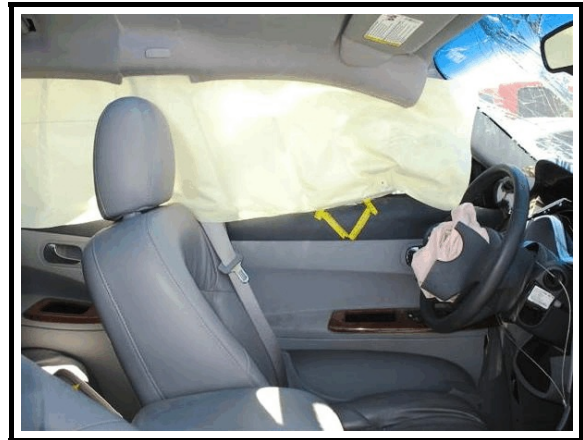
Figure 7. Left IC air bag

The left IC air bag deployed from the left roof side rail above the front and second rows (**Figure 7**) and it measured 170.0 cm (66.9 in) in length and 40.0 cm (15.7 in) in height. The deployed IC air bag covered the front and second row left side windows entirely and extended 8.0 cm (3.1 in) below the bottom edge of the side glass. The air bag's forward aspect was attached to the left A-pillar by a 21.0 cm (8.3 in) tether and the rear aspect was attached to the left C-pillar without a tether. The IC air bag revealed a skin oil transfer measuring 4.0 x 12.0 cm (1.6 x 4.7 in) located 4.0 cm (1.6 in) above the bottom edge and 40.0 cm (16.0 in) aft of the leading edge indicating occupant loading during the crash.

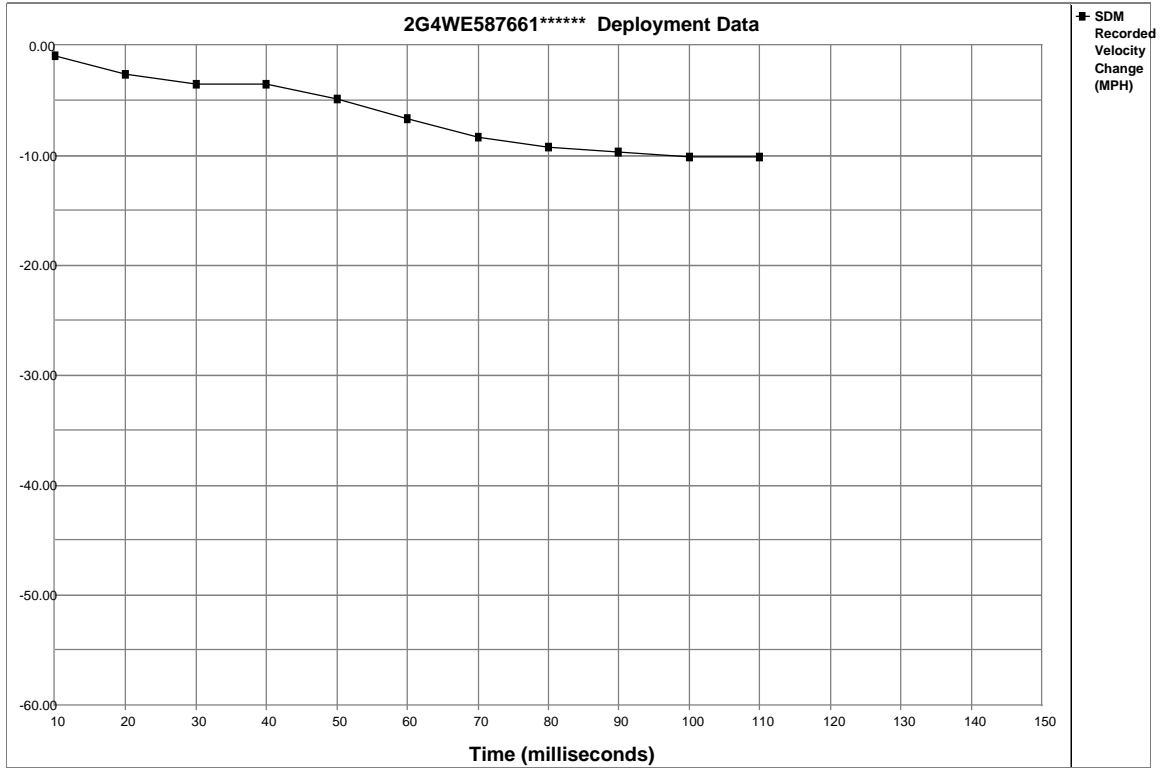
Time (milliseconds)	10	20	30	40	50	60	70	80	90	100	110	120	130	140	150
SDM Recorded Velocity Change	-0.88	-2.63	-3.51	-3.51	-4.83	-6.58	-8.34	-9.21	-9.65	-10.09	-10.09	N/A	N/A	N/A	N/A

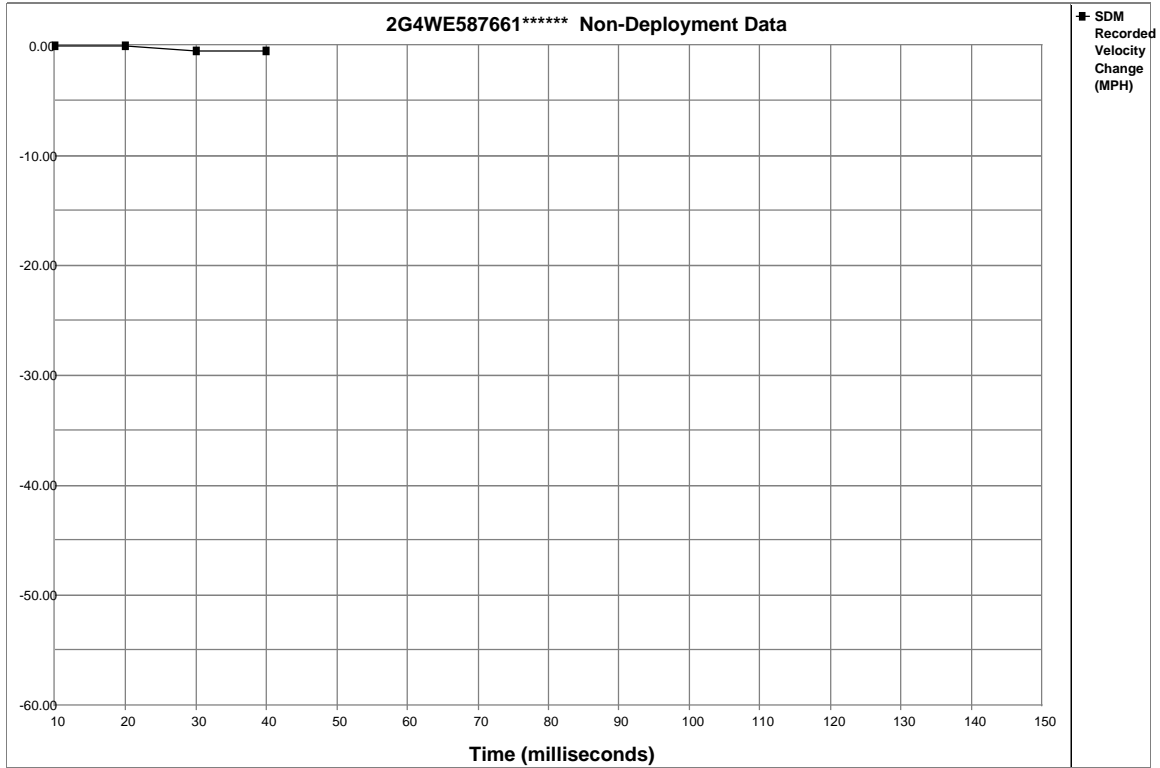
Time (milliseconds)	10	20	30	40	50	60	70	80	90	100	110	120	130	140	150
SDM Recorded Velocity Change	0.00	0.00	-0.44	-0.44	N/A	N/A	N/A	N/A	N/A	N/A	N/A	N/A	N/A	N/A	N/A
