ON-SITE OFFICE OF DEFECTS INVESTIGATION POTENTIAL UNINTENDED ACCELERATION INVESTIGATION

CASE NUMBER - IN10012
LOCATION - WISCONSIN
VEHICLE - 2009 TOYOTA CAMRY
CRASH DATE - March 2010

1. <i>Report No.</i> IN09012		2. <i>Government Accession No.</i>		3. <i>Recipient's Catalog No.</i>	
4. <i>Title and Subtitle</i> On-Site Office of Defects Investigation Unintended Acceleration Investigation Vehicle - 2009 Toyota Camry LE Location - Wisconsin			5. <i>Report Date:</i> August 10, 2010

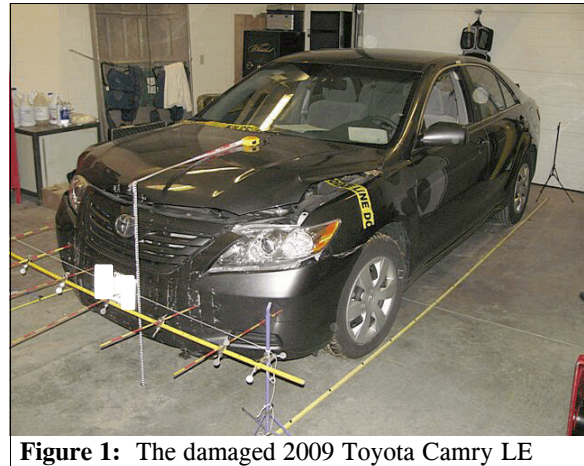
Figure 1: The damaged 2009 Toyota Camry LE

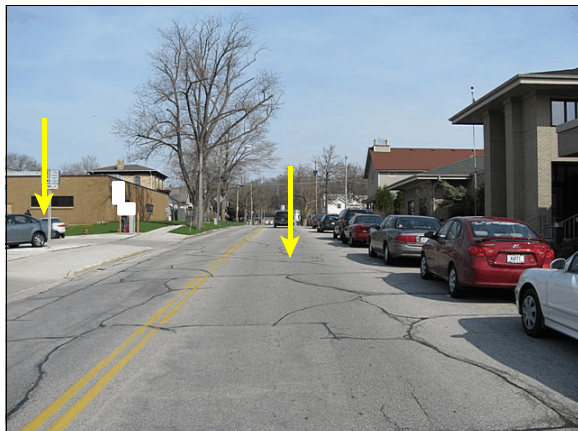
Figure 2: Approach of the Toyota; arrow on left shows the location of the impact on the building; arrow on right shows area of double-parked delivery van

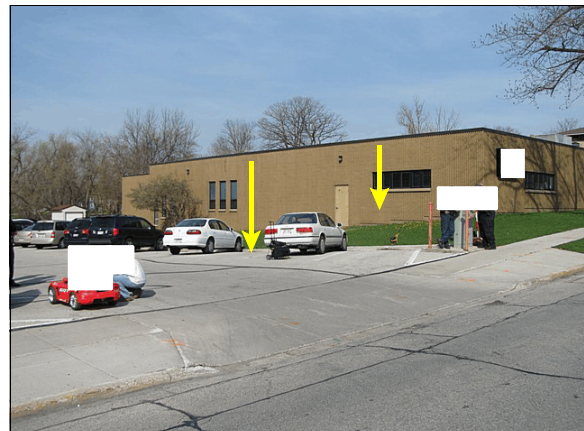
Figure 3: Approach through parking lot entrance to parking space (arrow on left); arrow on right shows location of impact on the building

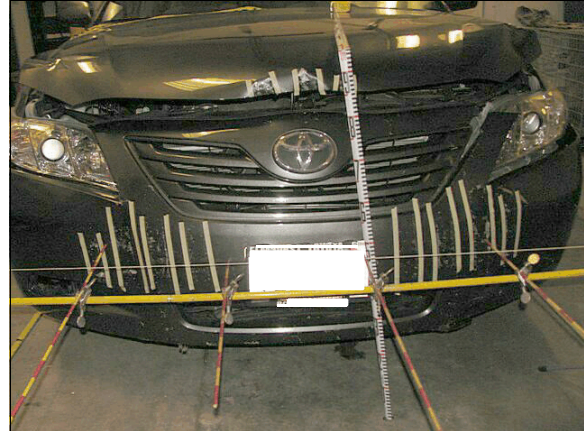
Crash: The front plane of the Toyota (**Figure 4**) impacted the building. The direction of force on the vehicle was within the 12 o'clock sector. The driver's frontal air bag did not deploy. The vehicle traversed a distance of 7.6 m (24.9 ft) from the curb to the building. The tire mark evidence on the grass (**Figure 5**) indicated that the vehicle traveled along a path that was slightly curved to the right. Acceleration marks were evident on the grass (**Figure 6**) and were located approximately 0.6 m (2 ft) from the building. The impact cracked several mortar joints on the inside and outside of the wall but did not displace the cinder blocks or the building's exterior fascia. The vehicle came to final rest heading north with the front end located approximately 1 meter (3.3 ft) from the building.

Figure 4: Damage on the front plane of the Toyota from the impact with the building; impressions of the building's fascia are highlighted with tape

Exterior Damage: The Toyota sustained front plane damage during the impact with the building. The front bumper and hood were directly damaged. The direct damage began 23 cm (9.1 in) right of the front left bumper corner and extended 114 cm (44.9 in) across the bumper. The crush measurements were taken on the bumper bar and the maximum residual crush was 22 cm (8.7 in) occurring at C₄. The left and right wheelbases were unchanged. The induced damaged involved the hood and both headlamp/turn signal assemblies. The table below presents the front crush profile.

Damage Classification: The Collision Deformation Classification for the front impact with the building was 12FDEW1 (0 degrees). The WinSMASH program could not be used to calculate a Delta-V since an impact with a yielding object is out of scope for the program. The wall of the building yielded and was cracked in several locations from the impact. The Barrier Algorithm of WinSMASH was used to calculate a Barrier Equivalent Speed (BES) for the impact. The calculated BES was 22.3 km/h (13.9 mph). A maximum velocity change of 19.1 mph (30.7 km/h)

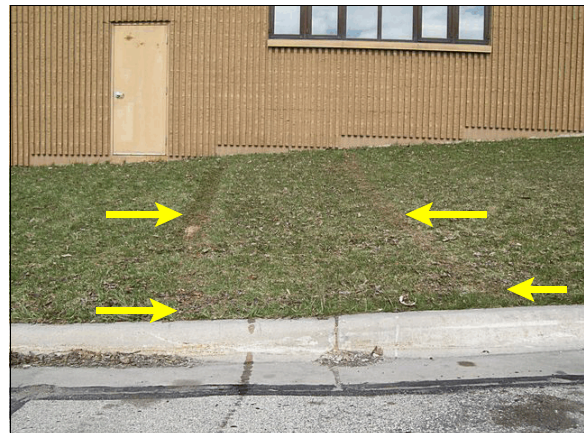
Figure 5: Police photo showing tire marks on grass from the Toyota

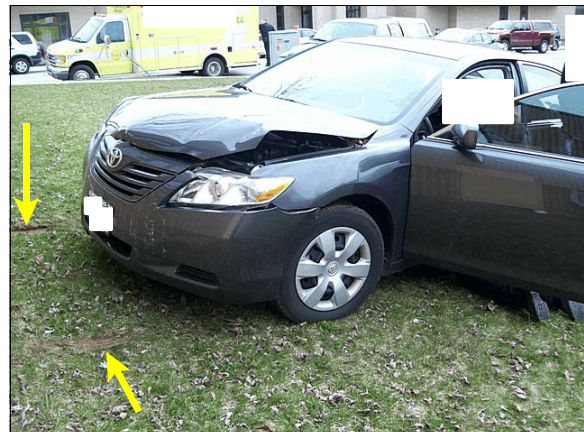
Figure 6: Police photo showing the final rest position of the vehicle; arrows show marks in the grass from spinning front wheels
