**OFFICE OF DEFECTS INVESTIGATION
CALSPAN ON-SITE POTENTIAL UNINTENDED ACCELERATION
CRASH INVESTIGATION**

SCI CASE NO.: CA10013

VEHICLE: 2002 TOYOTA HIGHLANDER

CRASH DATE: OCTOBER 2009

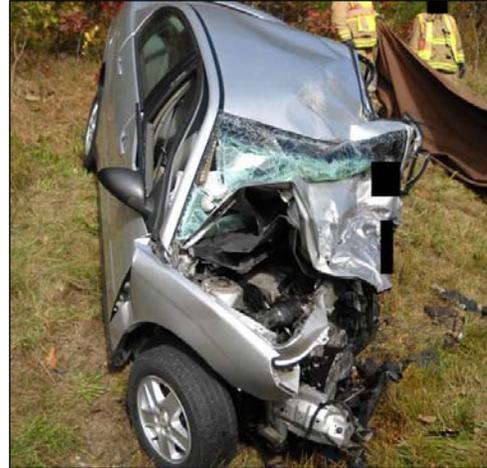
Figure 4: Frontal view of the Chevrolet.
(Local law enforcement on-scene image)

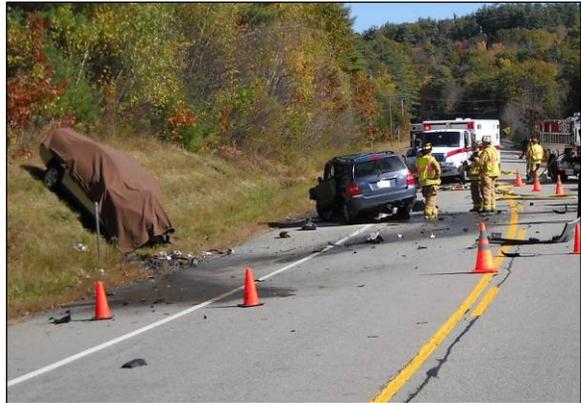
Figure 5: Final rest position of the Toyota and Chevrolet. (*Local law enforcement on-scene image*)

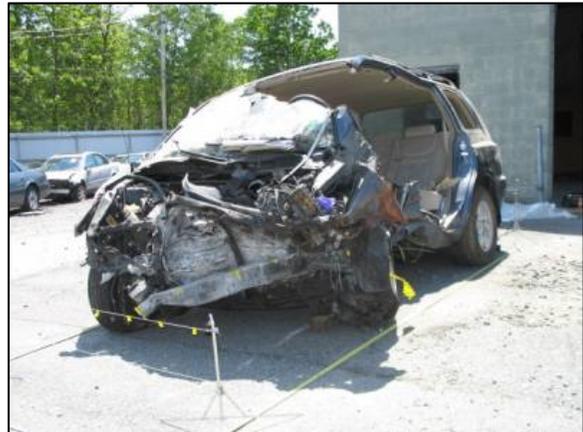
The Toyota Highlander sustained severe frontal impact damage and deformation as a result of the crash (Event 1). **Figure 6** is a left front oblique view of the vehicle. The offset impact configuration resulted in a left bias to the damage with deformation to the left A-pillar area. The combined width of the direct and induced damage extended across the entire 160 cm (63 in) frontal end width. The direct damage began 38 cm (15 in) right of center and extended to the left bumper corner. The frontal crush was documented along the bumper reinforcement beam and was as follow: C1 = 112 cm (44.1 in), C2 = 109 cm (42.9 in), C3 = 103 cm (40.6 in), C4 = 89 cm (35.0 in), C5 = 64 cm (25.2 in), C6 = 42 cm (16.5 in). The left A-pillar was deformed in a near-vertical position. The force of the impact and the extent of the deformation resulted in buckling of the left sill at the B-pillar location. The left doors were jammed closed post-crash, but the right doors remained operational. The left wheelbase was reduced 49 cm (19.3 in). The Collision Deformation Classification (CDC) associated with the initial impact event was 12FDEW5.

Figure 6: Left oblique view of the Toyota.

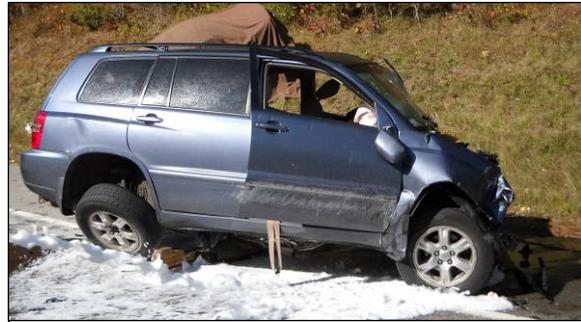
The right plane of the vehicle sustained minor damage that was associated with the one-quarter turn rollover (Event 2). The damage consisted of minor vertically oriented abrasions dispersed over the right front and right rear doors. These abrasions extended from the sill to the hardware supports of the roof rack. In addition, the right rear axle mount yielded as a result of lateral loading of the tire/wheel during trip-over (**Figure 7**). The CDC of the rollover event was 00RYAO3.

Figure 7: Right side view of the Toyota's rollover damage. (Local law enforcement on-scene image)

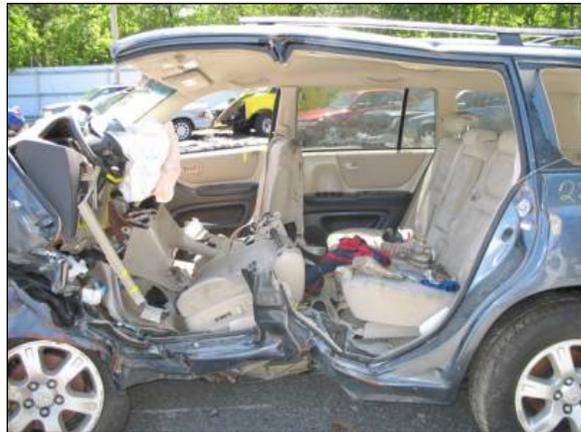
The Toyota sustained extensive interior damage that was associated with exterior deformation, intrusion into the passenger compartment, occupant contact, air bag deployment, and extrication efforts by emergency response personnel. The documentation of the interior intrusion was hampered by the extrication, as the associated efforts consisted of cutting and removing a section of the left A-pillar and left B-pillar, forcing the roof vertically, and hydraulically lifting the instrument panel forward and upward (**Figure 8**).

Figure 8: Left interior view of the Toyota.

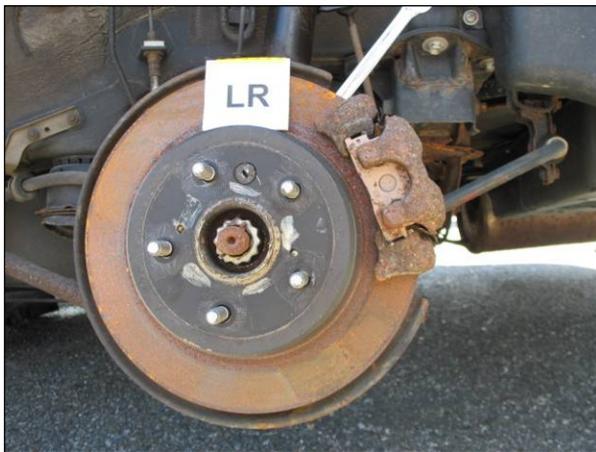
The left rear tire and wheel were removed without difficulty. Initial inspection of the brake rotor, caliper, and brake pads revealed a significant build-up of surface rust that was attributed to the long duration of storage between the crash and inspection dates. The brake rotor was intact with no evidence of wear or damage (**Figure 9**). The brake pads, as viewed through the top of the caliper, were in good condition. Removal of the caliper supported this observation as the pads were in good condition without evidence, wear, or damage (**Figure 10**).

Figure 9: Left rear brake assembly.

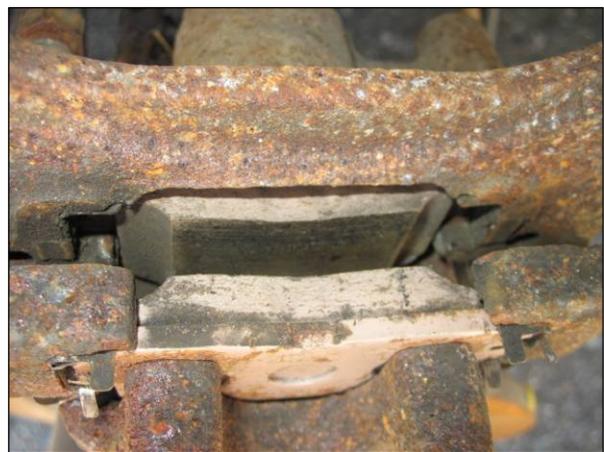
Figure 10: Left rear brake caliper and shoes.

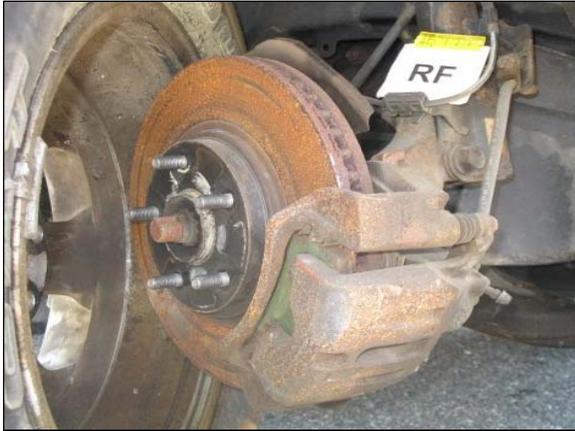
The right front tire and wheel were removed with minimal difficulty as the inflated tire was in contact with the aft edge of the right front fender. Initial inspection of the brake assembly (**Figure 11**) revealed that the lower caliper bolt was fractured and that the upper bolt was loose. The status of the lower caliper bolt was the result of the post-crash inspection by the

investigating police department. It is unknown if the upper caliper bolt was fractured during this inspection. The upper spindle casting for the caliper bracket was fractured at the mounting point. This damage appeared to have been impact related.

Figure 11: Right front brake assembly.

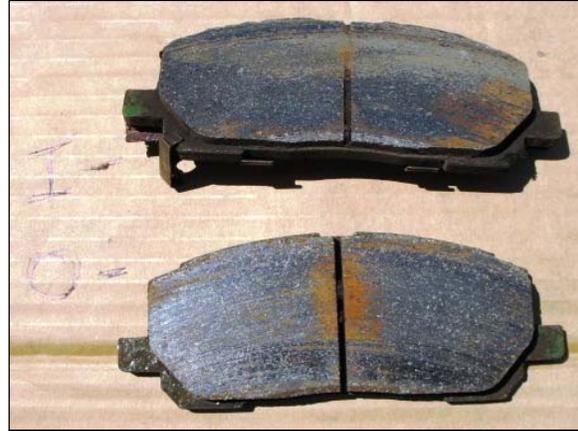
Figure 12: Right front brake pads.

The right front brake rotor, caliper, and brake pads were covered with surface rust similar as noted for the left rear. The rotor had two score lines on each side of the machined surface. The brake pads were removed from the rotor and were found to be in worn condition (**Figure 12**). The outer brake pad had 4 mm (5/32 in) of lining remaining on the pad while the inner (piston side) had 5 mm (6/32 in) of lining remaining. The rotor and linings did not display evidence of heat or damage.

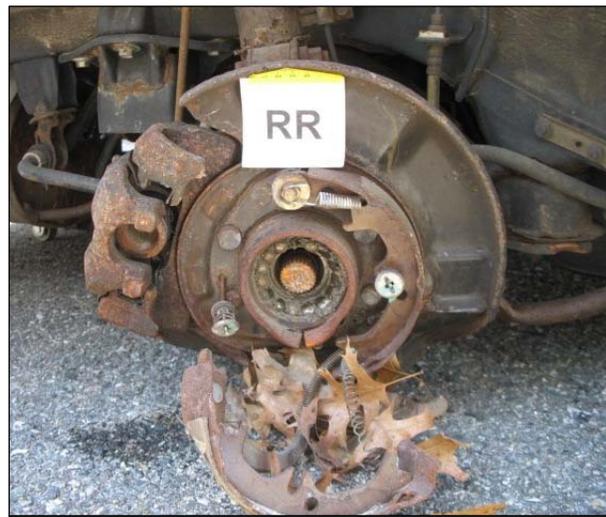
The right rear disc brake (**Figure 13**) incorporated the drum-activated parking brake within the rotor. An on-scene image of the Toyota showed the right rear tire and wheel still attached to the axle, though angled inward at the lower aspect as a result of the rollover event dynamics. At the time of SCI inspection, the axle was completely fractured with the wheel removed from the hub assembly. The rotor was fractured into multiple pieces and the rear parking brake shoe was removed from the backer plate, with the brake cable still attached to the lower shoe clip. This disassembled state was the result of the prior police inspection process. The disc brake pads, although removed from the caliper, were in good condition with no evidence of heat or extreme wear. The rotor, although fractured, did not display evidence of brake-induced damage or wear.

Figure 13: Right rear disk brake assembly.

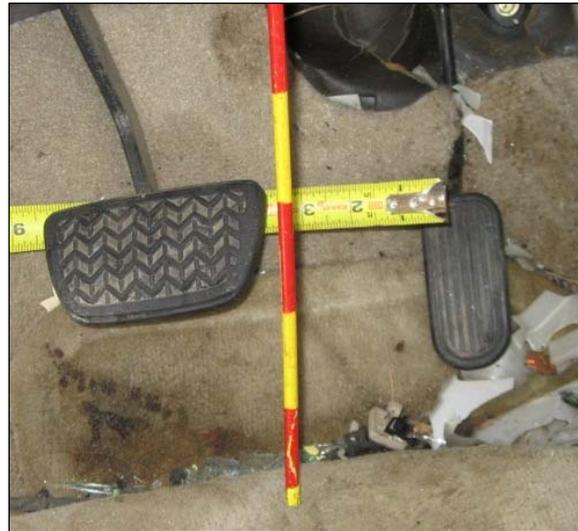
The foot controls of the Toyota consisted of the mechanical cable-actuated accelerator pedal and the conventionally mounted brake pedal. The pedals were intact, although the toe and floor pans were displaced rearward and vertically by intrusion that was associated with exterior deformation. The rubber pedal pads were in place and did not display excessive wear. **Figure 14** depicts the brake and accelerator pedals at the time of SCI inspection.

Figure 14: Brake pedal (left) and accelerator pedal (right) of the Toyota.

The accelerator pedal consisted of a pedal plate welded to the stalk. The stalk was mounted to the left side of a pivot arm that was attached to the toe pan with two vertically oriented bolts. A coil return spring was positioned between the pedal stalk and the mounting bracket. The throttle cable was attached to the top on the stalk, above the level of the pivot arm. As a result of the crash, the toe pan was intruded rearward against the accelerator pedal. Therefore, the pedal could not be depressed to test for evidence of binding or other anomalies.

The brake pedal was stalk mounted to a sub-instrument panel-mounted bracket, and was linked to the power brake booster and the hydraulic master cylinder. The pedal stalk was deformed by a combination of intrusion and probable driver contact during the crash sequence. As a result of this damage, the range of motion of the pedal was restricted.

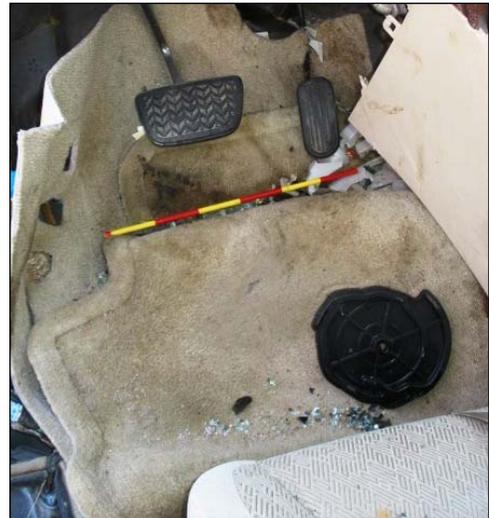
The Toyota was equipped with OEM carpeted floor mats within the front seating positions. At the time of the SCI inspection, the forward edge of the driver's floor mat was positioned under the accelerator and brake pedals, lying flat against the OEM carpet floor covering. The mat was creased rearward of the foot pedals due to the deformation and intrusion of the respective toe and floor pans (**Figure 15**). The rearward edge of the floor mat was secured to the floor-mounted pegs located below the leading edge of the driver's seat. These pegs held the mat secure to the floor of the Toyota. There was no visible wear to the leading edge of the floor mat from contact with the accelerator pedal.

Figure 15: Left front floor mat of the Toyota.

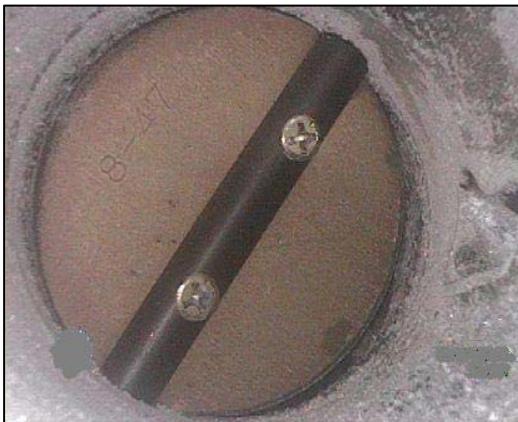
The borescope was inserted into the alloy throttle body to inspect and photograph the position of the throttle plate. The images were displayed on a remote handset monitor and stored on an image card. Figures 16 and 17 are images of the throttle plate provided by the ODI investigator. Based on the images provided by ODI; it appeared that the throttle plate was in the closed position within the throttle body. The throttle plate was stamped with the nomenclature 8-47. There was no visible damage to the throttle plate or to the surrounding alloy casting of the throttle body. A mechanical check of the operation of the throttle assembly post-crash was not performed.

Figure 16: Borescope view of the throttle plate within the 2002 Toyota. Image provided by ODI.

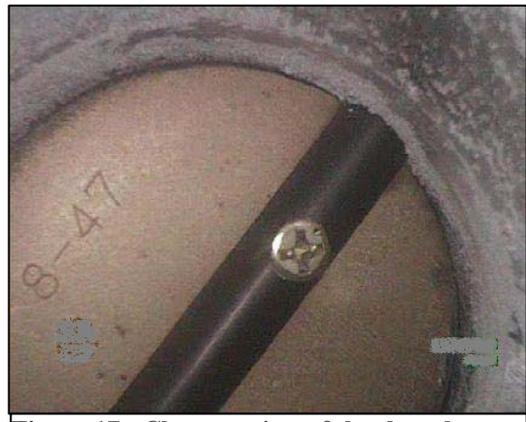
Figure 17: Close-up view of the throttle plate and the pivot rod. Image provided by ODI.

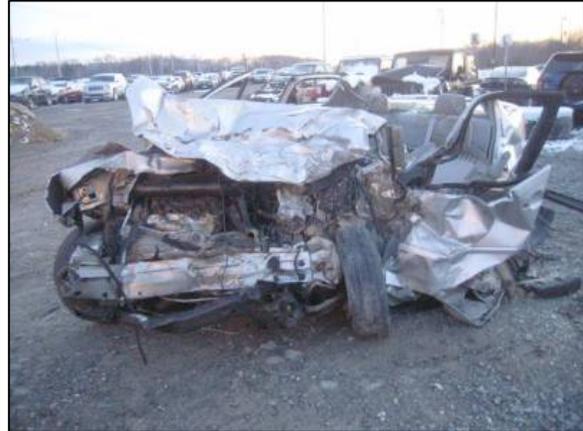
As previously stated, the Chevrolet Malibu was sold as salvage prior to SCI's involvement in this investigation; therefore it was not inspected. An assessment of the vehicle's damage was based on a review of the images provided by the insurance salvage yard and the investigating police agency, **Figure 18** is a front view of the Chevrolet. The exterior of the Chevrolet sustained severe impact damage as a result of the frontal crash. The width of the direct and induced damage extended across the entire 147 cm (58 in) end-width of the vehicle. The direct contact damage began an estimated 36 cm (14 in) right of center and extended 109 cm (43 in) to the left corner. The maximum crush was located at the left corner and was an estimated 91 cm (36 in). The estimated crush profile of the frontal damage was C1 = 91 cm (36 in), C2 = 74 cm (29 in), C3 = 55 cm (22 in), C4 = 38 cm (15 in), C5 = 18 cm (7 in), C6 = 0. The left bias of the impact configuration resulted in crush to the left A-pillar area. The left A-pillar was deformed to a vertical orientation. The roof was buckled above the driver's position with associated buckling that continued to the left C-pillar. The left front door compressed an estimated 30 cm (12 in), and was buckled. The left wheelbase was significantly reduced. The CDC of the impact was 12FDEW5.

Figure 18: Front left oblique view of the Chevrolet. (Image supplied by the insurance salvage facility)
