## ON-SITE ROLLOVER INVESTIGATION

CASE NUMBER - IN10014

VEHICLE - 2010 NISSAN ROGUE SL

CRASH DATE - March 2010

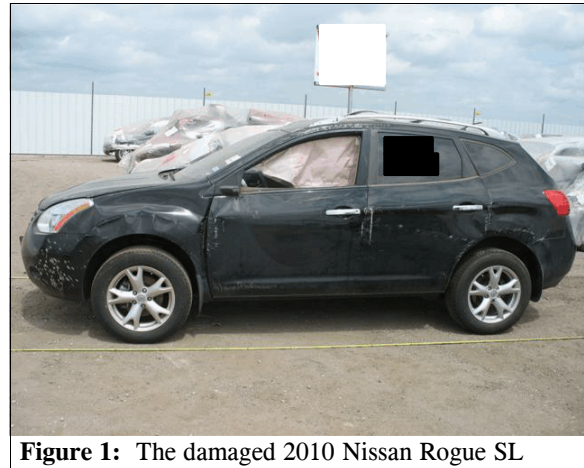
**Figure 1:** The damaged 2010 Nissan Rogue SL

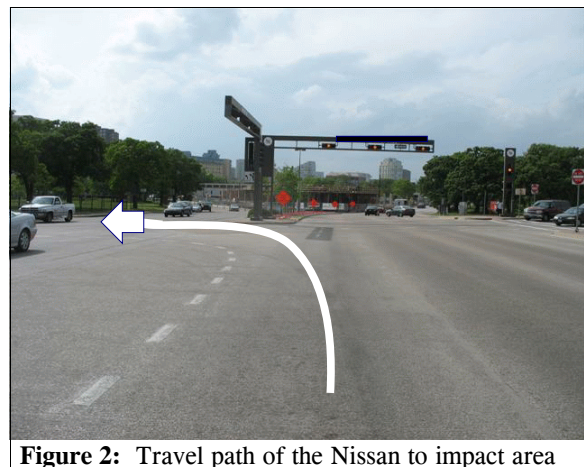
**Pre-Crash:** The restrained 32-year-old male driver of the Nissan was traveling northwest in the through/left turn lane. The driver was in the process of executing a left turn at the intersection (**Figure 2**), intending to proceed south on the service road. The Lexus was stopped at the intersection in the second lane from the right (**Figure 3**) heading southeast. The driver proceeded into the intersection when the traffic signal changed to green. The driver intended to proceed straight through the intersection.

**Figure 2:** Travel path of the Nissan to impact area

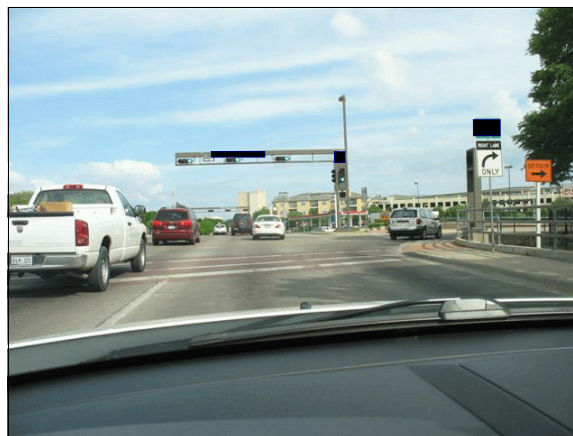
**Figure 3:** Approach of the Lexus to the intersection

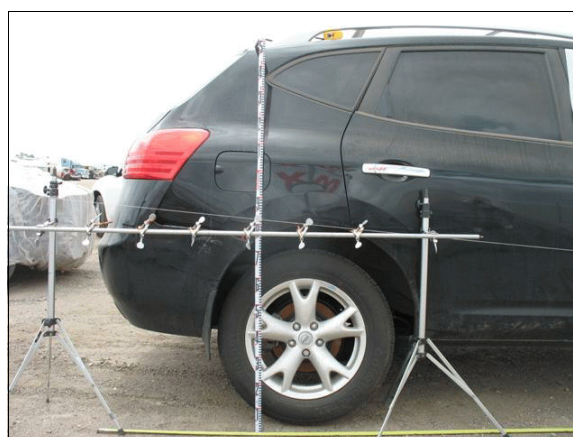
**Crash:** The front plane of the Lexus impacted the right side plane of the Nissan (**Figure 4**) (event 1). The direction of force on the Nissan was within the 2 o'clock sector and the impact force was sufficient to trigger deployment of the Nissan's rollover/side impact inflatable curtain (IC) air bags and seat-mounted side impact air bags. Following the impact, the Nissan rotated clockwise and rolled over (event 2), left side leading two quarter turns. The Nissan came to final rest on its top plane heading north in the mouth of the south leg of the intersection. The Lexus rotated clockwise and came final rest in the intersection heading southeast.

The rollover of the Nissan was initiated by the impact with the Lexus. The impact on the Nissan occurred on the right rear wheel and quarter panel, which induced a rapid clockwise rotation causing the vehicle to rollover, left side leading two quarter turns onto its top plane.

**Figure 4:** Damage on the right side of the Nissan from the impact with the front of the Lexus

**Exterior Damage:** The Nissan sustained right side plane damage during the impact with the Lexus. The right rear wheel, right quarter panel, and rear bumper fascia were directly damaged. The direct damage began 257 cm (101 in) rear of the right front axle and extended 93 cm (36.6 in) along the side of the right quarter panel and back bumper fascia. The crush measurements were taken along the middle portion of the quarter panel and the maximum residual crush was measured as 5 cm (2 in) at C<sub>2</sub>. The right wheelbase was extended 2 cm (0.8 in) and the left wheelbase was extended 1 cm (0.4 in). The table below presents the right side crush profile.

**Damage Classification:** The Nissan’s Collision Deformation Classifications were 02RBEW1 (60 degrees) for the right side plane impact with the Lexus and 00TYDO2 for the rollover. The Missing Vehicle algorithm of the WinSMASH program calculated the Nissan’s total Delta-V for the right side impact as 4 km/h (2.5 mph). The longitudinal and lateral velocity changes were -2 km/h (-1.2 mph) and -3 km/h (-1.9 mph), respectively. The results appeared low since the right rear wheel was directly engaged resulting in negligible crush on the sheet metal of the quarter panel. Based on the extent of the roof crush, the severity of the rollover damage was minor.

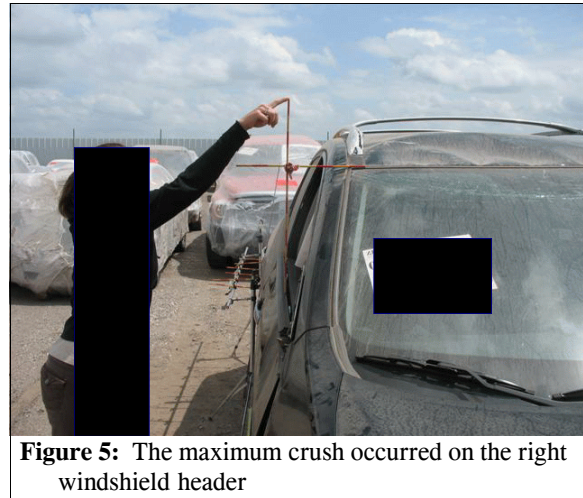
The top and left side planes of the Nissan sustained direct damage during the rollover. The direct damage on the top plane began at the front of the hood and extended 271 cm (107 in) rearward, and involved the full width of the roof, 130 cm (51 in). The direct damage on the left side plane began 38 cm (15 in) forward of the left front axle and extended 352 cm (138 in) rearward along the left side, A-pillar, and roof rail. The right fender and sideview mirror were damaged when the vehicle was rolled back onto its wheels during removal operations. The maximum vertical crush (**Figure 5**) was 3 cm (1.2 in) and occurred at the right corner of the windshield header, 107 cm (42 in) rear of the front axle. There was no lateral crush.

**Figure 5:** The maximum crush occurred on the right windshield header

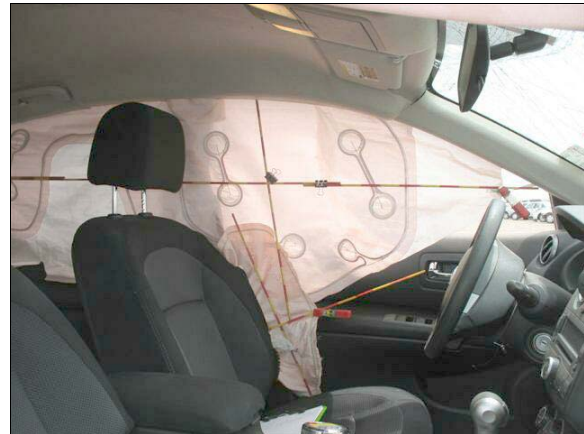
The IC air bags were located along the roof side rails inside the headliner (**Figure 6**) and extended from the top of the A-pillar to slightly behind the C-pillar. The deployed IC air bags were 154 cm (60.6 in) in width and 61 cm (24 inches) in height. They were attached at the front end by a non-inflating fabric that was 23 cm (9.1 in) wide. This fabric was connected to the IC air bags by a 10 cm (3.9 in) rope tether. The IC air bags extended 20 cm (7.9 in) below the beltline. There was no visible tether at the C-pillar. Inspection of the IC air bags revealed no discernable evidence of occupant contact, and they did not sustain damage.

**Figure 6:** Left side IC and seat-mounted side impact air bags

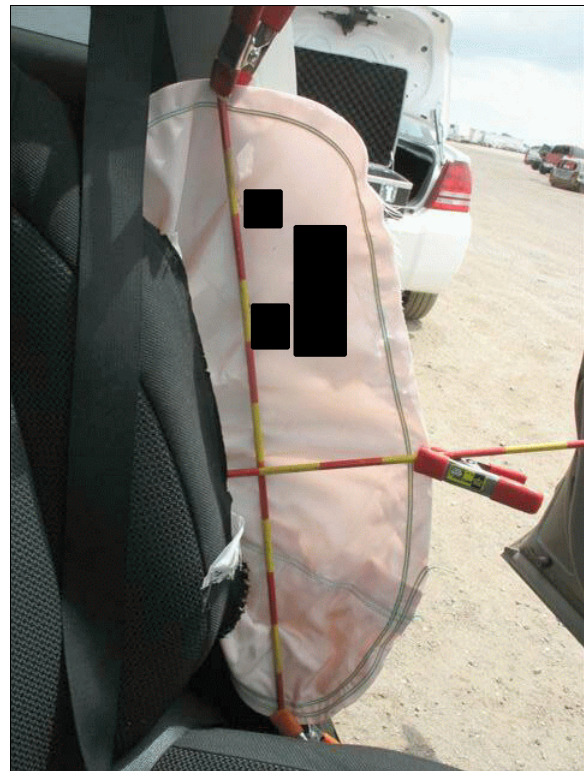
The driver's seat-mounted side impact air bag was located in the outboard side of the driver's seat back and deployed through vertical tear seam. The deployed air bag (**Figure 7**) was 53 cm (20.9 inches) in height and 21 cm (8.2 in) in width. There was one vent port, 3 cm (1.2 in) in diameter, located at the top of the outboard side. Inspection of the deployed air bag revealed no damage and no discernable evidence of occupant contact.

**Figure 7:** Driver's seat mounted side impact air bag

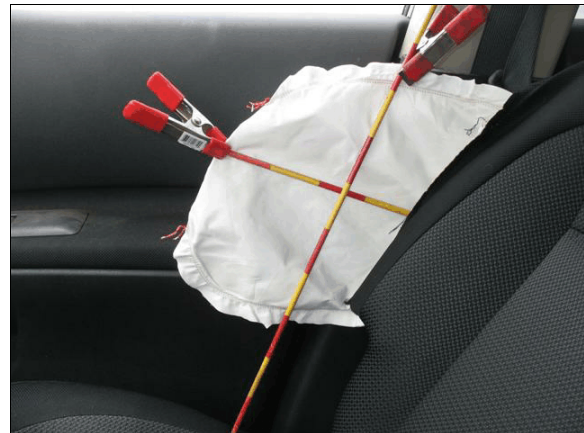
The passenger's seat-mounted side impact air bag was located in the outboard side of the passenger's seat back and deployed along a vertical tear seam. The deployed air bag was 29 cm (11.4 in) in height and 21 cm (8.2 in) in width. There were no vents or tethers and inspection of the deployed air bag showed no damage.

**Figure 8:** The front right passenger's seat-mounted side impact air bag

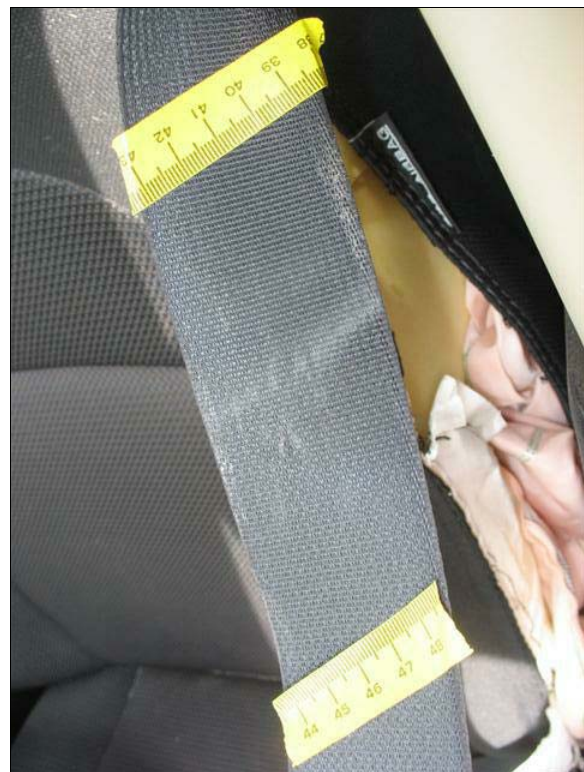
Inspection of the driver's safety belt assembly revealed load marks on the belt webbing located 126 cm (49.6 in) from the stop button (**Figure 9**). The latch plate showed historical usage scratches and load abrasions were present on the latch plate belt guide. This evidence indicated that the driver was restrained by the lap-and-shoulder belt at the time of the crash. Actuation of the pretensioner could not be confirmed since the retractor was not jammed and spooled freely.

**Figure 9:** Load marks on the driver's safety belt webbing
