**CALSPAN ON-SITE CHILD RESTRAINT SYSTEM CRASH INVESTIGATION
SCI CASE NO: CA10015**

VEHICLE: 2001 CHRYSLER TOWN & COUNTRY MINIVAN

LOCATION: MARYLAND

CRASH DATE: APRIL 2010

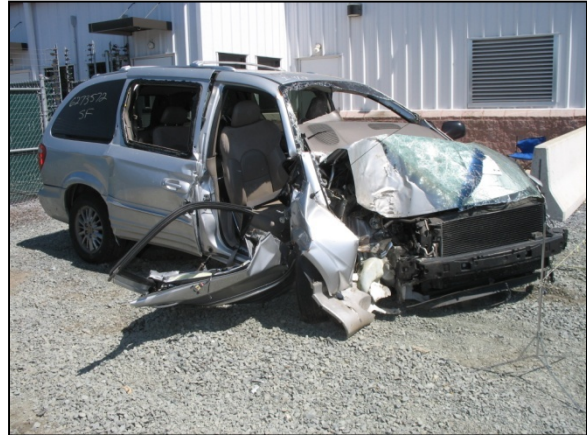
Figure 1: Front right oblique view of the 2001 Chrysler Town & Country.

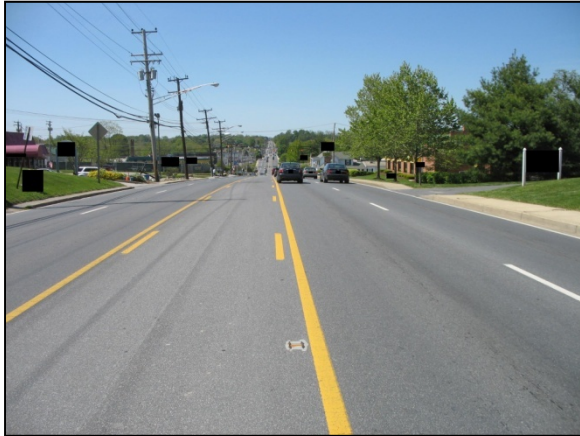
Figure 2: Northbound trajectory view of the Chrysler.

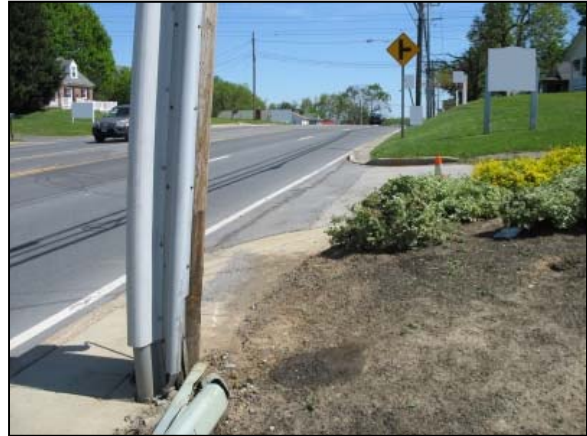
The crash occurred during daylight hours in April 2010. At the time of the crash, the weather was clear and the bituminous roadway was dry. The crash sequence occurred within an undivided section of roadway that consisted of two northbound travel lanes, two southbound travel lanes and a center left turn lane. This segment of roadway maintained a straight alignment with a four percent grade, negative to the north. The outboard travel lanes measured 3.4 m (11.2 ft) in width and the inboard lane measured 3.2 m (10.5 ft) wide. The left turn lane measured 3.2 m (10.5 ft) in width. The west edge of the roadway was bordered by an 8 cm (3 in) concrete curb with a 1.2 m (4.0 ft) wide concrete sidewalk that paralleled the curb line. A commercial driveway that measured 7.4 m (24.3 ft) in width was located on the west side of the roadway. A 38 cm (15 in) diameter wooden utility pole was located 1.2 m (4 ft) west of the west side curb line and 5.4 m (17.7 ft) north of the driveway. The posted speed limit for this portion of roadway was 64 km/h (40 mph). **Figure 2** is a northbound view of the section of roadway which depicts the pre-crash travel path of the Chrysler. **Figure 3** is a look back view from the utility pole (the

Figure 3: Look back view from the point of impact along the Chrysler's path of travel.

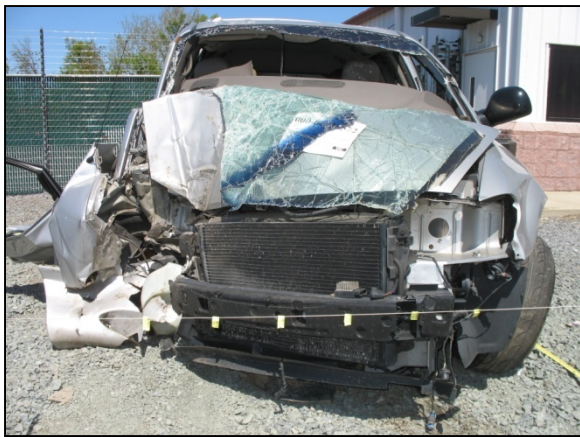
Figure 4: View of the Chrysler's front plane damage from event 3.

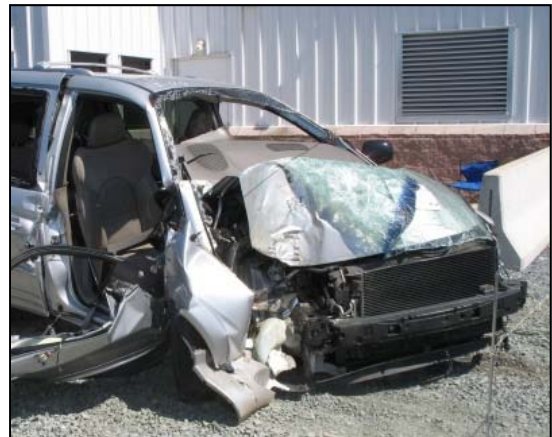
The front right area of the Chrysler impacted the utility pole resulting in an impact force of 12 o'clock. **Figures 5 and 6** are views of the impact damage. Maximum crush was 91 cm (35.8 in) located at the right corner of the bumper beam. The direct contact damage began 43 cm (16.9 in) right of the vehicle's centerline and extended 38 cm (15 in) to the front right corner. The combined induced and direct damage length was 84 cm (33 in) and involved the full (deformed) width of the bumper beam. The impact resulted in deformation to the front bumper fascia, reinforcement bar, right headlight, hood, grille, radiator components, and the left front fender. The front tire and wheel engaged the struck utility pole which displaced the axle position rearward 42 cm (16.5 in). The crush profile was measured at the level of the bumper beam and was as follows: C1 = 5 cm (2 in), C2 = 5 cm (2 in), C3 = 14 cm (5.5 in), C4 = 27 cm (10.6 in), C5 = 44 cm (17.3 in), C6 = 91 cm (35.8 in). The CDC for this impact was 12FREE5.

Figure 5: Right side view of the pole impact damage.

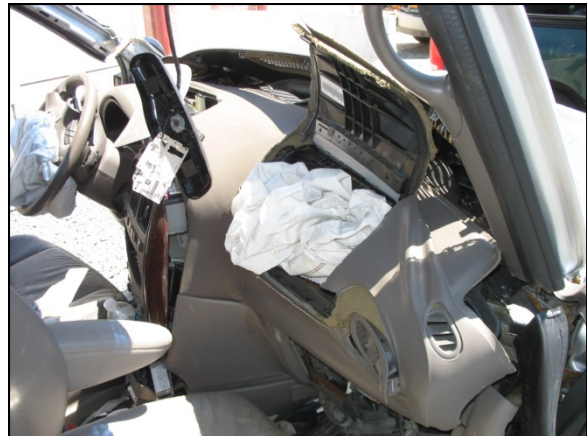
The interior damage to the Chrysler (**Figure 6**) consisted of the deployment of the vehicle’s air bag systems, actuation of the pretensioners, occupant contact points and passenger compartment intrusion. The maximum intrusion involved 49 cm (19.3 in) of rearward displacement of the right toe pan. The right instrument panel intruded 24 cm (9.4 in) rearward into the front right occupant space. The measured intrusions are listed by component, magnitude and direction front left to right in the following table:

Figure 6: Right interior view of the Chrysler's front row.

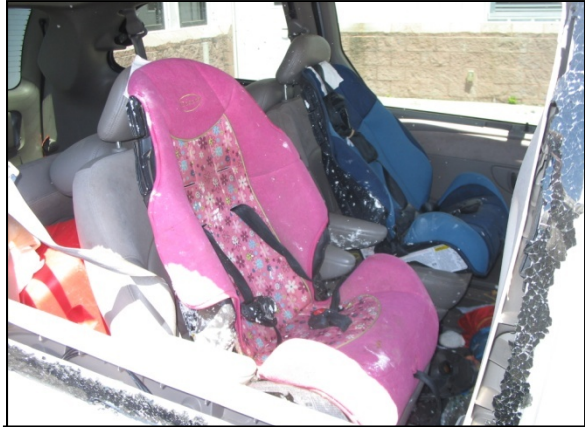
At the on-set of the SCI inspection, the pink CRS was found on the floor forward of the second row left position. It was determined that this CRS was removed from the vehicle post-crash and placed back into the Chrysler prior to its removal from the crash site. The pink CRS was re-positioned in its pre-crash placement in the second row right. **Figure 7** is a right interior view of the Chrysler depicting the reconstructed positions of the CRS's.

Figure 7: Right interior view of the Chrysler and the reconstructed positions of the CRS's.

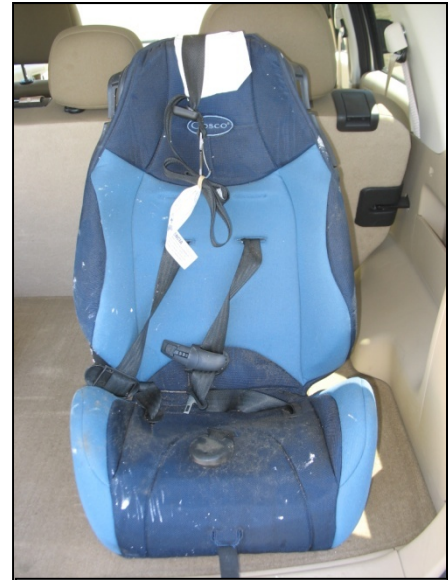
The blue CRS (**Figure 8**) was installed in the rear left position and was loosely secured by the vehicle's 3-point lap and shoulder belt system. The safety belt system was routed through the forward facing belt path. The CRS was identified as a Cosco/Dorel Highback Booster, with a Model No. of 22277-CPL and a Date of Manufacturer of 10/09/2009. The CRS was stamped with an expiration date of 2015. The CRS was designed for use as a forward-facing CRS or as a highback belt positioning booster seat. As a forward facing CRS, the manufacturer recommended size limits were 10-18 kg (22-40 lbs) and 86-109 cm (34-43 in). The size requirements for use as a forward-facing booster seat were 18-36 kg (40-80 lb) and 109-132 cm (43-52 in). The CRS was also equipped with Lower Anchors and Tethers for CHildren (LATCH). The LATCH system was not used for this installation.

Figure 8: View of the Cosco Highback that was located in the second row left seat position

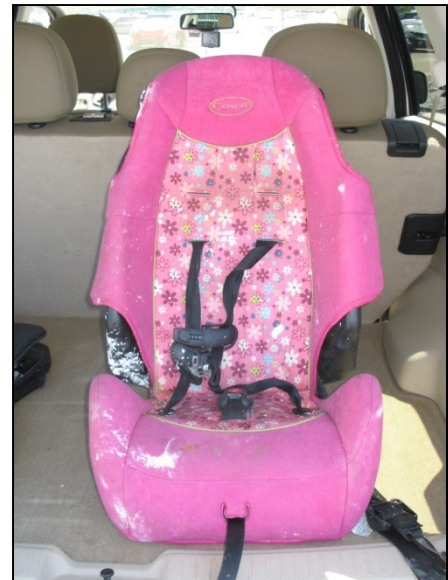
The pink Cosco CRS (**Figure 9**) was manufactured on 12/22/2008 and was identified by Model No. 22233-PDP. The expiration date posted on this CRS was 2015. The manufacturer size requirements were the same for this CRS as the blue CRS. The CRS was equipped with LATCH, but this system was not used in this crash. The CRS was secured by the vehicle's safety belt system routed through the forward facing belt path. There was no loading evidence at the belt path or stress to the shell of this CRS.

Figure 9: View of the Cosco Highback that was located in the second row right seat position

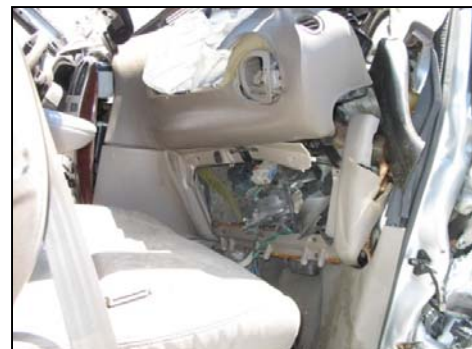
The passenger's knees engaged the glove box door and the sub-instrument panel as they intruded rearward into her position. **Figure 10** depicts the front right occupant's lower extremity contact points within the Chrysler. The glove box door was fractured and the sub-instrument panel components intruded into the glove box space. As a result of contact, the passenger sustained bilateral open fractures of the supracondylar femurs. The energy from this loading was transmitted through the femurs into the pelvis. She sustained a pelvic ring fracture that included the bilateral superior inferior pubic rami and the left sacro-iliac joint.

Figure 10: View of the Chrysler's lower right instrument panel.
