On-Site Child Restraint System Investigation
Dynamic Science, Inc. (DSI), Case Number DS10016
1996 Saturn SL1
Nevada
June 2010

1. Report No. DS10016		2. Government Accession No.		3. Recipient Catalog No.	
4. Title and Subtitle On-Site Child Restraint System Investigation				5. Report Date February 14, 2011

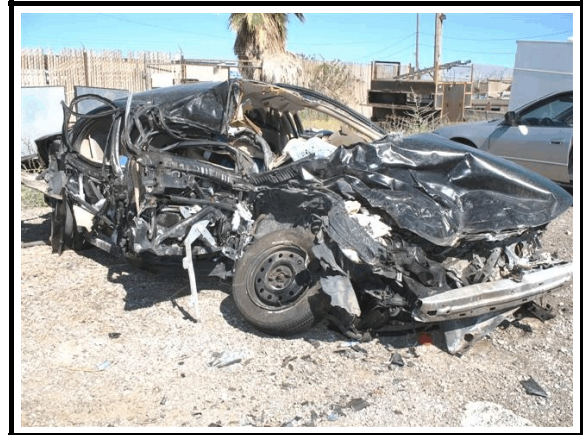
Figure 1. Subject vehicle, 1996 Saturn SL1

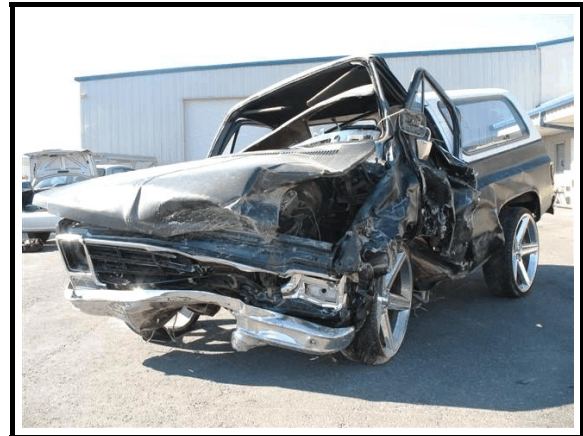
Figure 2. Other vehicle, 1979 Chevrolet Blazer

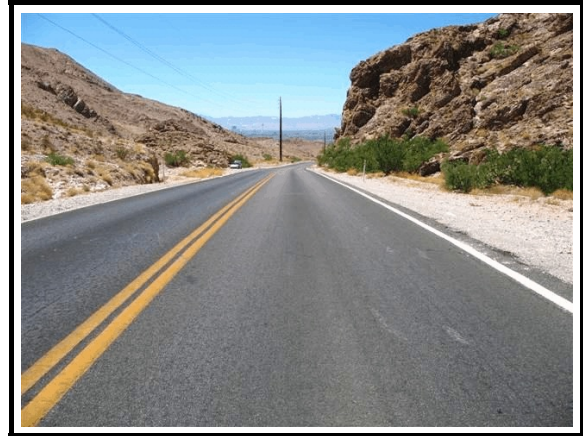
The crash occurred on an undivided east/west asphalt roadway that had a posted speed limit of 72 km/h (45 mph). At the time of the crash, conditions were dusk without street lamp illumination, partly cloudy and dry. The temperature at the nearest reporting station was 34.0° C (93.2° F), winds were east/southeast at 5.6 km/h (3.5 mph) and visibility was 16.0 km (10.0 mi).

Figure 3. Crash site, looking west

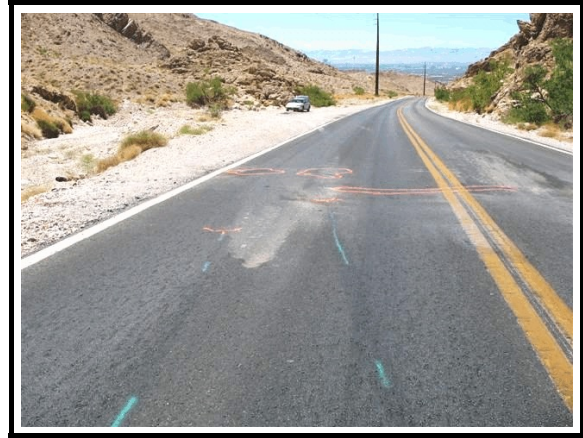
The crash sequence included two events. Initially, the front end of the Chevrolet impacted the right side of the Saturn in an angle impact configuration (Event 1). **Figure 4** shows the westbound travel path of the Saturn to the point of impact. The POI was determined based on scene evidence

including the Saturn's tire yaw marks, a scrape mark located 80.0 cm (31.5 in) north of the south roadway edge, and a fluid spill deposit. For Event 1 the directions of force were within the 2 o'clock sector for the Saturn and the 12 o'clock sector for the Chevrolet. Following the first impact, the Saturn continued its counterclockwise rotation and was displaced rearward. It deposited a scrape mark measuring 2.3 m (7.5 ft) in length across the center line on its path to final rest, which was identified by a fluid spill deposit. The vehicle came to rest facing north in the eastbound lane and its estimated post-impact travel distance to final rest was 4.0 m (13.0 ft).

Figure 4. View showing the Saturn's westbound approach to the point of impact in the eastbound travel lane

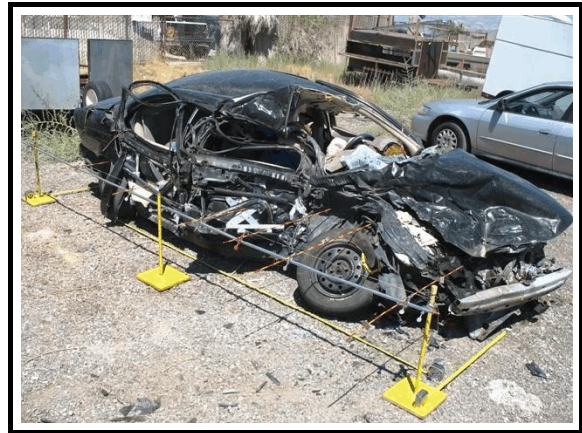
The Saturn sustained direct and induced damage to the right and top planes, and induced damage to the left, front and back planes. The right front tire sidewall was holed and de-beaded, and the rim sustained a 40-degree inboard cant. The right rear rim sustained a 5-degree outboard cant. The front and rear bumper fasciae and the right side view mirror were displaced. The right side polymer door

The direct damage to the right side began 95.0 cm (37.4 in) forward of the rear axle and extended forward 220.0 cm (86.6 in) to the front right bumper corner. The Field L extended from the rear bumper corner to the front bumper corner and measured 378.0 cm (148.8 in). Vertically, the direct damage to the right side extended from the sill to the roof and measured 109.0 cm (42.9 in). Six crush measurements were taken at mid-door level as follows (**Figure 5**): $C_1 = 8.0$ cm (3.1 in), $C_2 = 0$ cm, $C_3 = 7.0$ cm (2.8 in), $C_4 = 50.0$ cm (19.7 in), $C_5 = 54.0$ cm (21.3 in), $C_6 = 19.0$ cm (7.5 in). Maximum crush was located 199.0 cm (78.3 in) forward of the rear axle between C_4 and C_5 and measured 59.0 cm (23.2 in). The Collision Deformation Classification (CDC) for Event 1 was 02RYAW4.

Figure 5. Right side crush profile measurement of subject vehicle

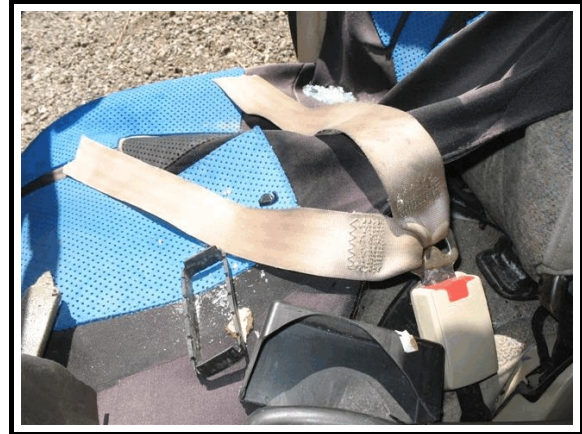
Figure 6. Front right occupant's safety belt as found during vehicle inspection

The front right passenger's safety belt D-ring was in the full-down position and the latch plate was scratched indicating historical usage. The lap and shoulder belt webbing were cut during extrication activities and at the time of the inspection the latch plate was found inserted into the buckle (**Figure 6**). The lap belt webbing was cut 43.0 cm (16.9 in) from the latch plate and the shoulder belt webbing was cut 41.0 cm (16.1 in) from the latch plate. The upper section of the shoulder belt was in the spooled out position and measured 41.0 cm (16.1 in) from the D-ring. The safety belt retractor was not functional due to B-pillar deformation. Based on the vehicle inspection, the front right safety belt was used to restrain the front right occupant during the crash.

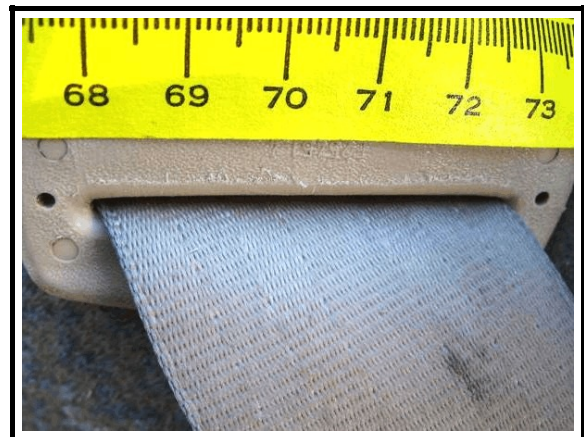
Figure 7. Left rear position safety belt latch plate showing occupant load marks

The rear left lap and shoulder safety belt was used in combination with a Graco TurboBooster belt positioning BSS to restrain the 4-year-old male occupant. The latch plate revealed a scuff mark indicating occupant loading at impact (**Figure 7**).

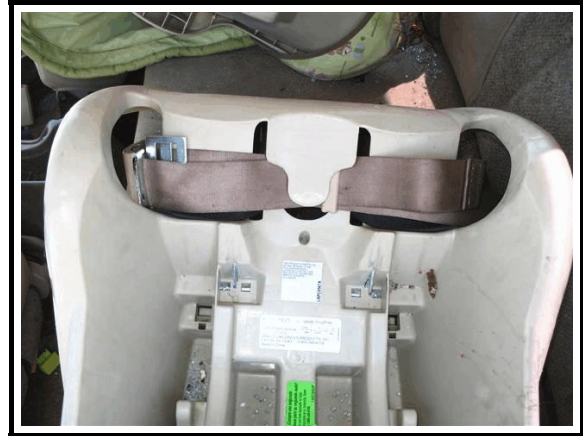
week-old female occupant. At the time of the inspection, the belt webbing was found routed through the ISS base (**Figure 8**). The latch plate was found unbuckled and a locking clip was attached to the webbing near the latch plate. The belt webbing measured 61.0 cm (24.0 in) from the seat cushion to the latch plate, which was the length required to properly install the ISS. The safety belt components were not damaged and did not show any evidence of occupant loading.

Figure 8. Rear center seat position lap safety belt as found routed through ISS base

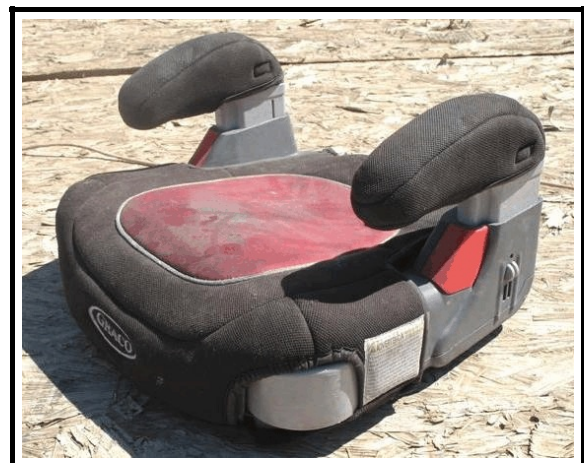
The Saturn's second row left seat position was occupied by a 4-year-old male occupant seated in a Graco TurboBooster forward-facing belt positioning BSS (**Figure 9**). The TurboBooster was intended to be used with or without a detachable high back support with a headrest, depending on the user's age, height and weight. The occupant was using the BSS without a back support at the time of the crash. Proper usage of the BSS required it be used in combination with the vehicle's lap and shoulder belt and not the lap

Figure 9. Graco TurboBooster BSS

The child was of the appropriate age and weight, but not of the recommended height, to use the BSS without the back support. He was otherwise properly restrained by the vehicle's lap and shoulder belt.

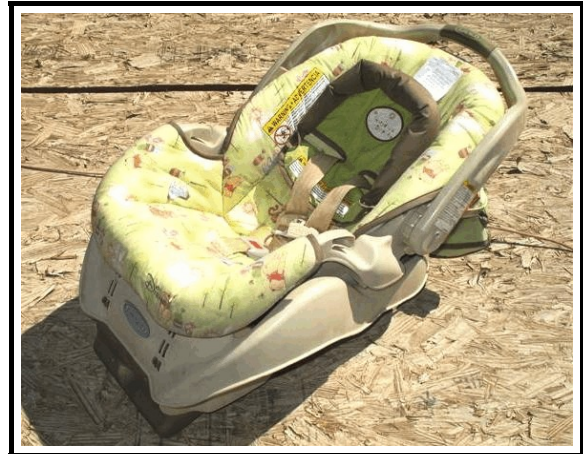
The Saturn's second row center seat position was occupied by the 12-week-old female occupant seated in a Graco SnugRide rear-facing ISS (**Figure 10**). During the vehicle inspection the ISS was located in the center seat position with the vehicle's lap belt routed through the rear-facing slots. A locking clip was attached to the lap belt webbing near the latch plate.

Figure 10. Graco SnugRide rear-facing ISS

The occupant was the appropriate height and weight for the ISS, and based on the vehicle inspection, it was determined the SnugRide was used in accordance to the manufacturer's recommendations. The ISS based revealed a fracture measuring 8.0 cm (3.1 in) located at the bottom aspect where it interfaced with the base. The ISS exhibited a fracture measuring 4.0 cm (1.6 in) located on the left aspect of the carry handle. The fracture to the stay-in-vehicle base probably resulted from occupant loading and the fracture to the carry handle probably resulted from contact by the occupant in the second row left seat position. When positioned on the vehicle's rear center seat, the ISS seat cushion angle measured 23.0 degrees from horizontal and the seat back measured 47.0 degrees from horizontal. The harness shoulder straps were routed through the bottom set of slots and the retainer clip was positioned 18.0 cm (7.1 in) below the slots.

A locking clip was found attached to the lap belt. However, locking clips are designed to hold the webbing of both the lap and shoulder belts tight until the ELR locks the belt in place and, therefore, the locking clip was of no benefit in this crash.

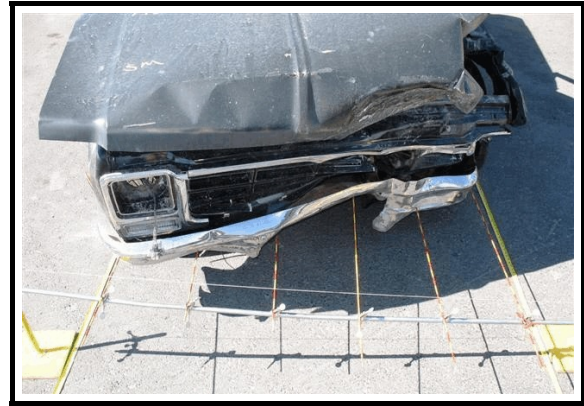
The direct damage to the front end began at the front left bumper corner and extended 178.0 cm (70.1 in) to the right. The Field L was distributed from bumper corner to bumper corner and measured 162.0 cm (63.8 in). Six crush measurements were taken at bumper level as follows (**Figure 11**): $C_1 = 74.0$ cm (29.1 in), $C_2 = 61.0$ cm (24.0 in), $C_3 = 59.0$ cm (23.2 in), $C_4 = 31.0$ cm (12.2 in), $C_5 = 20.0$ cm (7.9 in), $C_6 = 5.0$ cm (2.0 in). Maximum crush was located at C_1 . Additionally, induced damage extended down the left side 347.0 cm (136.6 in) and ended 25.0 cm (9.8 in) aft of the left rear axle. The CDC for Event 1 was 12FDEW3.

Figure 11. Front end crush profile measurement, 1979 Chevrolet Blazer

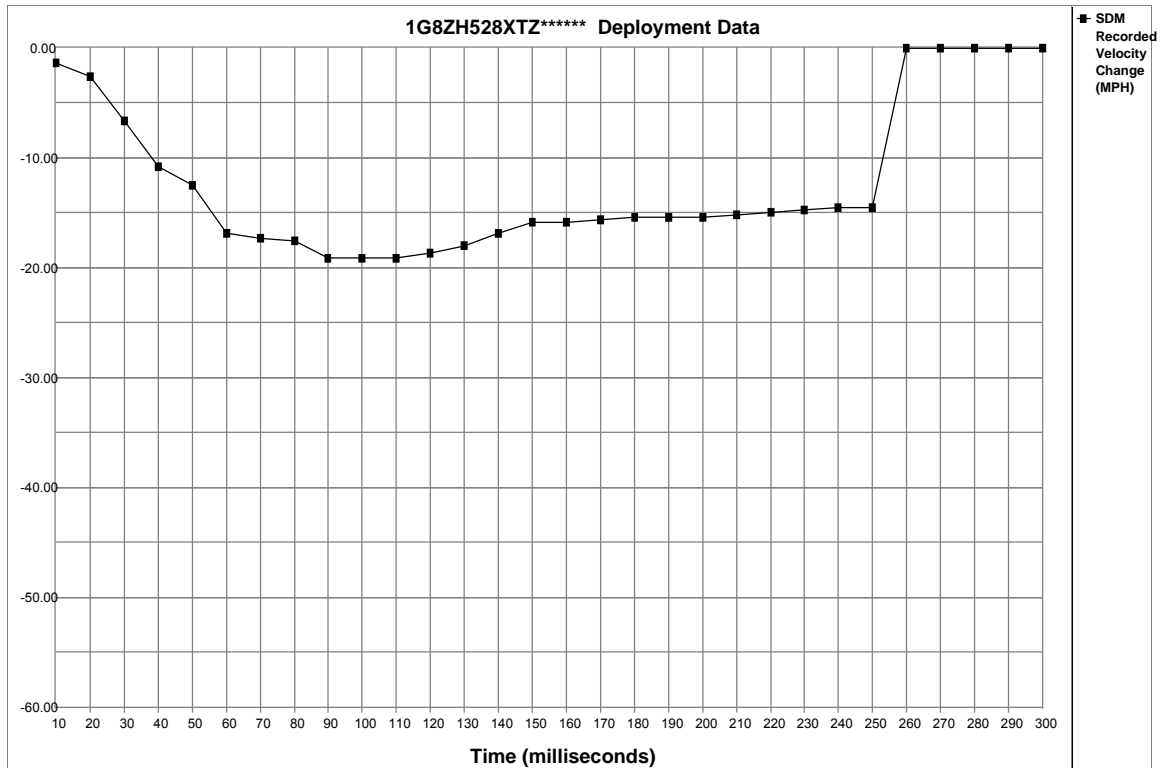
The EDR was configured to record 300 msec of longitudinal velocity change during an event. The maximum recorded longitudinal velocity change was -30.72 km/h (-19.09 mph) and occurred from 90 - 110 msec after AE. At 250 msec after AE the recorded velocity change was -23.3 km/h (-14.48 mph). At 260 msec after AE power to the ACM was lost and from 260 - 300 msec after AE the recorded velocity change defaulted to 0.

System Status At Deployment

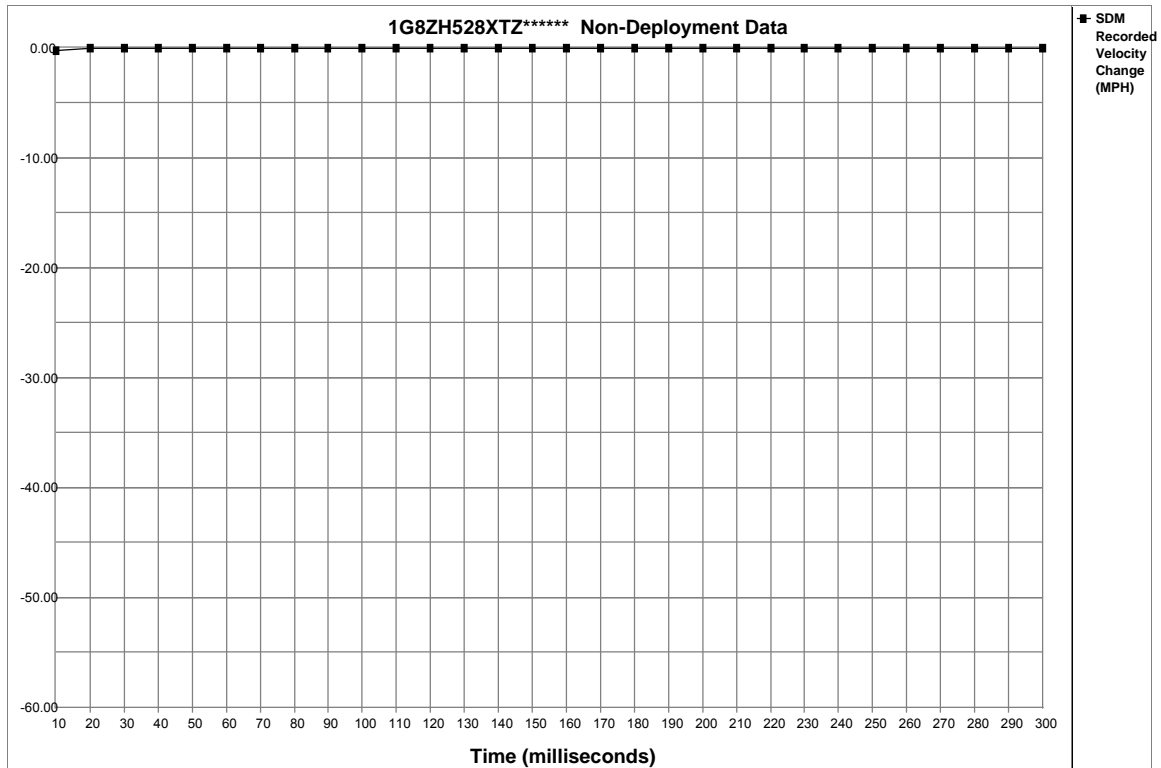
System Status At Non-Deployment
