**CALSPAN ON-SITE CHILD RESTRAINT SYSTEM CRASH INVESTIGATION
SCI CASE NO: CA10018**

VEHICLE: 2002 FORD RANGER

LOCATION: FLORIDA

DATE: MAY, 2010

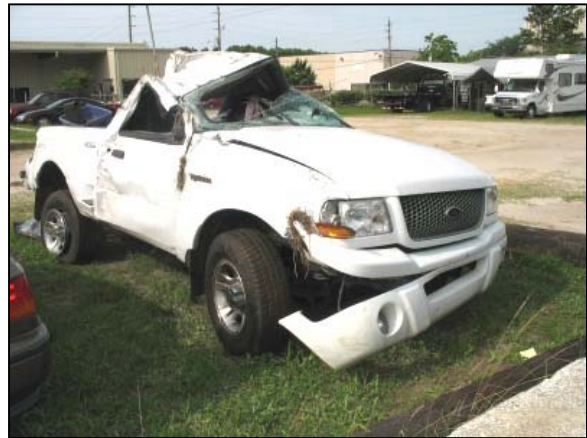
Figure 1: Front right oblique view of the Ford Ranger.

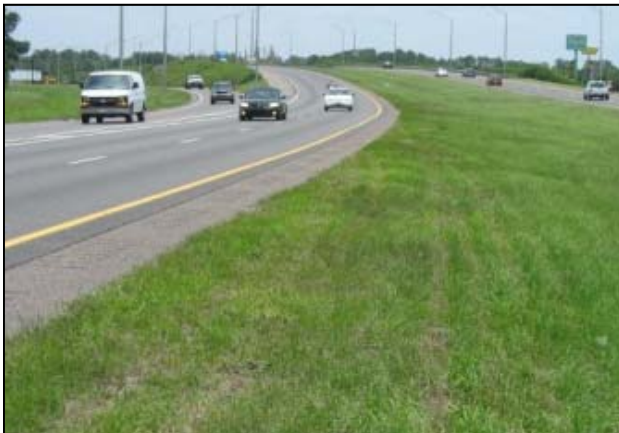
a negative grade along the pre-crash trajectory of the Ford. **Figure 2** is a look back view at the crash site of the Ford's roadside departure. The west roadside terrain sloped away from the travel lanes to a wide drainage area located approximately 15 m (50 ft) west of the road. The Ford came to rest on its top at the base of the slope. **Figure 3** is a look back at the crash site from the final rest area of the Ford. An overhead light pole supported by a concrete base was located along the Ford's rollover trajectory. The speed limit was 105 km/h (65 mph). **Figure 19**, at the end of this report, is a schematic of the crash.

Figure 2: Look back view of the crash site at the roadside departure of the Ford.

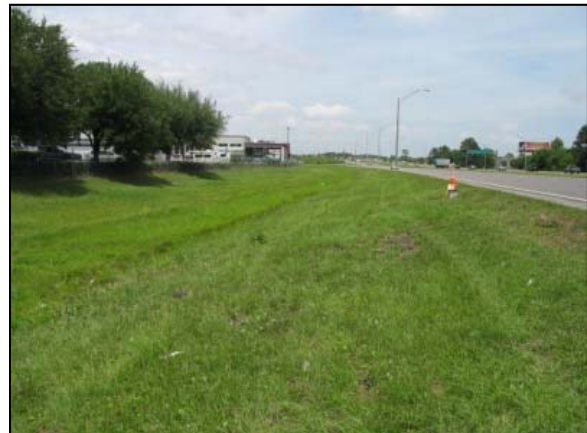
Figure 3: Look back view from the final rest area of the Ford along its rollover trajectory

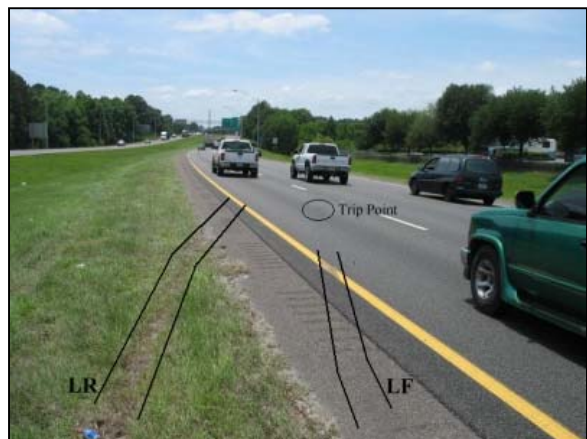
The 2002 Ford Ranger was southbound, driven by the unrestrained 25-year-old male. The 2-year-old female was restrained within a forward-facing CRS and secured in the front right position of the Ford. The vehicle departed the left side of the interstate and entered the center median. The driver reacted to the vehicle's errant trajectory by steering clockwise (right) in an attempt to regain the road. In the process of the steering maneuver, the driver overcorrected and the vehicle began to yaw clockwise. Diverging tire marks in the median identified during the SCI scene inspection evidenced the vehicle's off-road trajectory, **Figure 4**. The total length of the off-road travel was approximately 98 m (322 ft). As the Ford reentered the southbound travel lane, the left front tire rolled under and exposed the rim to the pavement.

Figure 4: View of the Ford's yaw marks as the vehicle reentered the travel lane.

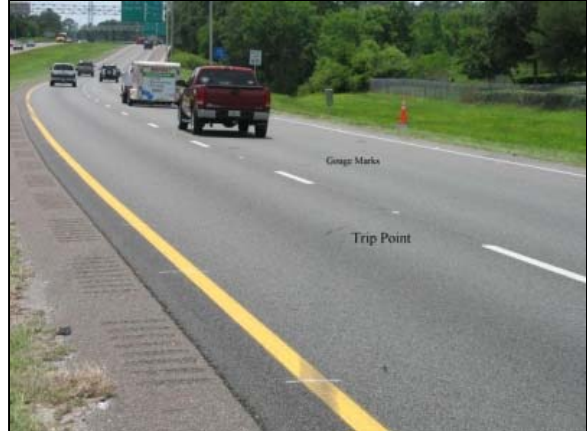
The left front wheel contacted the road surface and tripped the vehicle into a left side leading rollover (Event 1). The Ford rolled across the interstate highway and departed the right side of the road. A series of gouge marks were dispersed across the traffic lanes and evidenced the vehicle's trajectory. **Figure 5** is a view of the Ford's roll trajectory. The right side of the Ford impacted the concrete base and fractured the frangible mount of a light pole (Event 2). At the time of the impact the Ford was in a non-horizontal attitude. The Ford then rolled down the shallow embankment and came to rest on its top. The vehicle rolled a total of 10-quarter turns over a distance of approximately 82 m (270 ft). The driver was ejected through the backlight during the later stages of the rollover. He came to rest 18.6 m (61 ft) south the Ford's final rest location.

Figure 5: Roll trajectory of the Ford.

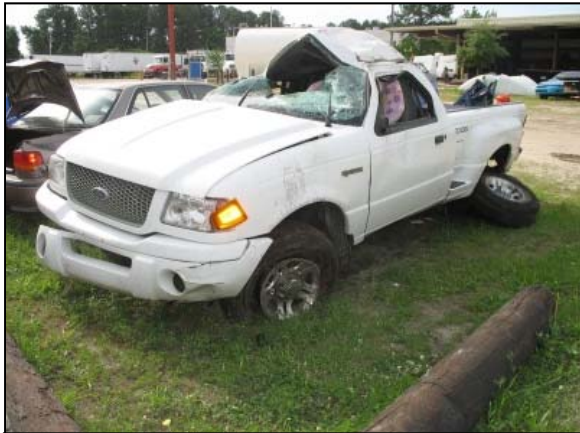
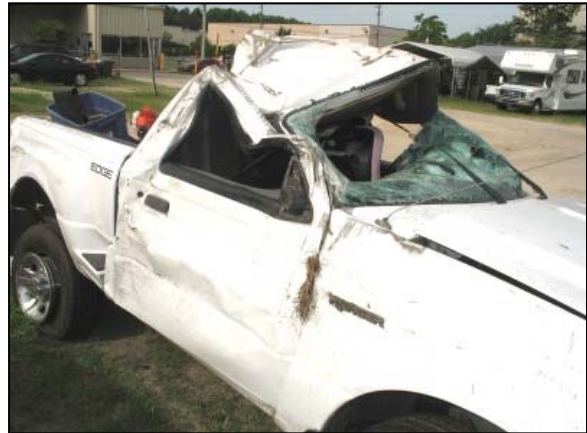
The exterior damage to the Ford Ranger was consistent with a multiple quarter turn rollover event. The vehicle's two side planes, top plane and the all wheels/tires exhibited damage from multiple ground impacts (**Figures 6 and 7**). The scratch pattern on the vehicle's roof was bi-directional indicative of rotation during the multiple ground contact rollover event. The body panels exhibited isolated areas of abrasion and deformation attributed to the rollover. Both doors could be opened and closed; however, their operation was impeded by deformation. The backlight and both side window glazings disintegrated during the rollover. The windshield was fractured by the exterior forces of the crash.

Figure 6: Left front oblique view of the Ford.

Figure 7: Right front oblique view of the cab.

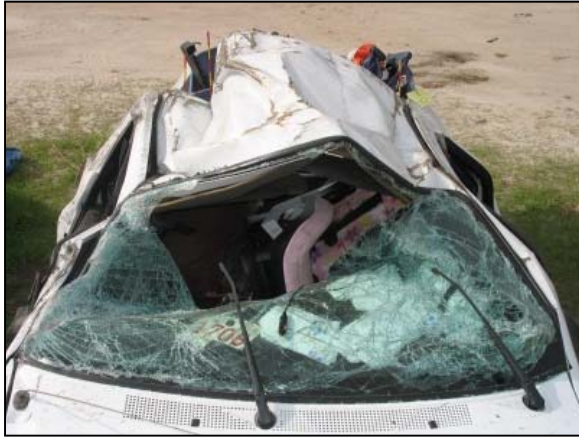
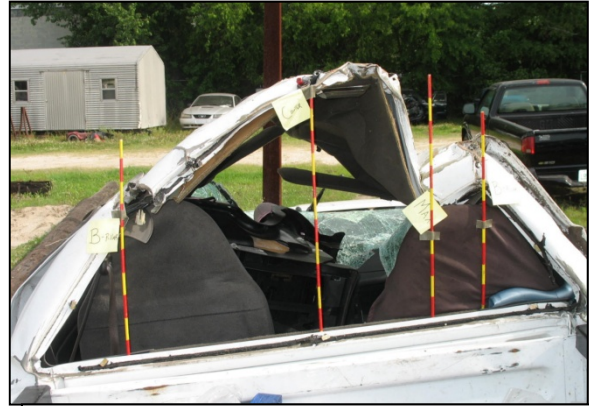
Figures 8 and 9 are front and back views of the greenhouse depicting the deformation of the roof. The pillars and side rails deformed inboard as the roof crushed down. The roof was crushed down over both the driver and front right passenger seat positions and had deformed in the shape of an inverted V. The headliner/roof was in contact with the head restraints of both outboard seats. The maximum vertical crush of the backlight header measured 21 cm (8.1 in). The deformed roof increased the size of the ejection portal for the driver through the backlight. **Figure 10** is a view of the right roof side rail and the location of the maximum vertical and lateral deformation. The maximum vertical and lateral side rail deformation of the side rail was 33 cm (13.0 in) and 12 cm (4.6 in), respectively. The Collision Deformation Classification (CDC) of the rollover was 00TDDO5.

Figure 8: Front view of the roof deformation.

Figure 9: Back view of the roof and backlight header deformation

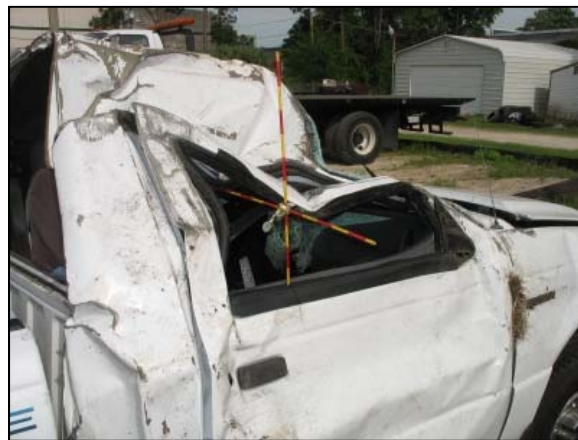
Figure 10: View of the maximum vertical and lateral deformation at the right roof side rail.

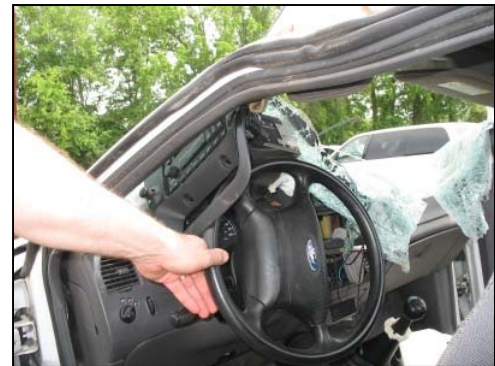
During the rollover, the OEM radio separated from the instrument panel and became captured between the steering wheel rim and the deformed left A-pillar, (**Figure 11**). The captured radio had jammed the steering wheel rim, which restricted rotation of the wheel. The wheel rim was rotated 90 degrees CW.

Figure 11: View of the left interior depicting the displaced radio and jammed steering wheel rim.

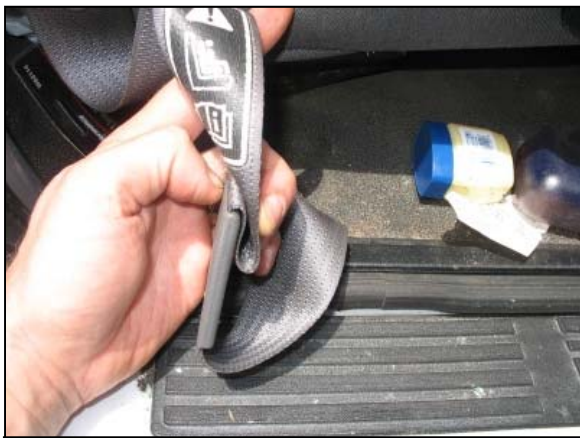
The front right restraint consisted of continuous loop webbing, a sliding latch plate, adjustable D-ring and a switchable Automatic Locking/ELR. The D-ring was adjusted to the full-up position. The belt system was equipped with a buckle pretensioner that did not actuate during the crash. The latch plate exhibited indications of historical use. There was minor polishing of the friction surface. The webbing was stowed on the retractor at the time of the inspection. Examination of the webbing revealed it was loaded and creased in the lap section over a 53 cm (21 in) length from its interaction with forward-facing belt path of the CRS. An Energy Management Loop (EML) in the webbing was located immediately above the outboard floor anchor. Refer to **Figures 12 and 13**. The stitching in the webbing had released. The release of the EML increased the webbing length approximately 8 cm (3 in). The manufacturer's label on the webbing indicated that the belt system had to be replaced.

Figure 12: View of the reconstructed pre-crash condition of the EML.

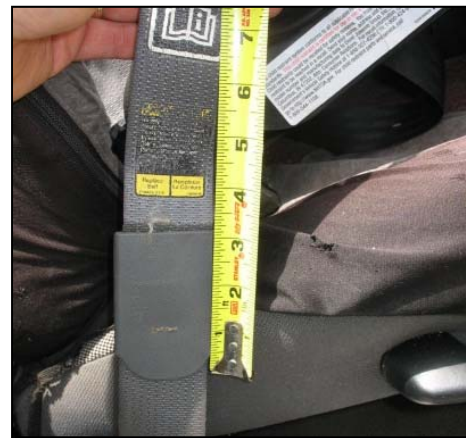
Figure 13: View depicting the deployed EML.

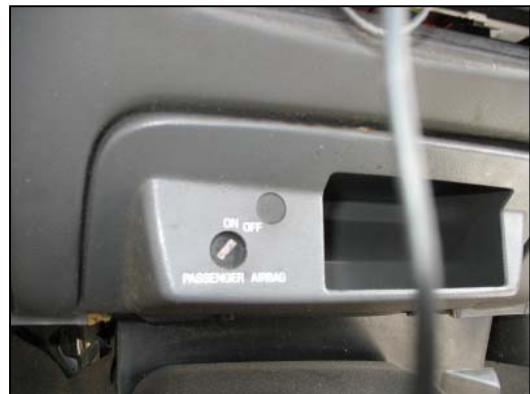
The Ford was equipped with redesigned frontal air bags in the driver and frontal right passenger positions. The air bags did not deploy in the crash. The driver air bag was located in the center hub of the steering wheel rim. The front right passenger air bag was a mid-mount design located in the right aspect of the instrument panel. The front right passenger air bag was configured with a cut-off switch in order to suppress the deployment of the air bag. The switch was mounted in the lower aspect of the center instrument panel. The switch was turned to the “Air Bag Off” position (**Figure 14**).

Figure 14: View of the air bag cut-off switch.

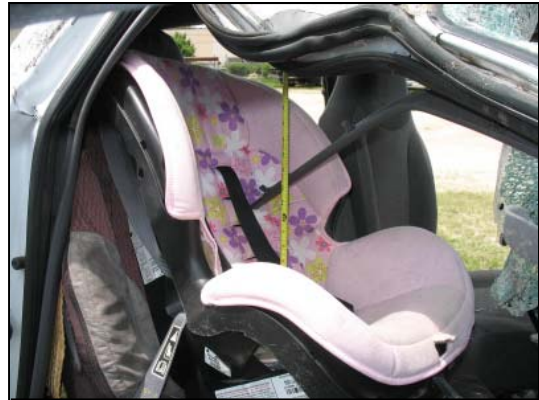
The 2-year-old female was restrained in a forward-facing mode within a Cosco Scenera S CRS that was secured in the front right position (**Figure 15**). The CRS was manufactured on April 10, 2008 and was identified as Model No. 22123-DDZ, Serial No. WC C 660693. The CRS was a convertible seat designed for both rear-facing and forward-facing use. In the forward-facing mode the seat was compatible with children over 1 year of age weighing 10 - 18 kg (22 - 40 lb) and 85 - 110 cm (34 - 43 in) in height. Infants less than 1 year of age and less than 16 kg (35 lb) were required to be rear-facing.

Figure 15: View of the CRS reconstructed into the front right seat position.

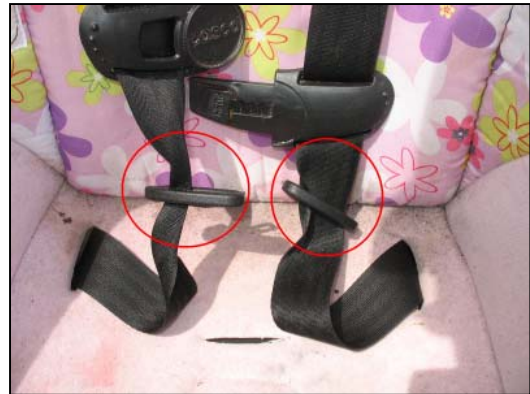
The CRS was found loose within the vehicle's front row at the time of the SCI inspection. The adjustable foot was in the extended position required for forward-facing use. The 5-point harness straps were routed through the top slots and had been adjusted (post-crash) to the fully slack position. The at-crash harness adjustment was unknown. There was no crash related evidence on the harness straps. Both harness straps were roped in the buckle clips (**Figure 16**). The strap was twisted a single turn as it passed under the bottom of the shell.

Figure 16: View of the harness straps roped within the buckle clips.

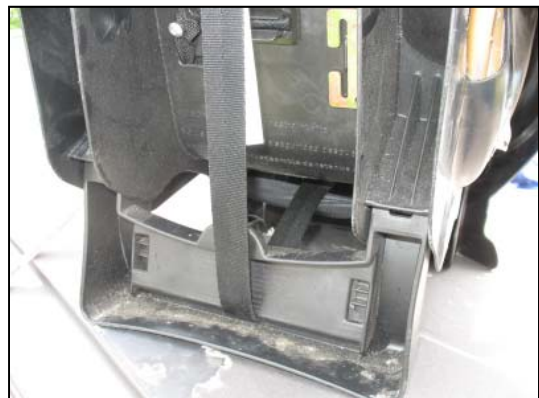
Examination of the complete harness system revealed that the harness adjustment strap of the CRS was unconventionally routed. The adjustment strap was attached to the harness at the splitter plate and then was unconventionally routed through the adjustment foot (**Figure 17**). The adjustment strap should have been routed along the perimeter of the shell. The fit of the harness straps was adjusted by pulling the end of the adjustment strap located at the front of the shell. Tension on the adjustment strap would have pulled on the adjustable foot of the CRS and effected the tension placed on the harness straps.

Figure 17: View of the improperly routed adjustment strap.

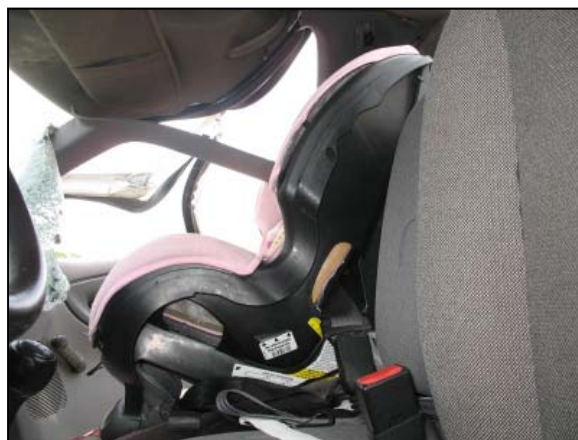
The CRS was repositioned in the front right seat. **Figure 18** is a left interior view of the repositioned CRS. For reference, the horizontal distance from the seat bight of the CRS to the instrument panel measured 58 cm (23.0 in). The vertical distance from the CRS seat bight to the intruded roof measured 62 cm (24.5 in). The vertical clearance from the top the CRS shell to the intruded roof measured 9 cm (3.5 in). The partially detached interior trim is visible in the image.

Figure 18: Left interior view of the repositioned CRS.
