On-Site Side Air Bag Investigation  
Dynamic Science, Inc. (DSI), Case Number DS10021  
2009 Toyota Camry  
California  
August 2010

1. Report No. DS10021	2. Government Accession No.	3. Recipient Catalog No.	
4. Title and Subtitle  On-Site Side Air Bag Investigation		5. Report Date  January 5, 2011

**Dynamic Science, Inc.**  
**Crash Investigation**  
**Case Number: DS10021**

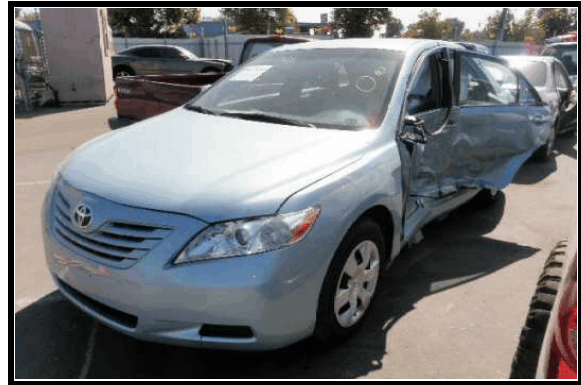
**Figure 1.** Subject vehicle, 2009 Toyota Camry

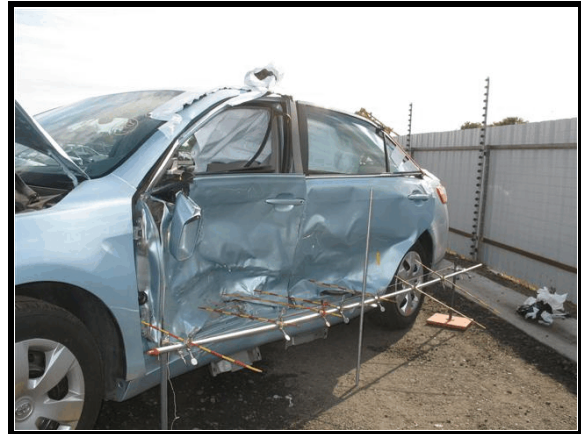
The Toyota sustained moderate left side damage from the impact with the front of the Kia (**Figure 4**). The direct damage began 60.0 cm (23.6 in) aft of the front axle and extended rearward 160.0 cm (62.9 in). The Field L began 44.0 cm (17.3 in) aft of the front axle and extended rearward 222.0 cm (87.4 in).

Six crush measurements were documented along the lower door as follows:  $C_1 = 0$  cm,  $C_2 = 12.0$  cm (4.7 in),  $C_3 = 22.0$  cm (8.7 in),  $C_4 = 27.0$  cm (10.6 in),  $C_5 = 24.0$  cm (9.4 in),  $C_6 = 0$  cm. Maximum crush was located at 129.0 cm (50.7 in) aft of the front axle and measured 37.0 cm (14.5 in). The height of the maximum door crush was 43.0 cm (16.9 in) and the Door Sill Differential (DSD) was 23.0 cm (9.0 in). The Collision Deformation Classification (CDC) for Event 1 was 10LPEW2.

**Figure 4.** Left side damage, 2009 Toyota Camry

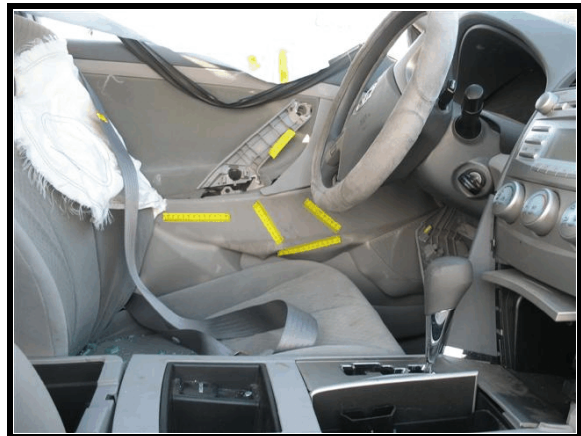
The Toyota sustained minor interior damage resulting from intrusion, occupant loading, and occupant contacts. There was minor lateral intrusion to the front left door panel, left armrest, driver's seat back, B-pillar, second row left door panel and frame. There was evidence of occupant contact to multiple locations on the left front door (**Figure 5**) and the center console was displaced. The left front door was jammed shut and the left front glazing was disintegrated.

**Figure 5.** Left interior door contacts

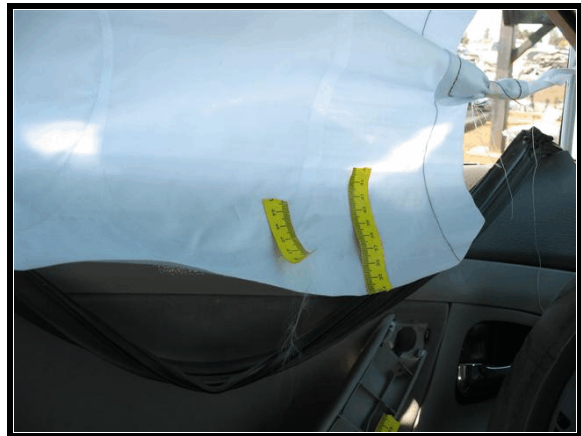
The left IC air bag deployed from the roof side rail above the front and rear rows. The IC air bag was rectangular in shape and measured 165.0 cm (64.9 in) in length and 36.0 cm (14.1 in) in height. An external 18.0 cm (7.0 in) tether attached the forward aspect of the air bag to the left A-pillar. A 9.0 x 5.0 cm (3.5 x 2.0 in) abraded area was documented on the exterior of the air bag. The abraded area was located 13.0 cm (5.1 in) aft of the leading edge of the air bag and 4.0 cm (1.6 in) above the bottom of the air bag. A 4.0 x 4.0 cm (1.6 x 1.6 in) occupant loading scuff mark was documented on the inboard panel of the air bag (**Figure 6**). The scuff mark was located at the bottom of the air bag 9.0 cm (3.5 in) aft of the leading edge of the air bag.

**Figure 6.** Loading scuff mark to side IC air bag

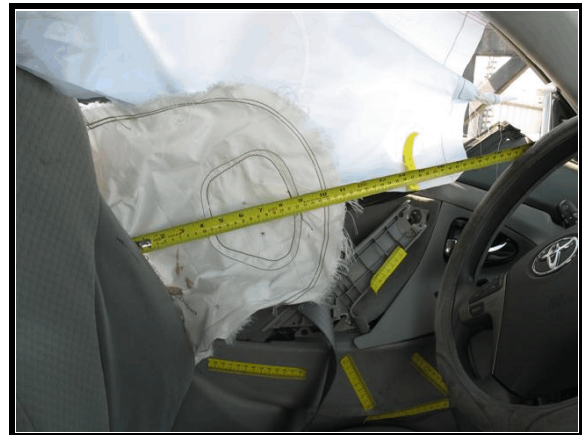
**Figure 7.** Seat-mounted side impact air bag

The left seat-mounted side impact air bag deployed at impact from the outboard aspect of the driver's seat back (**Figure 7**). The air bag was semicircular in shape measuring 30.0 cm (16.5 in) in height and 28.0 cm (11.0 in) in length. In its deflated state, the air bag excursion covered the left B-pillar and rear upper quadrant of the door panel. The air bag was configured with three small vent ports in a non-inflatable sector located at its forward aspect. There were no indications of loading to the air bag. There was a small amount of blood located on the inboard panel of the air bag next to the seat back.
