On-Site Child Restraint System Investigation  
Dynamic Science, Inc. (DSI), Case Number DS10022  
2001 Toyota Land Cruiser  
Idaho  
September 2010

| 15. Supplemental Notes<br><br>The focus of this on-site investigation was the child occupant and Child Restraint System (CRS) in a 2001 Toyota Land Cruiser that was involved in a single-vehicle rollover crash. | | | |

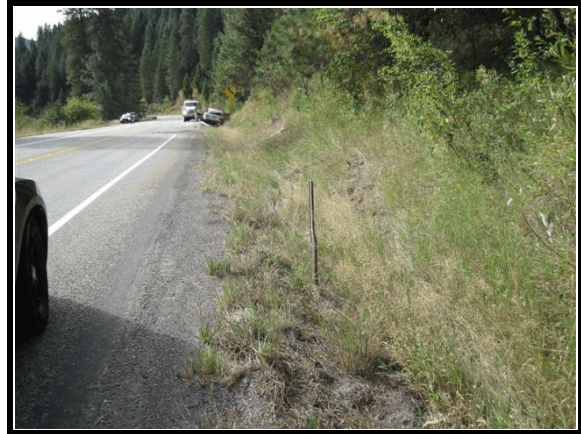
The Toyota traveled off the asphalt shoulder and impacted a metal snow pole (Event 1) (**Figure 3**). The Toyota continued off-road and traveled up an embankment. The vehicle vaulted, became airborne, and began an end-over-end rollover about its lateral axis (Event 2). The vehicle completed four quarter-turns and came to rest on the roadside on its wheels (**Figure 4**).

**Figure 3.** Impact with snow pole (police photo)

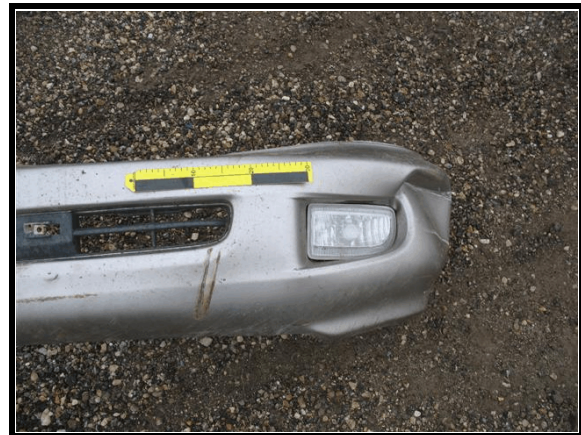
The Toyota sustained minor front end damage from the impact with the snow pole (**Figure 5**). The direct damage was located 38.0 cm (14.9 in) from the left front bumper corner and measured 2.0 cm (0.8 in) in width and 11.0 cm (4.3 in) in height. The Collision Deformation Classification (CDC) for the impact with the pole was 12FLLN1.

**Figure 5.** Front bumper damage from impact with snow pole

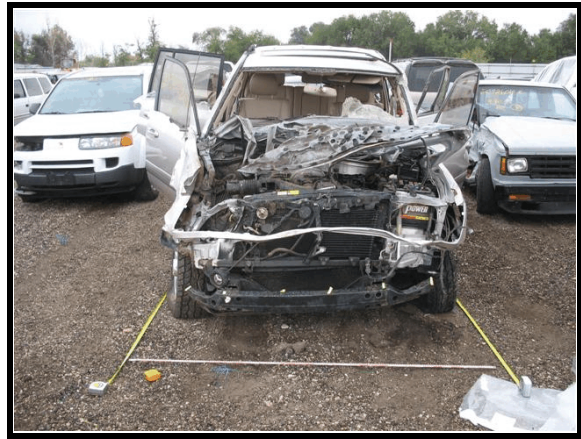
The Toyota sustained moderate front end damage from the impact with the embankment during the end-over-end rollover sequence (**Figure 6**). This was a non-horizontal impact but field measurements were taken for informational purposes. The direct damage began at the front right bumper corner and extended left 125.0 cm (49.2 in). The Field L extended from bumper corner to bumper corner. Six crush measurements were taken along the backing bar as follows:  $C_1 = 6.0$  cm (2.4 in),  $C_2 = 8.0$  cm (3.1 in),  $C_3 = 6.0$  cm (2.4),  $C_4 = 6.0$  cm (2.4 in),  $C_5 = 5.0$  cm (2.0 in),  $C_6 = 12.0$  cm (4.7 in). The maximum crush was

**Figure 6.** Frontal damage

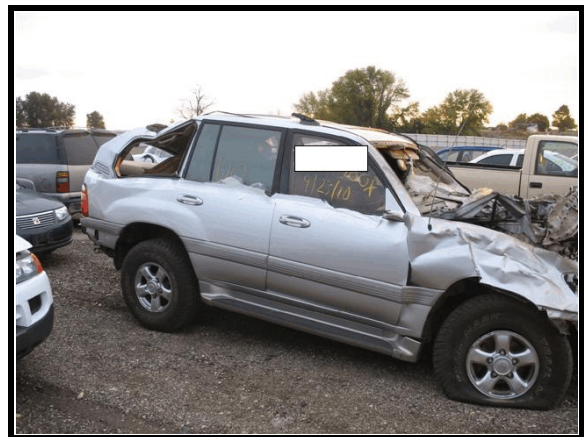
Additionally, the Toyota sustained damage to the hood and roof during the rollover event (**Figure 7**). The direct damage to the top of the vehicle extended laterally from roof side rail to roof side rail and measured 153.0 cm (60.2 in). The damage extended from the hood rearward 403.0 cm (147.2 in) to the backlight. The maximum vertical crush measured 40.0 cm (15.7 in) and was located at the left D-pillar; the maximum lateral crush was located at the same point and measured 20.0 cm (7.9 in) (**Figure 8**). The CDC for Event 2 was 00TDDO4.

**Figure 7.** Overview of rollover damage

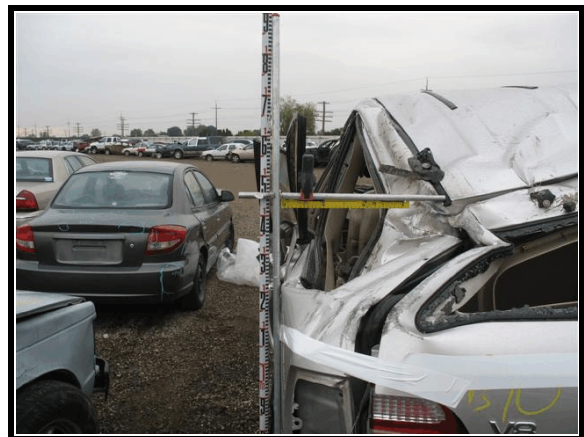
**Figure 8.** Maximum lateral and vertical crush at left D-pillar

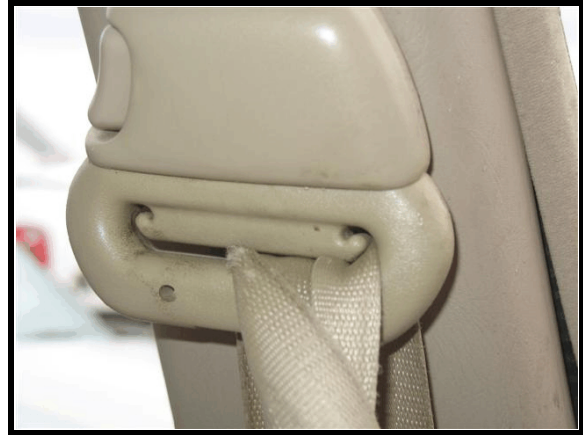
The driver's safety belt D-ring anchorage was in the full-down position and the latch plate was scratched indicating historical usage. The safety belt was locked in the spooled out position due to pretensioner actuation and the belt webbing was trapped in the D-ring (**Figure 9**). There was loading on the webbing at the D-ring. Based on the vehicle inspection it was determined that the front left safety belt was used to restrain the driver during the crash.

**Figure 9.** Driver's safety belt webbing at D-ring

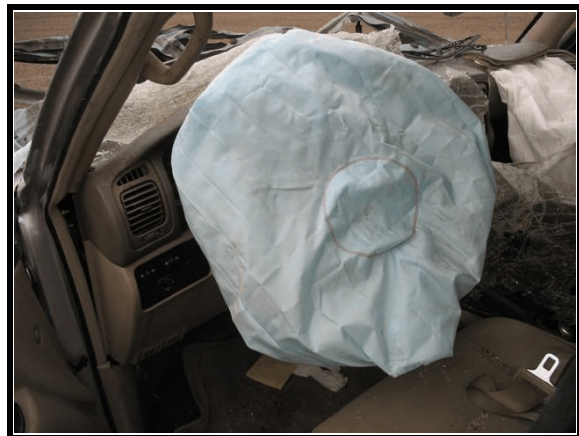
The driver's air bag deployed from the steering wheel hub through H-configuration cover flaps (**Figure 10**). It was circular in shape and measured 62.0 cm (24.4 in) in diameter from seam to seam.

**Figure 10.** Driver's frontal air bag

The air bag was configured with two 3.0 cm (1.2 in) diameter vent ports on the back panel and a single internal tether attached to the center of the front panel. The air bag was dirty and scuffed in several locations but this was due to it being in contact with vehicle components that had been placed in the vehicle after the crash.

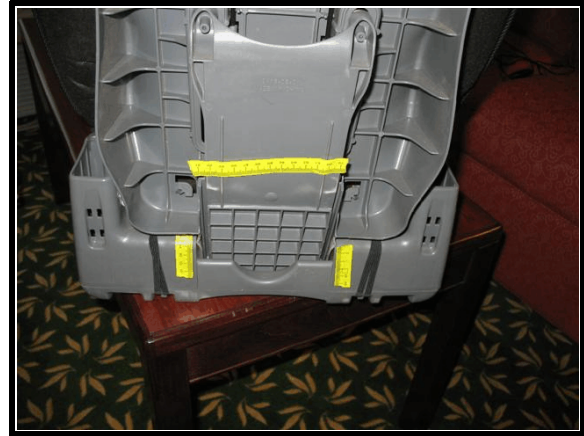
Inspection of the BSS revealed two areas of hazed plastic loading to the high back (**Figure 12**). The first area was located 13.0 cm (5.1 in) below the top of the backrest slide and measured 2.0 cm (0.8 in) in height and 12.0 cm (4.7 in) in width. The second area located at the points where the backrest connects to the seat bottom.

**Figure 12.** Loading to BSS back support

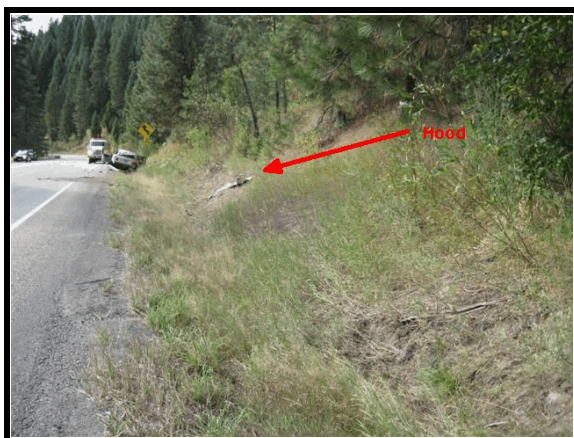
This vehicle was involved in an end-over-end, four quarter-turn rollover. The Toyota departed the roadway on the right side and traveled in a diagonal up an ascending embankment. As the vehicle reached a point on the embankment where the ground dropped away, the vehicle vaulted and became airborne. The vehicle traveled approximately 12.1 m (40.0 ft) in the air before the front of the vehicle impacted the ground, gouged the ground, and then displaced the hood (**Figure 13**). The vehicle continued the end-over-end movement as it went over on its roof and heavily impacted the area around the left D-pillar. The vehicle continued tumbling until landing on its wheels partially on the roadway. The vehicle then rolled forward a short distance and came to rest on the side of the road (**Figure 14**).

**Figure 13.** Impact with ground after vault (police photo)
