**CALSPAN ON-SITE SIDE IMPACT INFLATIBLE OCCUPANT
PROTECTION SYSTEM CRASH INVESTIGATION
SCI CASE NO.: CA10022**

VEHICLE: 2008 HONDA CIVIC SI COUPE

LOCATION: NORTH CAROLINA

CRASH DATE: MAY 2010

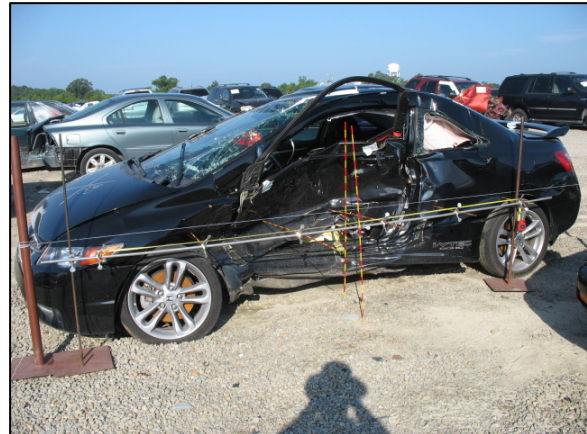
The left side of the Honda sustained moderate damage in this side impact crash (**Figure 3**). On the left plane, the direct contact damage began 76 cm (30 in) forward of the vehicle's left rear axle, and extended forward 155 cm (61 in). The maximum crush was located at C3, 132 cm (51.9 in) forward of the left rear axle, and measured 48 cm (18.9 in). The combined direct and induced damage (Field L) began 20 cm (7.9 in) forward of the left rear axle and extended forward 280 cm (110.2 in). The residual crush profile measured at the mid-door was as follows: C1 = 0 cm, C2 = 5 cm (2 in), C3 = 48 cm (18.9 in), C4 = 43 cm (16.9 in), C5 = 7 cm (2.8 in), C6 = 0 cm. The left door deformed, intruded into the passenger compartment and was jammed shut post-crash. The left wheelbase was shortened by 5 cm (2 in). The windshield was fractured by the impact forces, with more significant damage along the left A-pillar and windshield header. The left side windows were disintegrated by the initial impact. The Collision Deformation Classification (CDC) assigned for this impact was 10LPEW4.

Figure 3: Left side damage to the Honda.

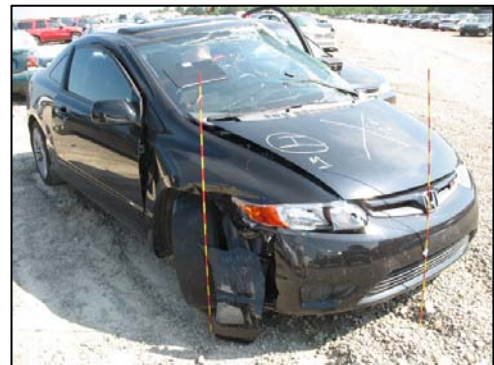
The direct damage on the front plane began 59 cm (23.2 in) right of the vehicle centerline and extended right 18 cm (7.1 in) to front right bumper corner. **Figure 4** depicts the damage to the front of the Honda. The combined direct and induced damage (Field L) extended from the front left bumper corner to the front right bumper corner. The maximum crush was located at C6, the front right bumper corner, and measured 8 cm (3.1 in). A residual crush profile was measured at the bumper level and was as follows: C1 = 7 cm (2.8 in), C2 = 6 cm (2.4 in), C3 = 6 cm (2.4 in), C4 = 4 cm (1.6 in), C5 = 2 cm (0.8 in), C6 = 8 cm (3.1

Figure 4: Frontal damage to the Honda.

in). The front bumper fascia was partially detached from the bumper support bar and was pressed back into place to obtain these measurements. Due to the corner type impact configuration, the direct contact damage wrapped around the corner and extended 61 cm (24.0 in) along the right plane. The right wheelbase was shortened by 9 cm (3.5 in) as a result of the longitudinal travel of the Pontiac down the right side, damaging the right front suspension. The right door remained closed during the crash and was operational post-crash. The right side windows, backlight and sunroof glazing were not damaged in this crash. The CDC assigned for this impact was 12FREE1.

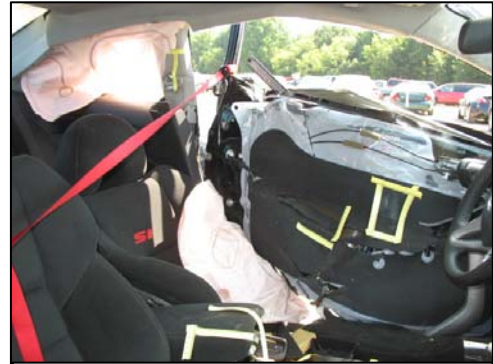
The driver's seat was compressed laterally by the intrusion of the left door and B-pillar. **Figure 5** depicts the damaged front left seat. The seat back was compressed 15 cm (5.9 in) and the seat cushion was compressed 17 cm (6.7 in). There was no damage to the front right seat. The front left seat was jammed in position; the front right seat track and seat back angle adjustment were operational.

Figure 5: Front left seat compression due to left side intrusion.

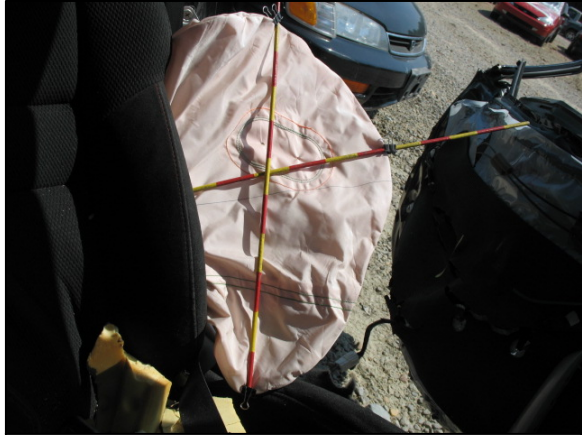
The side impact air bag deployed from a 35 cm (13.8 in) long seam in the upper outboard aspect of the front left seat back. The air bag measured 60 cm (23.6 in) in height and 35 cm (13.8 in) in width. The side air bag had one vent port on the outboard aspect at the 9 o'clock position. The left side air bag (**Figure 6**) was free from contact evidence or damage.

Figure 6: Inboard side of left side air bag.

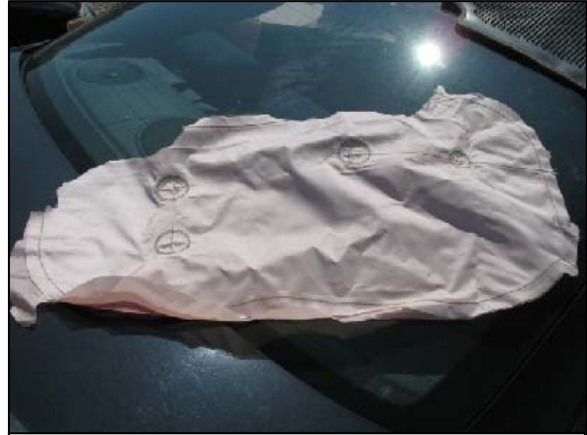
The left IC air bag deployed from the left roof side rail. The IC measured 135 cm (53.1 in) in length. It was 40 cm (15.7 in) in height at the front seating position, including a 4 cm (1.6 in) non-inflating strip at the bottom of the air bag. In the rear seating position, the IC measured 36 cm (14.2 in) in height. Vertically, the curtain air bags extended below the belt line at each outboard position. The front inflatable section of the left IC had been cut from the vehicle by EMS to allow access to the driver. The uneven vertical cut was approximately 75 cm (29.5 in) rearward of the forward edge of the fabric (in the area of the B-pillar). The cut extended from the lower edge of the IC to the top, and then forward along the top of the fabric to the front edge of the air bag (**Figure 7**). There was a trapezoidal-shaped opening between the front edge of the air bag fabric and the A-pillar that measured 44 cm (17.3 in) in length, and 24 cm (9.4 in) and 11 cm (4.3 in) in height at the rear and front, respectively. The IC was tethered to the A-pillars by a 26 cm (10.2 in) webbing strap that was attached to the outboard side of the air bag 14 cm (5.5 in) aft of the front edge of the fabric. At the rear of the curtain, the inflatable section of the membrane measured 33 cm (13 in) in length. Forward of this inflatable section was a non-inflated panel measuring 30 cm (11.8 in) in height and length. There was an inflatable tube connecting the front and rear inflatable sections of the IC measuring 30 cm (11.8 in) in length and 6 cm (2.4 in) in height. There was no contact evidence present on the left IC.

Figure 7: Forward aspect of the IC air bag cut by EMS.

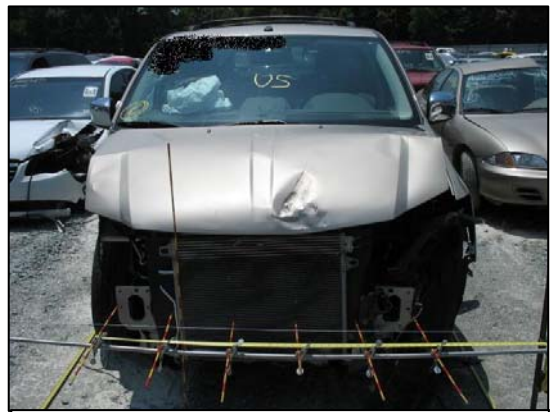
The front plane of the Dodge sustained moderate severity damage as a result of the impact with the Honda (**Figure 8**). The bumper support bar and fascia had been removed by a repair facility post crash, however there was still direct damage evident on the hood of the vehicle. The direct contact damage and Field L was measured between the frame rail ends of the Dodge. The Field L width was 117 cm (46 in) and the maximum crush measured 10 cm (3.9 in), located at the outboard edge of the right frame rail end. A crush profile based on the positions of the frame rail ends was documented and was as follows: C1 = 6 cm (2.4 in), C2 = 8 cm (3.1 in), C3 = 9 cm (3.5 in), C4 = 9 cm (3.5 in), C5 = 9 cm (3.5 in), C6 = 10 cm (3.9 in). The CDC assigned for this impact was 01FDEW1.

Figure 8: Frontal damage sustained by the Dodge minivan.

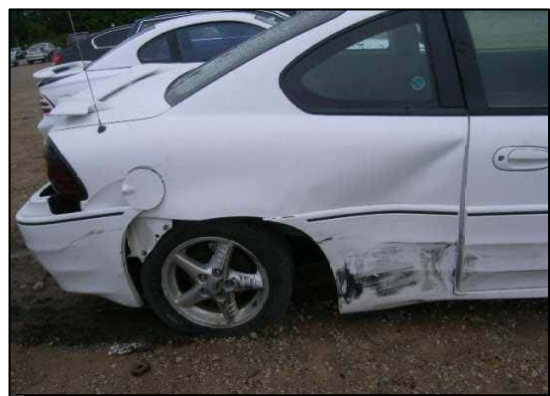
The right side of the Pontiac and the right rear suspension sustained minor damage as a result of the impact with the corner of the Honda. This damage is depicted in **Figure 9**. The direct damage began 152 cm (59.8 in) aft of the right front axle, and extended rearward 203 cm (80.0 in). The Field L began and ended at the same locations. On the right side, the maximum crush was located 220 cm

Figure 9: Right side sideswipe damage to the Pontiac.

(86.6 in) aft of the right front axle and measured 5 cm (2.0 in). The right rear suspension was impacted during the sideswipe engagement, increasing the right wheelbase by 8 cm (3.1 in). A residual crush profile was documented along the right side damage and was as follows: C1 = 0 cm, C2 = 1 cm (0.4 in), C3 = 0 cm, C4 = 3 cm (1.2 in), C5 = 1 cm (0.4 in), C6 = 0 cm. The CDC assigned for this impact was 12RZEW1.
