INDIANA UNIVERSITY

TRANSPORTATION RESEARCH CENTER

ON-SITE OFFICE OF DEFECTS INVESTIGATION POTENTIAL UNINTENDED ACCELERATION INVESTIGATION

CASE NUMBER - IN10023
LOCATION - TEXAS
VEHICLE - 2007 TOYOTA AVALON
CRASH DATE - January 2008

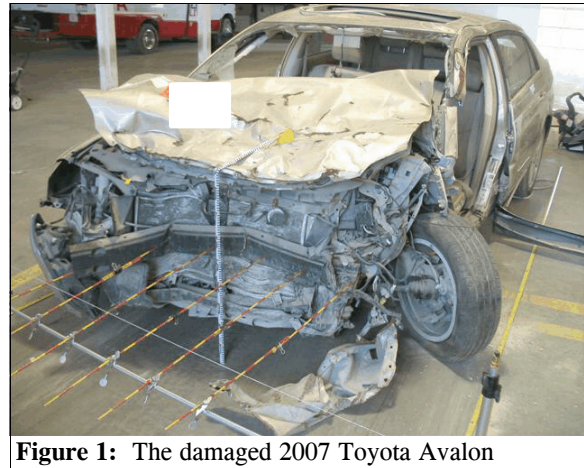
Figure 1: The damaged 2007 Toyota Avalon

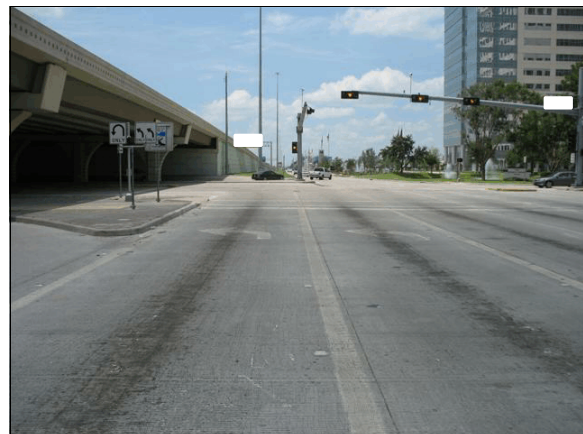
Pre-Crash: The Toyota was driven by a restrained 59-year-old male. He was westbound in the first left turn lane from the left approaching the intersection (**Figure 2**). The traffic signals were on the red phase for westbound traffic. The Infiniti was stopped at the intersection in the first

Figure 2: Approach of the Toyota westbound in the outside left turn lane

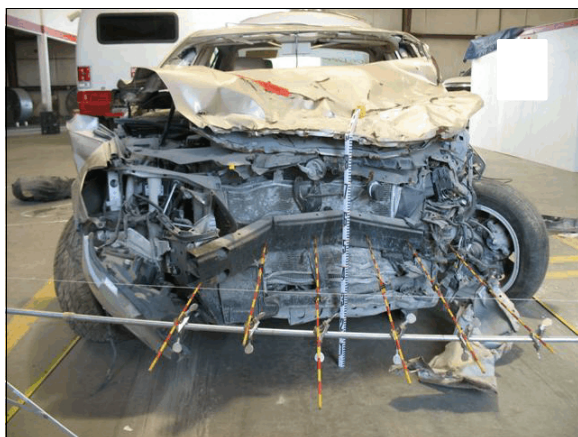
Figure 3: Damage on the front plane of the Toyota from the impact with the back plane of the Infiniti

Exterior Damage Event 2: The Toyota sustained front plane damage from the impact with the back plane of the Infiniti. The direct damage began at the front left bumper corner and extended 86 cm (33.9 in) across the front bumper. The crush measurements were taken on the bumper bar and the residual maximum crush was 69 cm (27.2 in) occurring at C2. The table below presents the front crush profile.

Damage Classification Event 2: The CDC for the front plane impact was 12FYEW3 (0 degrees). The Damage with CDC Only algorithm of the WinSMASH program calculated the Toyota’s total

Delta V as 88.0 km/h (54.7 mph). The longitudinal and lateral velocity changes were -88.0 km/h (-54.7 mph) and 0.0 km/h, respectively. Based on the damage on both vehicles, the results were reasonable. The EDR recorded the maximum velocity change as 77.4 km/h (48.1 mph).

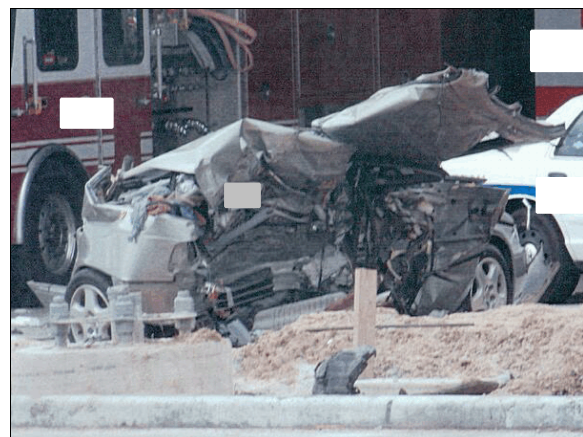
Figure 4: Back right view of the damaged Infiniti (on-scene photo provided by wife of the Toyota’s driver)

Exterior Damage: Based on the on-scene photographs, the Infiniti sustained extensive damage on the back plane from the impact with the Toyota. The direct damage was offset slightly to the right. The vehicle was towed from the crash scene due to damage. The Infiniti was under the control of a plaintiff's attorney and was not inspected.

Damage Classification: The CDC for the back plane damage on the Infiniti was estimated from the on-scene photographs as 06BDEW6 (180 degrees). The Damage with CDC Only algorithm of the WinSMASH program calculated the Infiniti's total Delta V as 78.0 km/h (48.5 mph). The longitudinal and lateral velocity changes were 78.0 km/h (48.5 mph) and 0.0 km/h, respectively. Based on the damage on both vehicles, the results were reasonable.

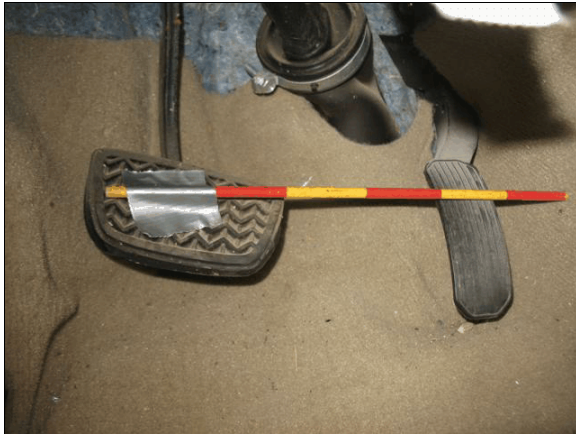
The SCI inspection revealed that the driver's floor mat appeared to have been moved following the crash since debris was found under the floor mat and the floor mat attachment clips were missing. The driver's wife stated during the SCI interview that the driver's right foot was entrapped under the brake pedal following the crash. It is possible that the floor mat was removed during the extrication of the driver from the vehicle. There was no discernable evidence of all weather floor mat usage. Inspection of the CTS accelerator pedal and the floor mat revealed no discernable evidence of interaction between the two. The product codes for the driver's floor mat were PT548 07C50, PPI-7P36L3, and LEFT FRONT. The brake pedal arm and accelerator pedal

arm had both made impressions in the carpet from the intrusion of the toe pan. The brake pedal was rotated clockwise slightly. There was no damage to the accelerator pedal. The lateral distance between the accelerator pedal and the brake pedal was 11 cm (4.3 in, **Figure 5**). On an exemplar vehicle this measurement was 6 cm (2.5 in). The face of the accelerator pedal was 1 cm (2.4 in) forward of the face of the brake pedal. On an exemplar vehicle this distance was 4 cm (1.6 in). The accelerator pedal was 4 cm (1.6 in) in width and 12 cm (4.7 in) in height. The brake pedal was 11.5 cm (4.5 in) in width and 7 cm (2.8 in) in height. The distance between the centerline of the driver's seat and the right edge of the brake pedal was 5 cm (2 in). The longitudinal distance from the brake pedal to the front of the driver's seat cushion was 49 cm (19.3 in). The accelerator pedal was pushed fully down and released three times. Each time it functioned smoothly and did not bind. **Figure 6** shows the CTS accelerator mechanism housing. The product numbers on the accelerator housing were 78110-07011, 0631782A, and 44830315055 LHD. The left front and right rear wheels were removed and the brake rotors and brake pads were inspected. Both brake rotors were rusted. The brake pads on each wheel showed no evidence of overheating (**Figures 7 and 8**) from prolonged braking.

Figure 5: The Toyota's brake and accelerator pedal, each increment on the measurement rod is 5 cm (2 in)

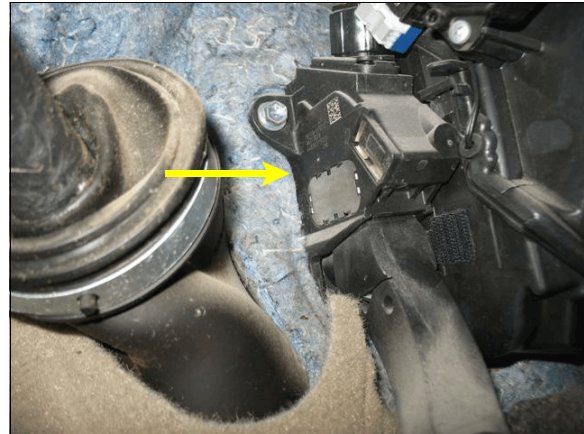
Figure 6: The CTS accelerator pedal mechanism housing (arrow)

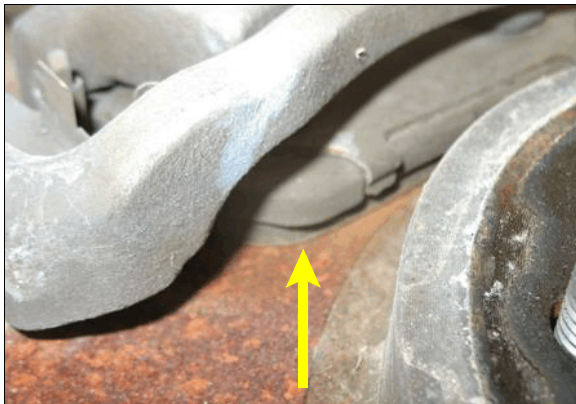
Figure 7: The bottom portion of the outside brake pad (arrow) on the left front wheel of the Toyota

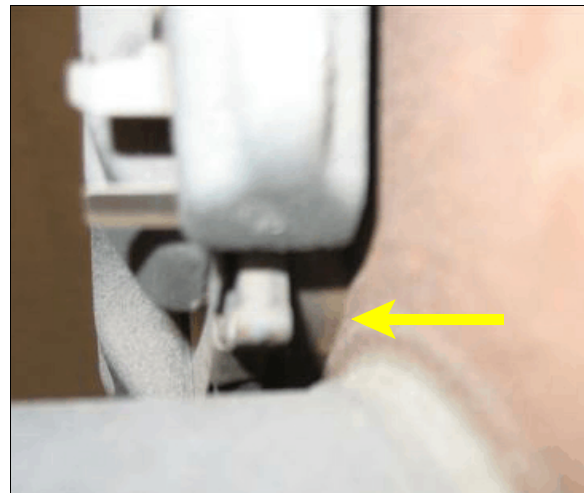
Figure 8: The top portion of the outside brake pad (arrow) on the right rear wheel of the Toyota

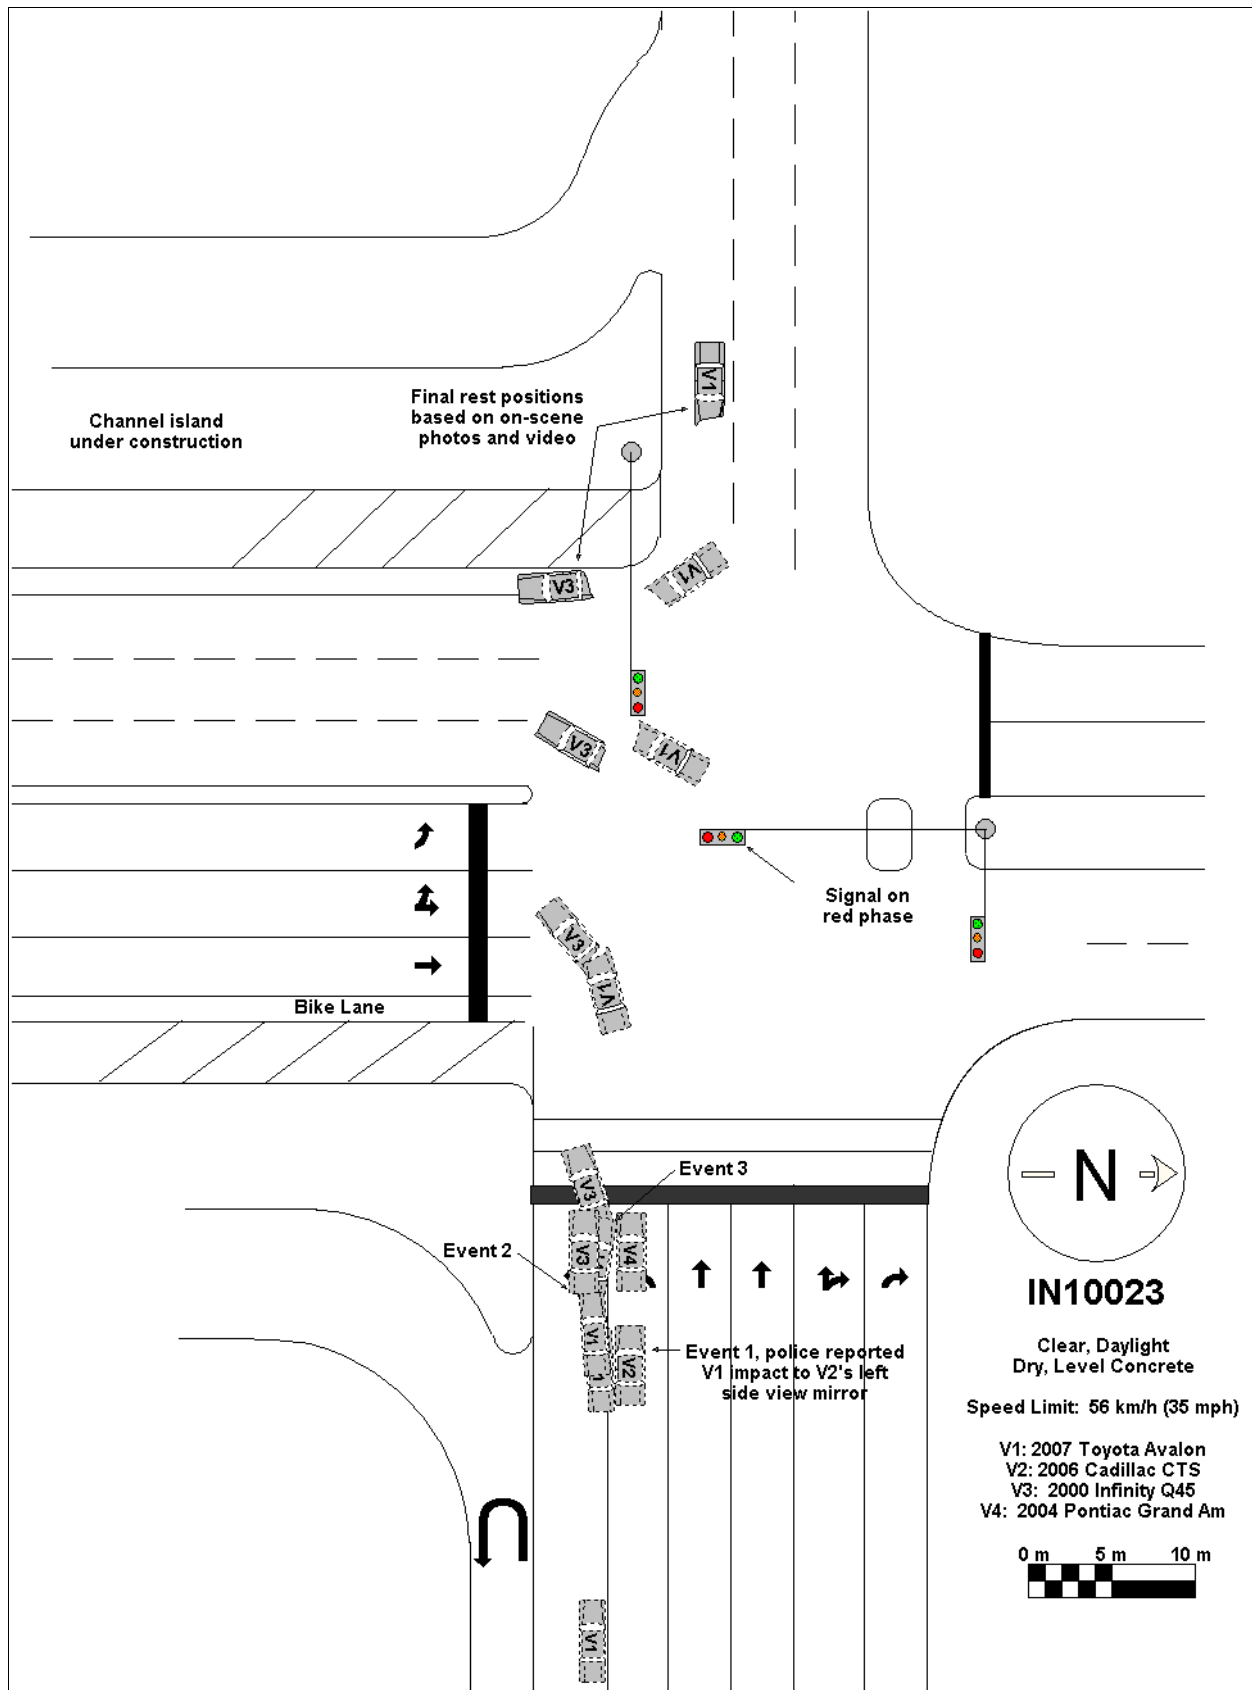
CRASH DIAGRAM 12

Crash Environment: The crash occurred during daylight hours and clear weather conditions at a 4-leg intersection on a westbound 7-lane, undivided, one-way service road for an interstate highway. The roadway had one U-turn lane, two left turn lanes, two through lanes, one right turn/through lane, and one right turn lane. Each lane was approximately 3.8 m (12.5 ft) in width with the exception of the first left turn lane from the left, which was 4.5 m (14.8 ft) in width. Roadway pavement markings consisted of solid white turn lane lines, solid white turn arrows, broken white through lane lines, solid white stop bar, and a designated pedestrian crossing. The intersection was controlled by 3-phase traffic signals. The roadway pavement was dry, level concrete and the speed limit was 56 km/h (35 mph). The Crash Diagram is on page 12 of this report.
