**CALSPAN ON-SITE REAR IMPACT CRASH AND FIRE INVESTIGATION
OFFICE OF DEFECTS INVESTIGATION
SCI CASE NO: CA10023**

VEHICLE: 2006 FORD CROWN VICTORIA POLICE INTERCEPTOR

LOCATION: FLORIDA

CRASH DATE: MAY 2010

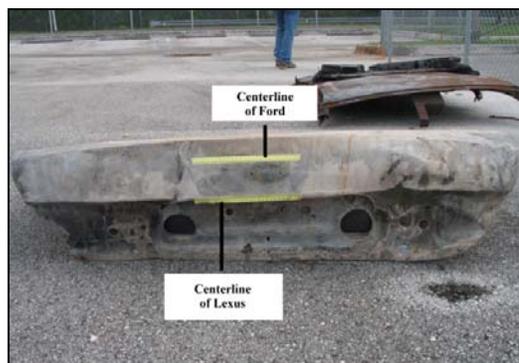
Figure 5: View of the Ford's trunk lid and the contact evidence from the Lexus.

An imprint of the Lexus emblem was identified on the trunk lid of the Ford (**Figure 5**) during the SCI inspection. The relative position of the emblems defined the vehicles' position at impact. The back of the stationary Ford was crushed and displaced forward by the 6 o'clock direction of force. The front plane of the Lexus, including the bumper, fascia, fenders, hood, and under-hood components, were crushed and displaced rearward by the 12 o'clock direction of force. This longitudinal crush also displaced both front axle positions of the Lexus, which immediately deflated the right front tire and shortened both wheelbases.

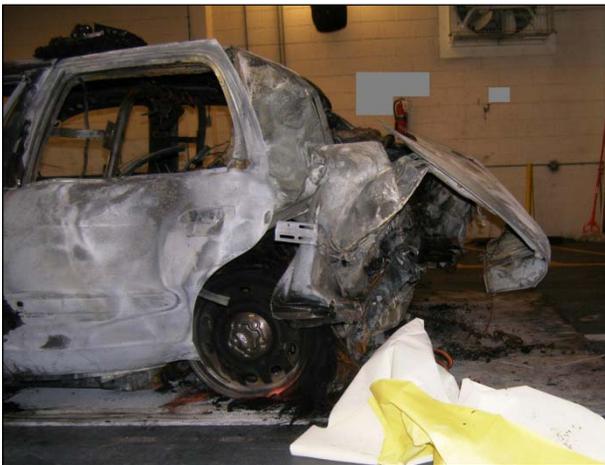
The back plane of the Ford sustained severe direct and induced damage as a result of the impact. **Figure 8** depicts the rear-impact damage as documented by the impounding law enforcement agency. The combined width of the direct and induced damage extended across the full 152 cm (62 in) end-width of the vehicle. The direct contact damage began at the left corner and extended 140 cm (55 in) to the right (consistent with the bumper width of the Lexus and the offset impact configuration). The dynamics and force of the impact completely compressed the volume of the trunk space and its contents forward, below the level of the rear parcel shelf.

Figure 8: Left lateral view of the damage to the Ford. Impound image provided by police investigator.

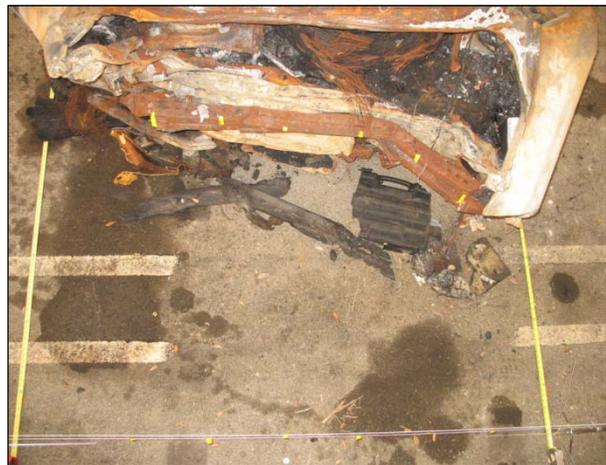
Figure 9: Overhead view of the damage profile to the back plane of the Ford.

The rear residual deformation profile of the Ford was documented along the rear bumper reinforcement bar, as depicted in **Figure 9**. The crush profile resultant to those measurements was as follows: C1 = 99 cm (39.0 in), C2 = 102 cm (40.2 in), C3 = 105 cm (41.3 in), C4 = 104 cm (40.9 in), C5 = 88 cm (34.6 in), C6 = 75 cm (29.5 in). The maximum crush measured 105

cm (41.3 in) and was located at C3. The rear axle was displaced forward during the impact. The left and right wheelbase dimensions were reduced 26 cm (10.2 in) and 8 cm (3.1 in), respectively. The Collision Deformation Classification (CDC) associated with this damage pattern was 06BDEW6.

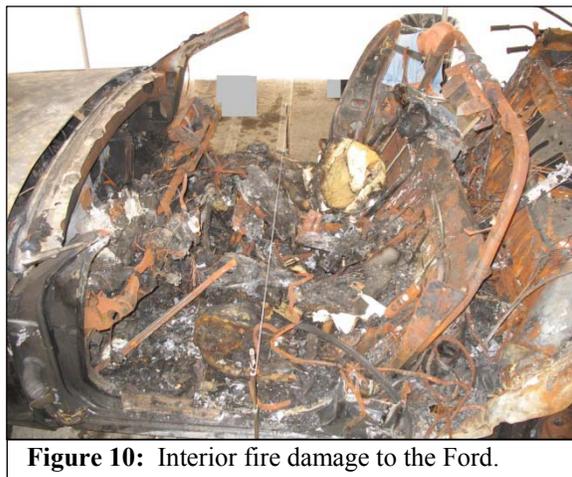
The interior of the Ford sustained severe damage attributed to the intrusion of rear vehicle components into the passenger compartment and the post-crash fire. Virtually all combustible components were burned full-thickness or fully consumed, as depicted in **Figure 10**. The longitudinal intrusion of the second row measured 25 cm (10 in) at the left position, 21 cm (8.2 in) at the center position and 17 cm (6.8 in) at the right position. The longitudinal intrusion of the left and right C-pillar measured 14 cm (5.5 in) and 9 cm (3.5 in), respectively.

Figure 10: Interior fire damage to the Ford.

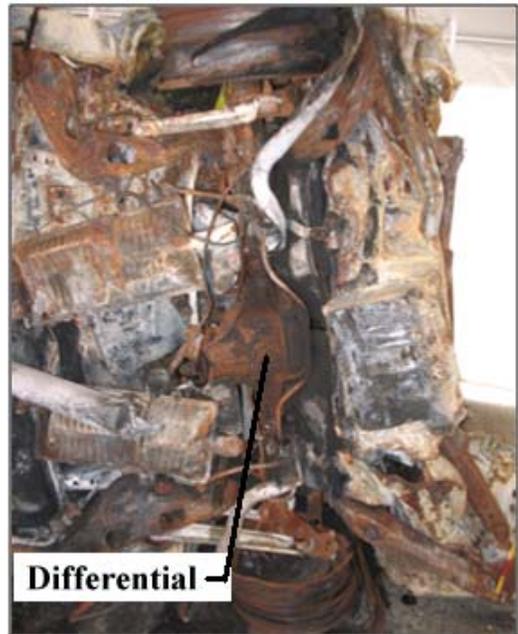
Figure 12: Close-up view of the damaged rear undercarriage of the Ford prior to disassembly.

During the impact sequence, the back section of the Ford crushed and deformed forward. The impact force fully compressed the trunk's volume and produced significant forward displacement of the rear undercarriage components resulted. The fuel tank mounted on the trunk's forward wall was displaced forward into the differential and the rear axle tube. The rear axle was displaced forward and the drive shaft fractured and separated from the differential. The aft aspect of the vehicle's frame members deformed and crushed. The arch of the left frame at the left rear wheel opening was compressed and hindered the removal of the rear axle. There was no apparent frame deformation forward of the C-pillar area. Relief cuts into the left frame arch allowed the rear axle to then be removed.

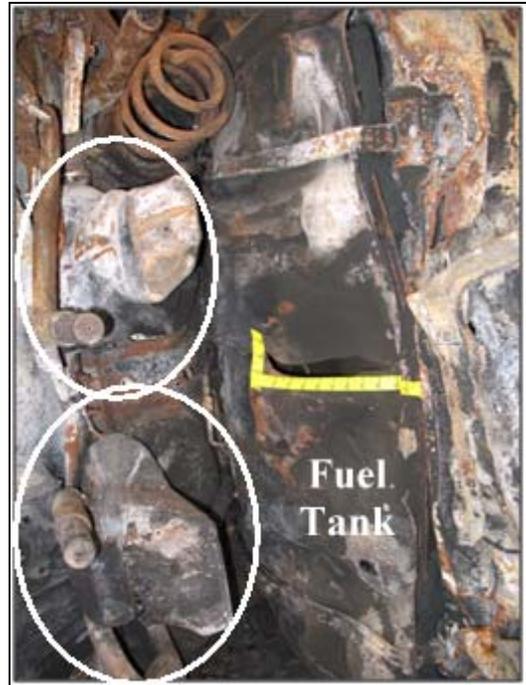
Figure 13 is a view of the damaged steel fuel tank and the deployed fire suppression system after the removal of the rear axle. As the lower aspect of the fuel tank crushed, hydraulic pressure in the nearly-full tank increased. Contact between the central aspect of the fuel tank and the differential's ring gear protrusion resulted in a 23 cm (9 in) long by 2 cm (1 in) wide split/tear in the forward wall of the fuel tank. The tear was not located at, or in close proximity to, any seam. There were no other noted perforations in the fuel tank. The fuel filler neck, routed through the left quarter panel, was entangled in the deformation but remained engaged with the tank and was intact. There were no indications of leakage at the filler neck. The sending unit located on the forward side of the fuel tank remained engaged. The grommets inserted in the various ports located on the top of the fuel tank were in place and melted from exposure to the fire.

Figure 13: View of the damaged fuel tank and deployed FSS (circled).

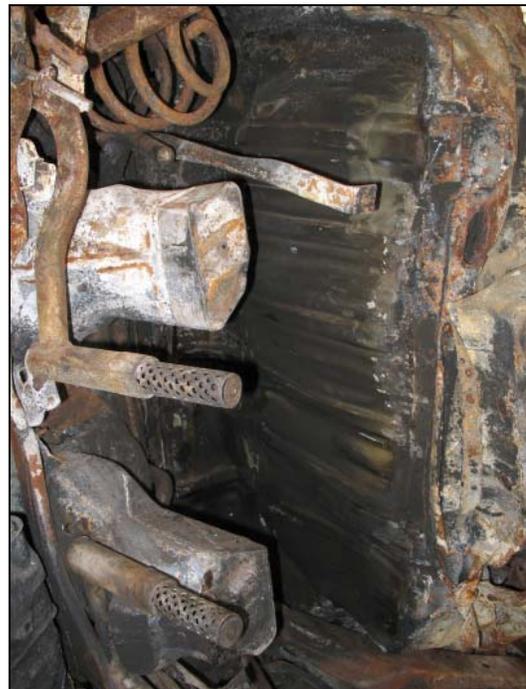
The fuel tank was removed by cutting the two mounting straps and removing the filler neck from the quarter panel. With the tank removed, the forward wall of the trunk was inspected. The trunk wall was observed to be intact and had not been penetrated by any interior trunk objects. **Figure 14** is a view of the forward trunk wall after removal of the fuel tank. The deployed fire suppression system can also be seen in the image.

Figure 14: View of the forward trunk wall after removal of the fuel tank.

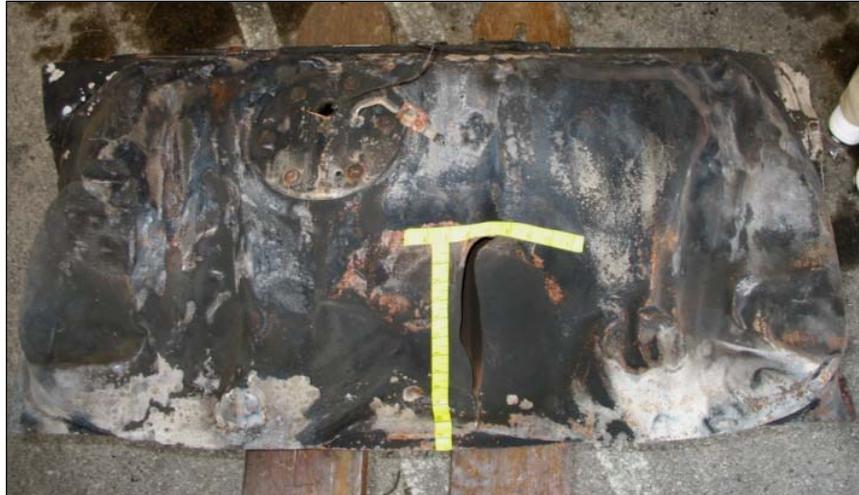
The fuel tank damage resulted in a pressurized fuel leak, the vapors of which were ignited by the high-temperature exhaust components and/or impact-related sparks. This was determined to be the probable cause of the post-crash major fire event which consumed the vehicle. **Figure 15** provides an overall view of the removed fuel tank and large split/tear. The fuel tank was a seam welded clam-shell design and was constructed of steel. The tank had a capacity of approximately 72 liters (19 gallons).

Figure 15: View of the forward wall of the removed fuel tank and the large split/tear.

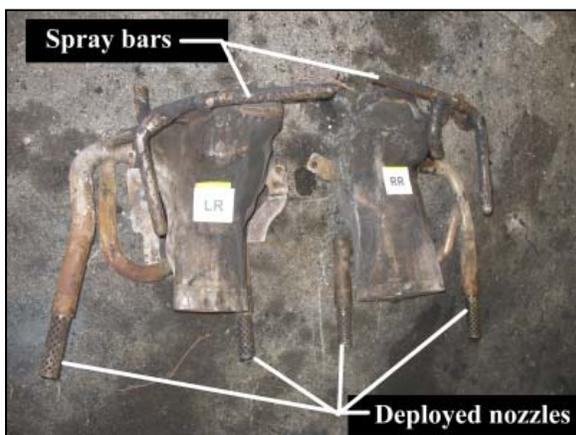
The FSS of the Ford deployed as a result of the rear-impact event. This was confirmed during SCI team inspection, wherein the four vertically oriented nozzles were located in their extended (deployed) position. **Figure 17** is an image of the FSS after its removal from the vehicle. The four deployed nozzles are highlighted in the image. In addition to the deployed condition of the nozzles, residue from the AFFF suppressant/surfactant was observed on the exterior body surfaces of the Lexus dispersed in an aerodynamic fashion, **Figure 18**. This evidence suggested that the FSS deployed after the impact and the Lexus passed through, and/or was contacted by, the plume of dispersed suppressant/surfactant as it traveled to final rest.

Figure 17: View of the deployed FSS after its removal from the Ford.

Although the FSS deployed during the crash, the major crash-induced fire developed. It was theorized that the volume of the gasoline dispersed from the nearly full and compromised fuel tank overwhelmed the capabilities of the suppression system thus leading the fuel-fed fire.

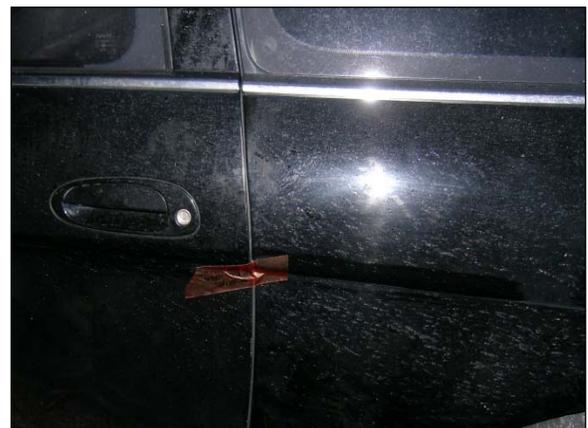
Figure 18: AFFF suppressant/surfactant residue on the exterior surfaces of the Lexus.

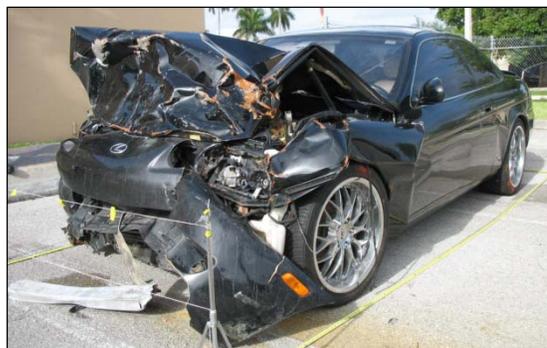
The front plane of the Lexus sustained moderate direct and induced damage as a result of the initial impact with the rear of the Ford. This included the disintegration of both headlight assemblies and the deformation of the bumper, fascia, grille, hood, and front fenders. These components were crushed rearward, with subsequent damage to the engine compartment and associated power train elements (**Figure 19**). Both the left and right front axle positions were displaced rearward, having shortened their corresponding wheelbase measurements by 2 cm (0.8 in) and 12 cm (4.7 in), respectively. The sidewall of the right front tire was punctured and lacerated by the longitudinally crushed body components.

Figure 19: Left front oblique view of the Lexus.

Direct damage extended the full 139 cm (54.5 in) bumper width from corner to corner, with induced damage extending across the full 160 cm (63 in) undeformed end width. The residual deformation profile of the Lexus was documented along the front plane at mid bumper level. The crush profile resultant to those measurements was as follows: C1 = 51 cm (20.1 in), C2 = 67 cm (26.5 in), C3 = 69 cm (27.2 in), C4 = 68 cm (26.8 in), C5 = 64 cm (25.2 in), C6 = 61 cm (24.0 in). The maximum crush measured 69 cm (27.2 in) and was located at C3. The CDC associated with this initial impact event was 12FDEW3.
