**CALSPAN ON-SITE SIDE IMPACT INFLATABLE OCCUPANT  
PROTECTION SYSTEM CRASH INVESTIGATION  
SCI CASE NO.: CA10024**

**VEHICLE: 2008 CHEVROLET TAHOE LTZ 4X4**

**LOCATION: NORTH CAROLINA**

**CRASH DATE: MAY 2010**

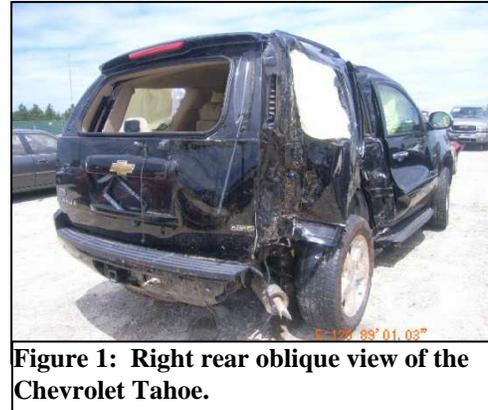
**Figure 1: Right rear oblique view of the Chevrolet Tahoe.**

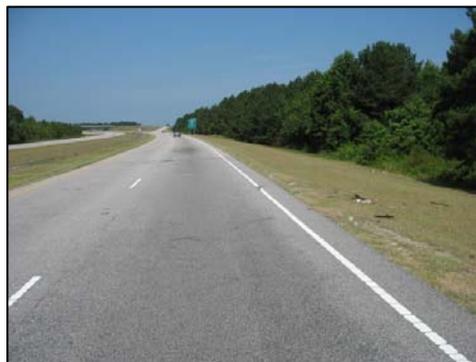
**Figure 2: Overall westbound view of the crash site.**

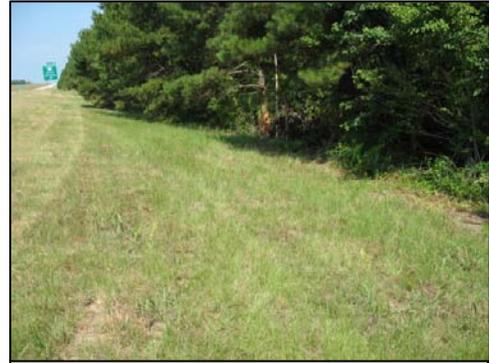
**Figure 3: Off-road trajectory of the Chevrolet.**

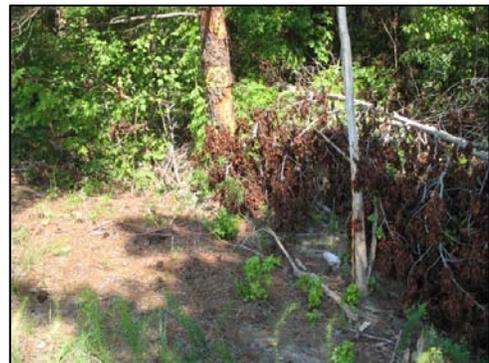
The right side of the Chevrolet impacted a small hardwood tree with a diameter of 7 cm (2.8 in) (Event 1). This tree was fractured approximately 2 m (6.6 ft) above the ground and bent over by the contact with the Chevrolet. The rear aspect of the right side of the Chevrolet then impacted a 26 cm (10.2 in) hardwood tree (Event 2). This tree was sheared off 10 cm (3.9 in) above ground level. The second event impact resulted in the maximum crush to the Chevrolet and redirected the vehicle approximately ten degrees clockwise. The Chevrolet continued traveling northwest and the right side impacted a third tree (Event 3) with a diameter of 8 cm (3.1 in). This tree also fractured 1.8 m (5.9 ft) above the ground and the Chevrolet pushed it over as the vehicle traveled over the tree. The right side of the Chevrolet then impacted a 36 cm (14.2 in) pine tree with the right rear door (Event 4). The fourth impact brought the vehicle to a stop. The area of impact is shown in **Figure 4**. The direction of force for this multiple impact sequence was within the 9 o’clock sector. The force of the impact actuated the front seat safety belt pretensioners and deployed the IC air bags. The damage algorithm of the WinSMASH program was used to calculate a total delta-V of 24 km/h (14.9 mph) for the Chevrolet. The longitudinal delta-V for the Chevrolet was 0 km/h, and the lateral delta-V was -24 km/h (-14.9 mph). The Chevrolet came to rest facing southwest against the pine tree.

**Figure 4: Area of impact with the four trees.**

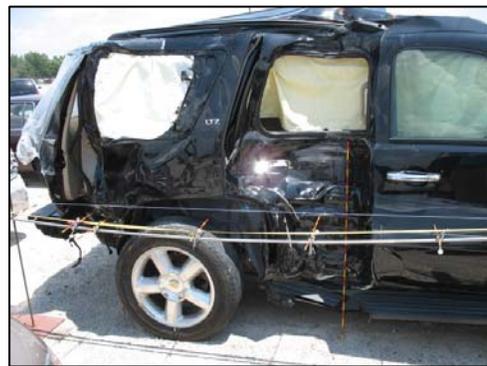
The right side of the Chevrolet sustained moderate damage in this side impact crash sequence (**Figure 5**). The damage from the four tree impacts was overlapping between the right B-pillar and right rear corner of the Chevrolet. On the right plane, the direct contact damage began 118 cm (46.5 in) forward of the vehicle's right rear axle, and extended rearward 204 cm (80.3 in). The maximum crush was located 54 cm (21.3 in) rearward of the right rear axle, and measured 37 cm (14.6 in). The combined direct and induced damage (Field L) began 212 cm (83.5 in) forward of the right rear axle and extended rearward 314 cm (123.6 in). A residual crush profile was documented along this full width and was as follows: C1 = 11 cm (4.3 in), C2 = 25 cm (9.8 in), C3 = 15 cm (5.9 in), C4 = 34 cm (13.4 in), C5 = 10 cm (3.9 in), C6 = 0 cm. The individual tree impacts from Events 2 and 4 were located 38-74 cm (15-29.1 in) aft of the rear axle and 46-118 cm (18.1-46.5 in) forward of the rear axle, respectively. The maximum crush for the second tree impact was the profile's maximum crush, 37 cm (14.6 in). The maximum crush for the fourth tree impact was 36 cm (14.2 in). The right doors were damaged and were jammed shut post-crash. Both doors intruded into the passenger compartment. The right wheelbase was shortened by 4 cm (1.6 in). The Collision Deformation Classification (CDC) assigned for the overall impact damage was 03RZAW3.

**Figure 5: Right side damage to the Chevrolet.**

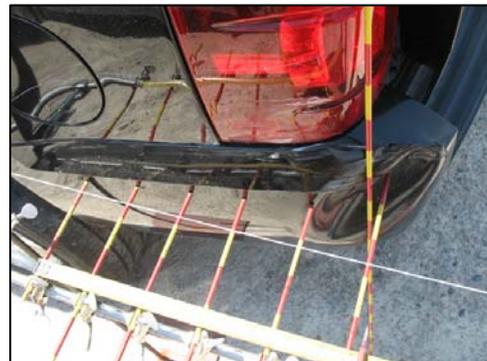
There was minor direct damage to the left rear corner of the Chevrolet that began 58 cm (22.8 in) aft of the left rear axle and extended rearward 43 cm (16.9 in) to the left rear bumper corner. **Figure 6** depicts the damage to the left rear of the Chevrolet. The combined direct and induced damage (Field L) also began 58 cm (22.8 in) aft

**Figure 6: Left rear corner damage to the Chevrolet.**

of the left rear axle, extending rearward to the bumper corner. The maximum crush was located at C1, the back left bumper corner, and measured 6 cm (2.4 in). A residual crush profile was measured at the lower door level and was as follows: C1 = 6 cm (2.4 in), C2 = 1 cm (0.4 in), C3 = 1 cm (0.4 in), C4 = 1 cm (0.4 in), C5 = 1 cm (0.4 in), C6 = 0 cm. Due to the Chevrolet traveling in a right side leading yaw into the tree line, it is likely that this damage occurred as the vehicle was being towed from final rest.

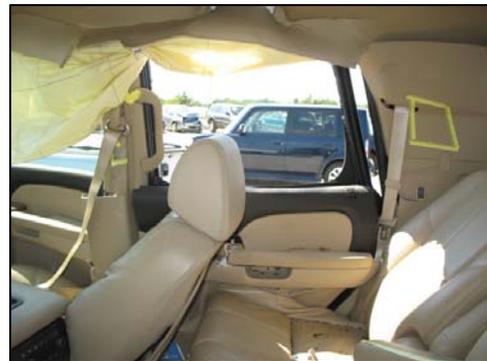
The Chevrolet sustained moderate severity damage that was attributed to passenger compartment intrusion, occupant contact and air bag deployment. The restrained driver had loaded the center console with the right side of his abdomen, depositing a scuff mark on the left side of the console that extended 0-13 cm (0-5.1 in) rearward from the front left corner of the console and 0-8 cm (0-3.1 in) below the top edge of the console. The driver's right knee impacted the center instrument panel, depositing a scuff mark 48-56 cm (18.9 – 22 in) above the floor and 11-17 cm (4.3-6.7 in) right of the steering column. The restrained front right passenger's right foot scuffed laterally across the glove compartment door from left to right, depositing a 17 x 6 cm (6.7 x 2.4 in) scuff mark that began 31 cm (12.2 in) left of the right edge of the door and 2 cm (0.8 in) below the top of the door. There was body fluid on the inboard side of the front left seat back located 0-9 cm (0-3.5 in) forward of the rear corner of the seat and 10-19 cm (3.9-7.5 in) below the top of the seat. The unrestrained rear left passenger deformed the inboard arm rest of the rear left seat to the right. He deposited a scuff mark on the right C-pillar in an area unprotected by the right IC. This scuff mark measured 11 cm (4.3 in) vertically and 12 cm (4.7 in) horizontally and was located 17 cm (6.7 in) below the right roof side rail and 9 cm (3.5 in) aft of the forward edge of the right C-pillar. There was smeared body fluid on the rear left seat back located 18-24 cm (7.1-9.4 in) above the bight of the seat and 0-12 cm (0-4.7 in) left of the inboard vertical seat back seam. There was lateral intrusion from the rear half of the front right door to the side panel immediately forward of the D-pillar. The front right seat was compressed laterally 10 cm (3.9 in) and the rear right seat was compressed laterally 20 cm (7.9 in). **Figure 7** depicts the intrusion to the right side of the interior of the Chevrolet.

**Figure 7: Lateral intrusion to the passenger compartment of the Chevrolet.**

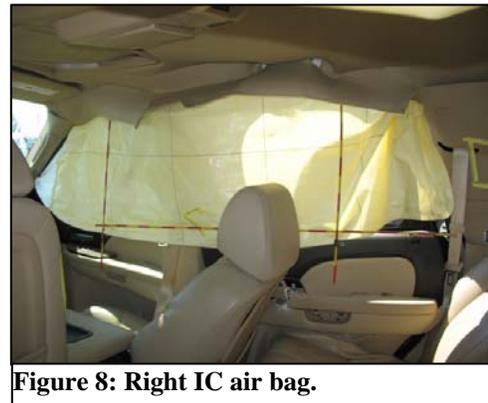
The inside aspect of the forward right IC contained a scuff mark attributed to the front right passenger's head. This scuff mark was located 5-15 cm (2-5.9 in) above the lower edge of the air bag and 72-85 cm (28.3-33.5 in) rear of the front edge of the air bag. **Figure 8** depicts the right front IC air bag.

**Figure 8: Right IC air bag.**

The outboard side of the right IC contained two abraded areas and a 4 cm (1.6 in) cut near the location of the right rear window. The upper left abrasion measured 45 cm (17.7 in) in width and 19 cm (7.5 in) in height. This abrasion began 9 cm (3.5 in) forward of the rear edge of the air bag and 31 cm (12.2 in) above the lower edge of the air bag. The 4 cm (1.6 in) cut was located 9 cm (3.5 in) above the lower edge of the air bag and 58 cm (22.8 in) forward of the rear edge of the air bag. The lower right abrasion measured 8 cm (3.1 in) in width and 7 cm (2.8 in) in height and was located 74 cm (29.1 in) forward of the rear edge of the air bag and 1 cm (0.4 in) above the lower edge of the air bag. The cut and abrasions resulted from contact with the impacted tree trunk.

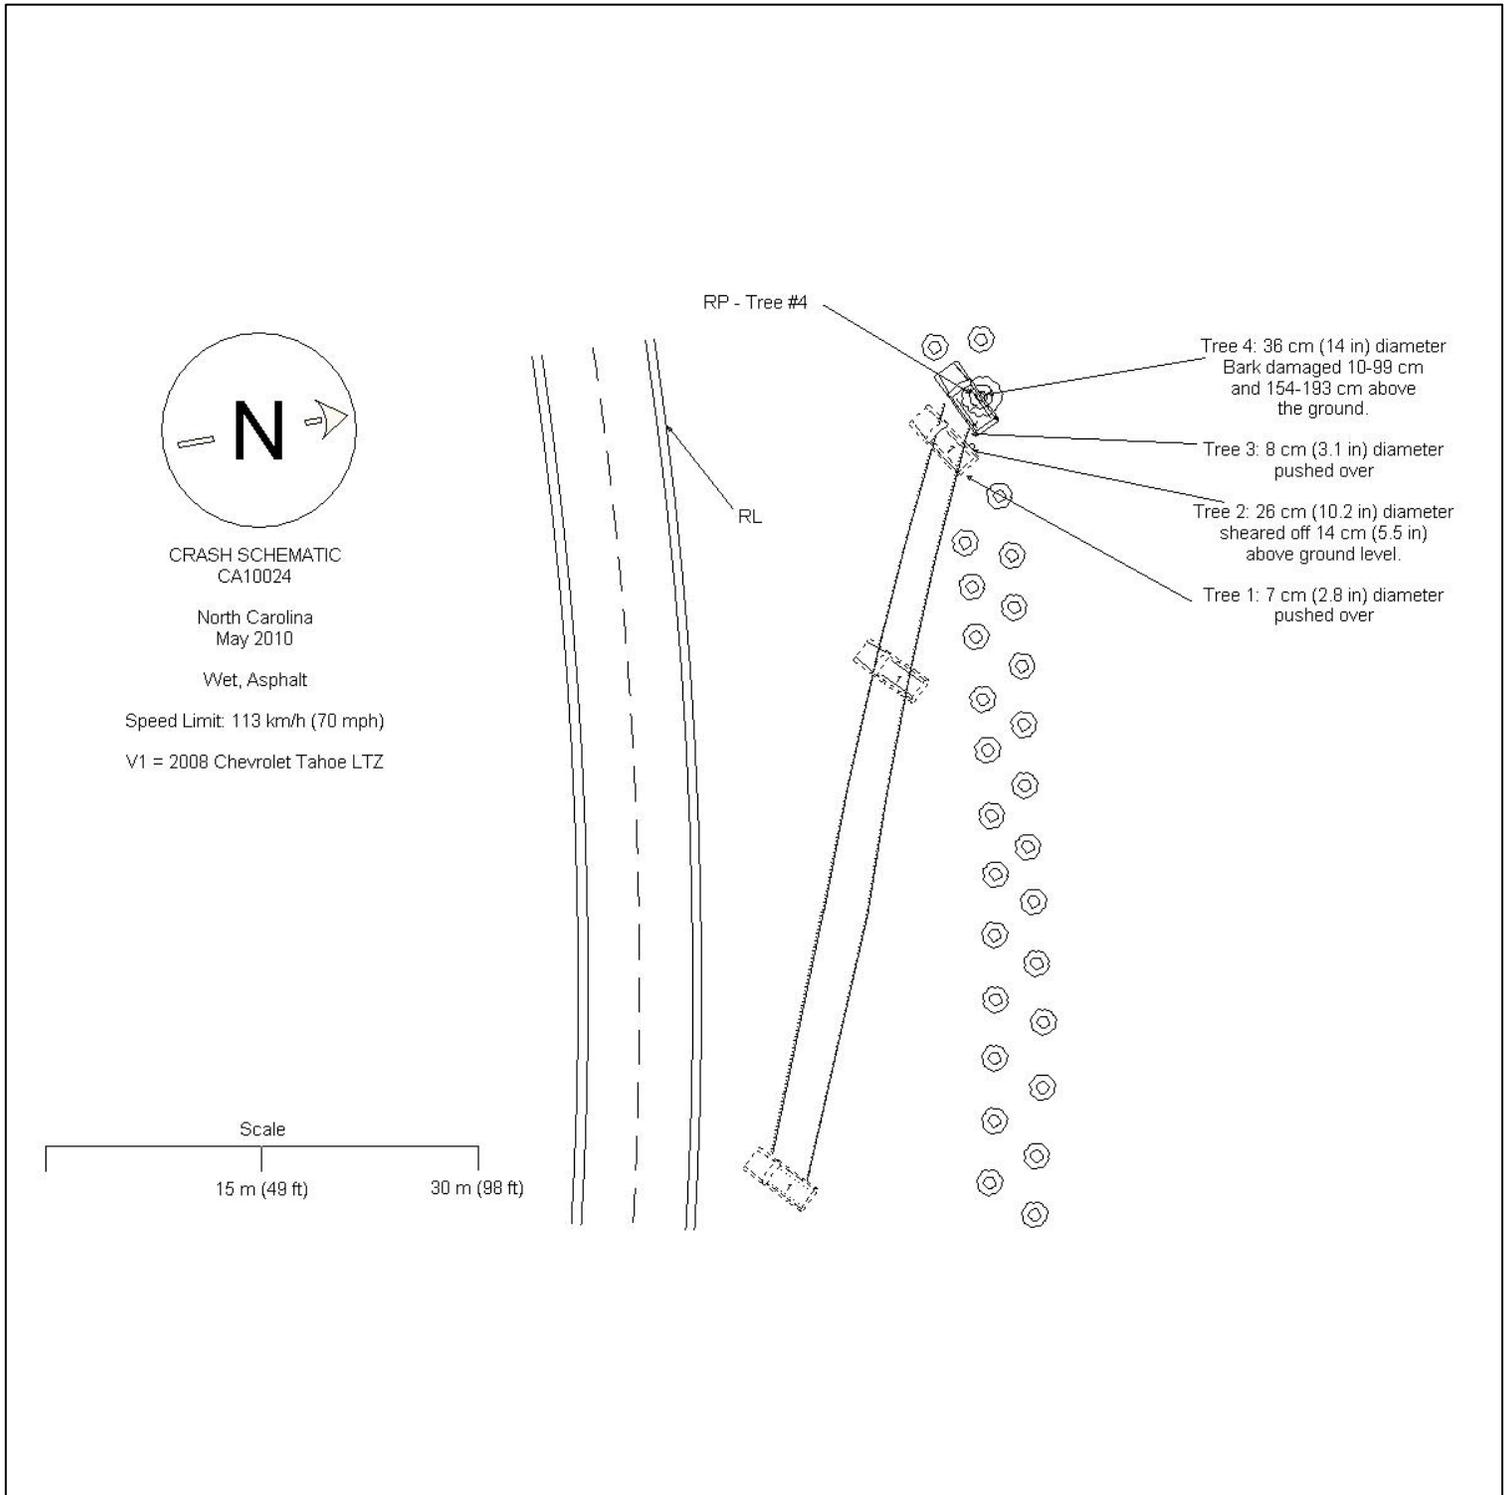
Tree 4: 36 cm (14 in) diameter  
Bark damaged 10-99 cm  
and 154-193 cm above  
the ground.

Tree 3: 8 cm (3.1 in) diameter  
pushed over

Tree 2: 26 cm (10.2 in) diameter  
sheared off 14 cm (5.5 in)  
above ground level.

Tree 1: 7 cm (2.8 in) diameter  
pushed over

**Figure 10: Enlarged area at impact locations.**
