ON-SITE OFFICE OF DEFECTS INVESTIGATION POTENTIAL UNINTENDED ACCELERATION INVESTIGATION

CASE NUMBER - IN10024

VEHICLE - 2008 TOYOTA TACOMA PRERUNNER

CRASH DATE - January 2010

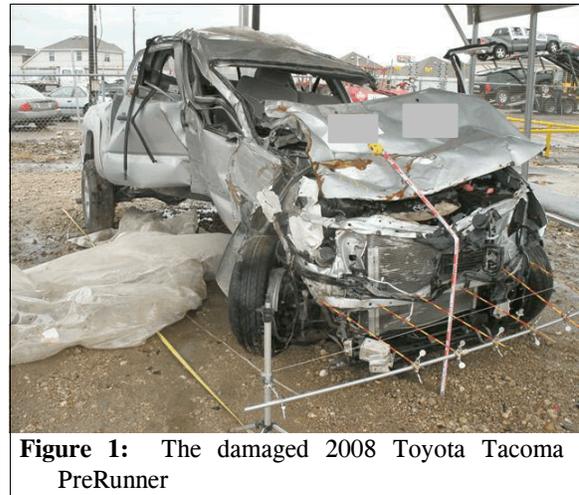
Figure 1: The damaged 2008 Toyota Tacoma PreRunner

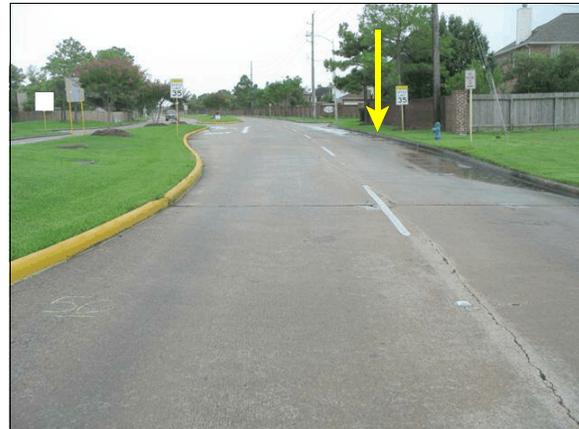
Figure 2: Southbound approach of the Toyota in the outside lane; arrow shows location of roadway departure

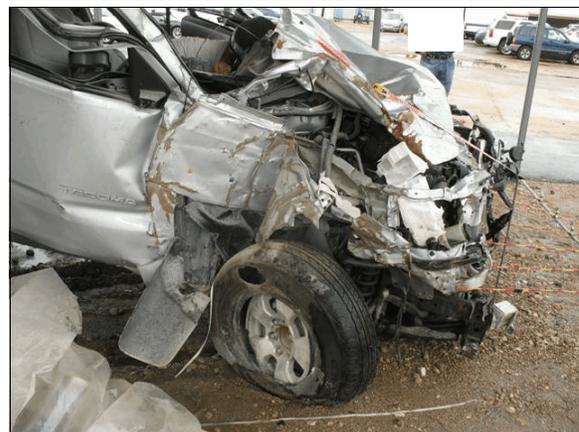
Figure 3: Damage on the front right bumper corner and right fender from the impact with the 18 cm (7.1 in) diameter metal streetlight pole

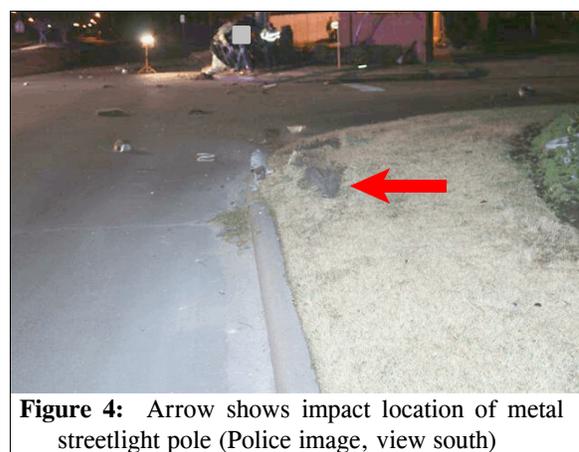
Figure 4: Arrow shows impact location of metal streetlight pole (Police image, view south)

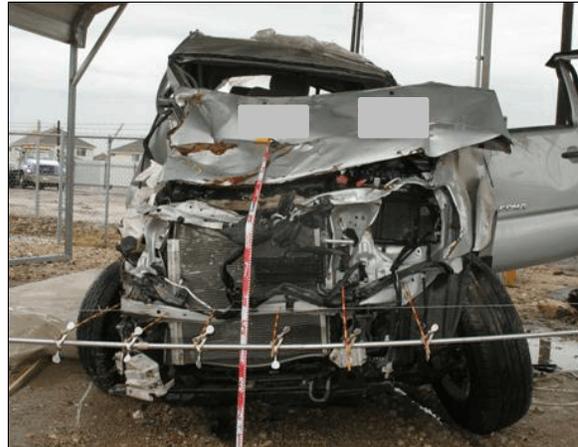
Figure 5: Damage on the front plane from the brick wall impact overlapped the damage on the front right corner from the metal streetlight pole impact

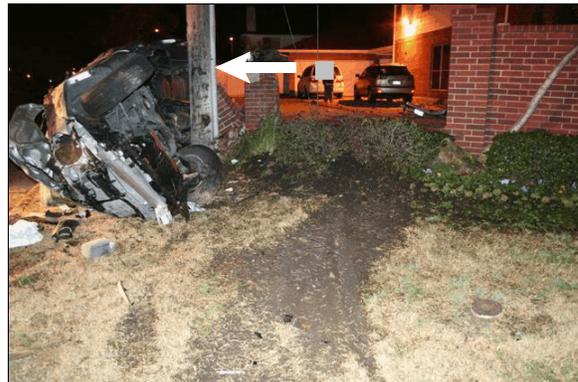
Figure 6: Section of brick wall was broken out from impact with vehicle's front plane; divot on ground shows touchdown location of left side plane of vehicle; arrow shows utility pole impacted by right side plane (Police image, view south)

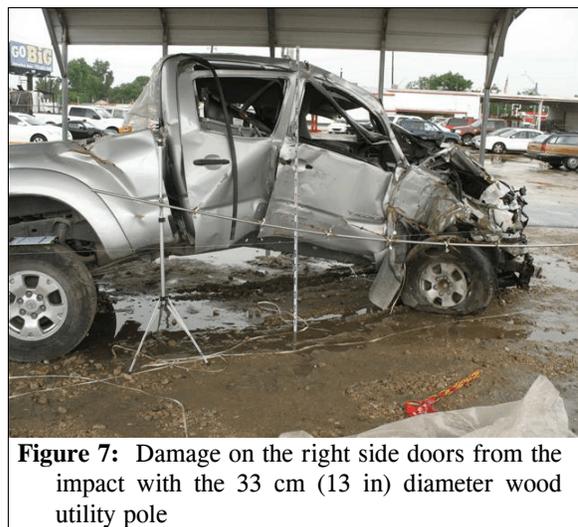
Figure 7: Damage on the right side doors from the impact with the 33 cm (13 in) diameter wood utility pole

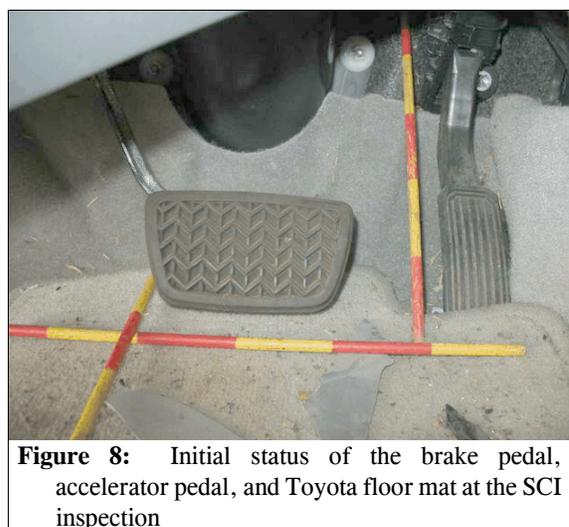
The initial status of the Denso accelerator pedal, brake pedal, and Toyota OEM floor mat at the time of the SCI inspection is shown in **Figure 8**. The floor pan below the brake pedal and accelerator pedal was deformed and intruded 7 cm (2.8 in) and 6 cm (2.4 in), respectively. The floor mat was displaced by the deformation of the floor pan and was in contact with the bottom end of the accelerator pedal. Since the floor mat was displaced by crash induced damage and the accelerator pedal was found in its full rear position, the accelerator pedal was not considered entrapped by the floor mat. There were no abrasions or marks on the floor mat in the area adjacent to the bottom end of the accelerator pedal. The accelerator pedal had a normal usage wear pattern. The floor mat was secured to the floor by the right side floor mat attachment clip.

Figure 8: Initial status of the brake pedal, accelerator pedal, and Toyota floor mat at the SCI inspection

The left side floor mat attachment clip was inserted in the floor mat receptacle, but the attachment clip was not connected to the floor anchor. The carpet was also folded and displaced from the floor pan intrusion. The displaced carpet was in contact with the right side of the accelerator pedal but was not entrapping it. There was no evidence on the carpet that the back of the accelerator pedal had been in contact with the carpet. When the accelerator pedal was pushed fully forward and released, it functioned smoothly and returned to its full rear position without binding.

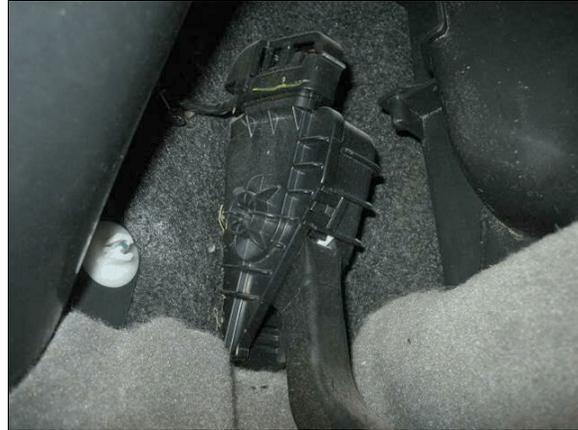
Figure 9: The Denso accelerator mechanism

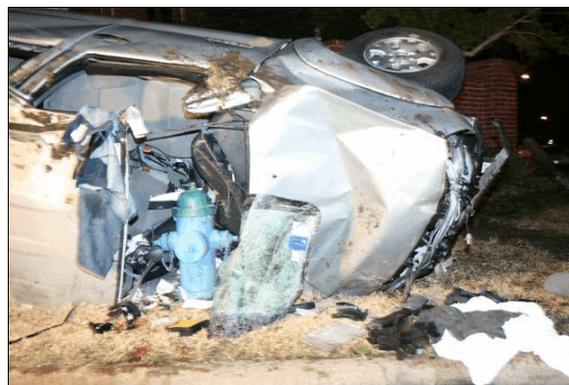
The windshield was partially displaced from the windshield frame by the impact with the fire hydrant, which created an opening for ejection and the driver’s upper torso was ejected. Based on the driver’s medical records, he was found by emergency responders with his upper torso out of the vehicle through the windshield opening with his legs entrapped by the steering wheel and his upper torso resting on the fire hydrant and his head and arms on the ground. Rescue personnel cut the left A-pillar, steering wheel, and removed the displaced windshield to extricate the driver (Figure 10).

Figure 10: Police photo showing the status of the Toyota following the extrication of the driver
