ON-SITE ROLLOVER INVESTIGATION

CASE NUMBER - IN10025
LOCATION - MISSOURI
VEHICLE - 2008 HONDA CIVIC
CRASH DATE - May 2010

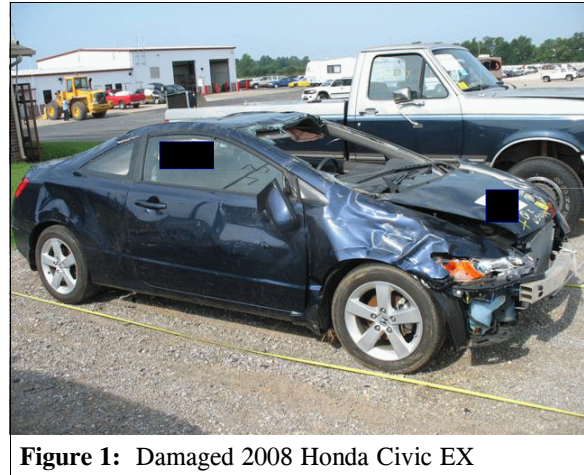
Figure 1: Damaged 2008 Honda Civic EX

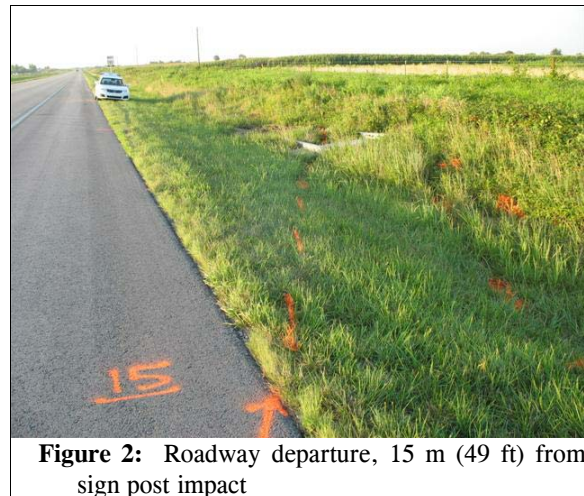
Figure 2: Roadway departure, 15 m (49 ft) from sign post impact

Crash: The Honda traveled onto the right roadside and was in a clockwise yaw as it traveled into a ditch, negatively sloped at 18% (**Figure 2**). The left quarter panel impacted a metal sign post (event 1) and the Honda continued up the back slope of the ditch, positively sloped at 30%. This caused the vehicle to trip and roll over (event 2), left side leading, four quarter turns. The Honda returned to its wheels and the front plane impacted a barbed wire fence (event 3). As the vehicle continued, the fence impacted the right A-pillar and roof and right door. During the crash sequence, both side impact inflatable curtain (IC) air bags deployed as well as both front seat-mounted side impact air bags.

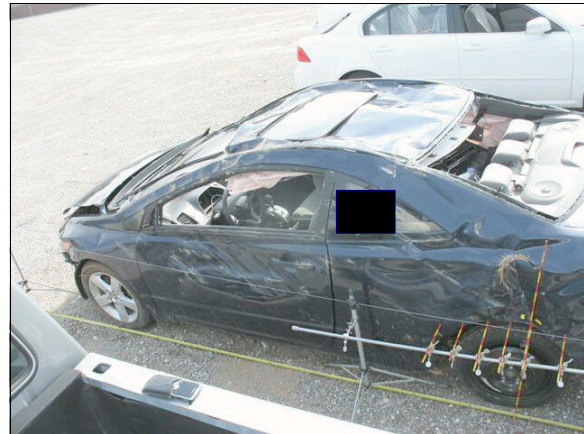
Exterior Damage Event 1: The Honda sustained left side plane damage during the impact with the sign post (**Figure 3**). The direct damage was limited to the left quarter panel. It began 276 cm (108.7 in) rear of the left front axle and extended rearward 3 cm (1.2 in). The maximum residual crush was 8 cm (3.1 in) occurring at C₂. The table below presents the vehicle’s left side plane crush profile.

Damage Classification Event 1: The Collision Deformation Classification (CDC) for the sign post impact was 08LBEN1 (230 degrees). The Barrier algorithm of the WinSMASH program was used to calculate a Barrier Equivalent Speed (BES) of 5.9 km/h (3.7 mph). A Delta V could not be calculated since impacts with yielding objects are out of scope for the program.

Figure 3: Left side rollover and sign post impact damage

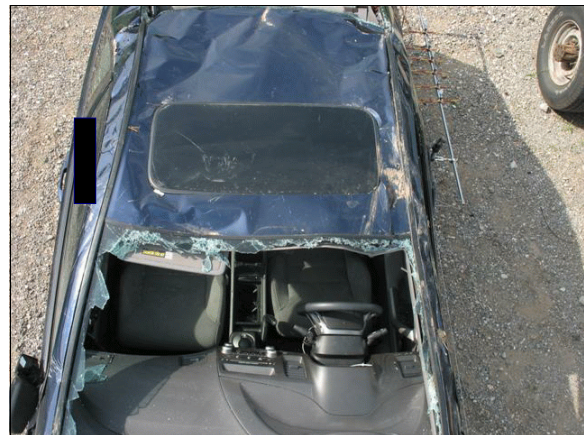
Exterior Damage Event 2: The Honda sustained damage on the both side planes and the top plane during the rollover (event 2). The direct damage on the left side plane began 39 cm (15.4 in) forward of the left front axle and extended 353 cm (138.9 in) rearward along the left fender, A-pillar, door, and quarter panel (**Figure 3**). The direct damage on the right side plane began 57 cm (22.4 in) forward of the right front axle and extended 350 cm (137.8 in) rearward along the right fender, A-pillar, door, and quarter panel. The direct damage on the top of the Honda began on the roof at the windshield header and extended 55 cm (21.6 in) along the roof rail, tapering off to the left side of the vehicle (**Figure 4**). The maximum width of the direct damage was 108 cm (42.5 in). The maximum lateral crush was located at the right roof side rail (**Figure 5**), 90 cm (35.4 in) forward of the right rear axle and measured 3.5 cm (1.4 in). The maximum vertical crush was located at the right rear roof area (**Figure 6**), 64 cm (25.1 in) forward of the right rear axle, and measured 13 cm (5.1 in). The left and right side wheelbases were extended 1 cm (0.4 in) but there was no other induced damage. Based on the amount of crush to the roof, the severity of the rollover damage was moderate.

Figure 4: Rollover damage to roof

Damage Classification Event 2: The CDC for the rollover was 00TYDO2. The WinSMASH program could not be used to calculate the Delta V for this event since rollovers are out of scope for the program. Based on the extent of the roof crush, the severity of the rollover damage was minor.

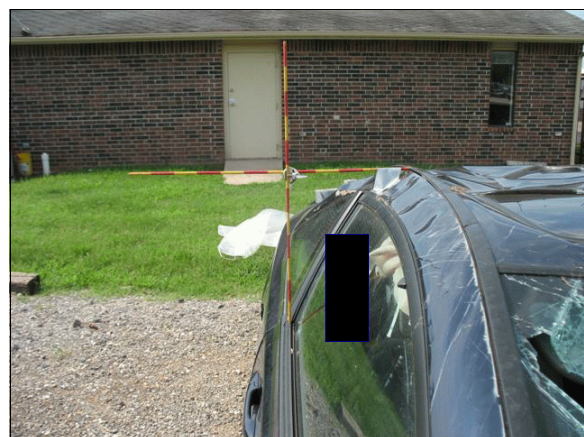
Figure 5: Lateral max crush to right roof rail

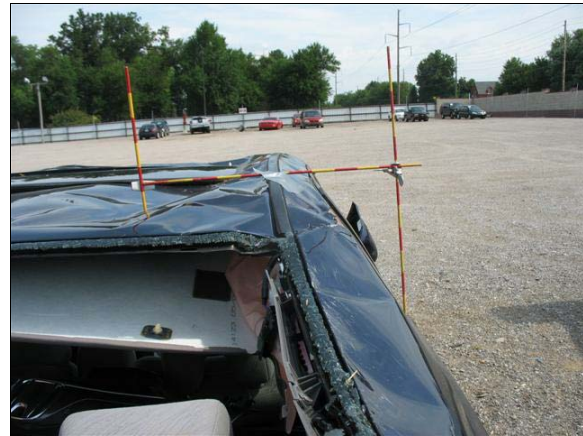
Figure6: Vertical max crush to roof

There were four vertical intrusions of the passenger compartment. Intrusion measurements were taken on the roof and windshield header at the driver’s position and were 7 cm (2.8 in) and 3 cm (1.2 in), respectively. The roof intrusion also involved the front right passenger and second row right passenger positions and these measured 6 cm (2.4 in) and 7 cm (2.8 in), respectively.

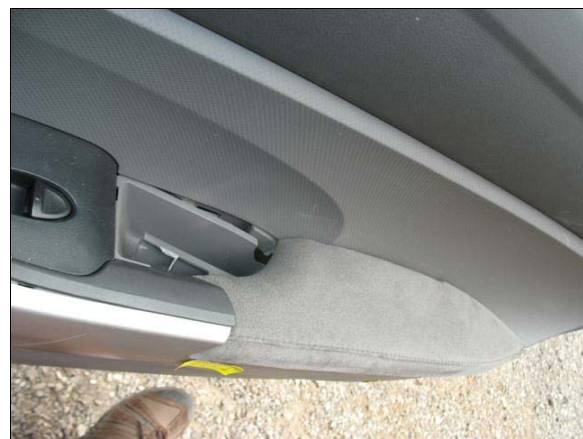
Vehicle Interior: The inspection of the Honda’s interior revealed evidence of occupant contact on the right front door arm rest (Figure 7). The arm rest was probably deformed from contact by the passenger’s right hip during the rollover.

Figure 7 Deformed right arm-rest
