ON-SITE ROLLOVER INVESTIGATION

CASE NUMBER - IN10028

VEHICLE - 2009 SCION tC

CRASH DATE - July 2010

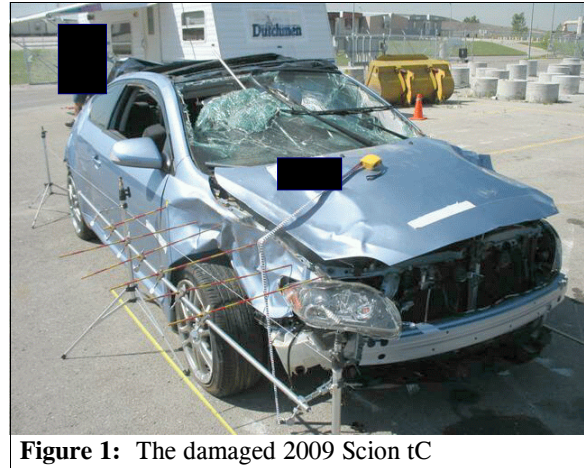
Figure 1: The damaged 2009 Scion tC

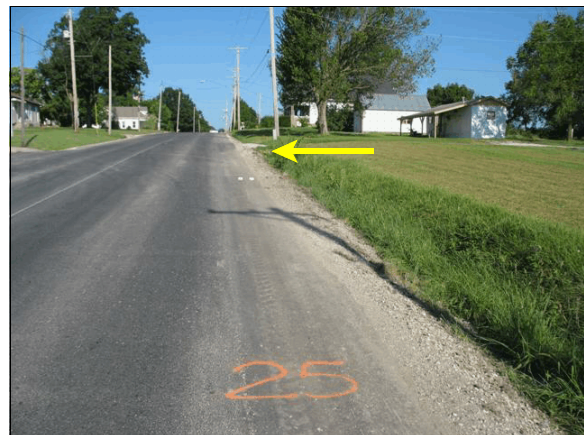
Figure 2: Approach of the Scion to area of roadway departure; arrow shows location of culvert impact

Pre-Crash: The Scion's restrained 21-year-old female driver was traveling east (**Figure 2**) with the cruise control engaged at a driver estimated speed of 97-105 km/h (60-65 mph). The driver stated that the visibility was poor due to the heavy rain and she was leaning forward to see the roadway. The vehicle's right front wheel traveled off the south side of the roadway onto the low gravel shoulder and the right side wheels entered a ditch. The driver attempted to avoid the crash by steering left.

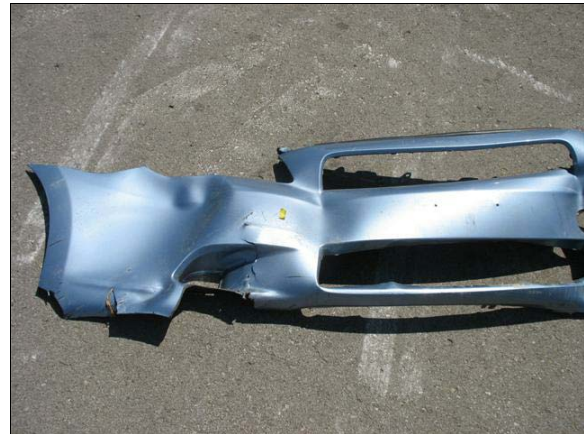
Figure 3: Direct damage on the front right corner of the bumper fascia of the Scion from the impact with the culvert

Exterior Damage Event 1: The Scion sustained front plane damage during the impact with the culvert. The direct damage began at the front right bumper corner and extended 23 cm (9.1 in) to the left on the front bumper fascia. The bumper fascia was displaced off the vehicle during the crash. The crush measurements were taken on the bumper reinforcing bar and the residual maximum crush was 5 cm (2 in) occurring at C₆. The table below presents the crush on the front plane.

Damage Classification Event 1: The Collision Deformation Classification (CDC) for the culvert impact was 12FRLE1 (0 degrees). The damage algorithm of the WinSMASH program calculated the total Delta V as 14 km/h (8.7 mph). The longitudinal and lateral velocity changes were -14 km/h (-8.7 mph) and 0 km/h, respectively.

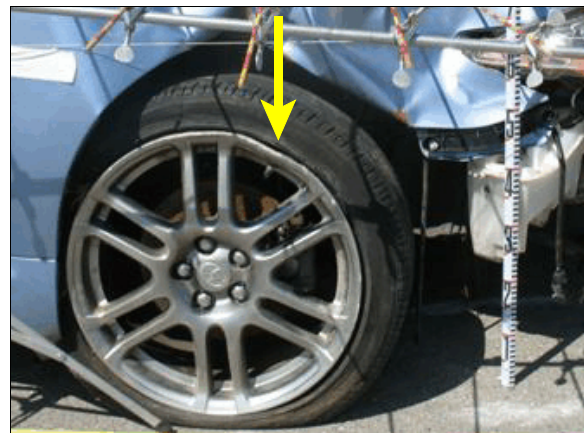
Figure 4: The right front wheel rim was dented (arrow) and the wheel displaced rearward 12 cm (4.7 in) from the culvert impact

Exterior Damage Event 2: The Scion also sustained right front wheel damage from the impact with the culvert. The sidewall of the tire was cut and the wheel rim was dented (**Figure 4**). The impact displaced the right front wheel rearward 12 cm (4.7 in).

Damage Classification Event 2: The CDC for the right front wheel impact was 12FRWN3. The WinSMASH program could not be used to calculate a Delta V for this impact since wheel impacts are out of scope for the program. The severity of the damage on the wheel was moderate based on the displacement of the wheel and the damage on the rim.

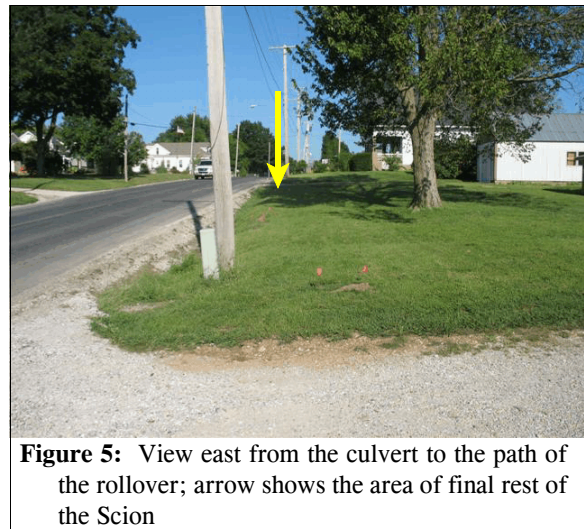
Figure 5: View east from the culvert to the path of the rollover; arrow shows the area of final rest of the Scion

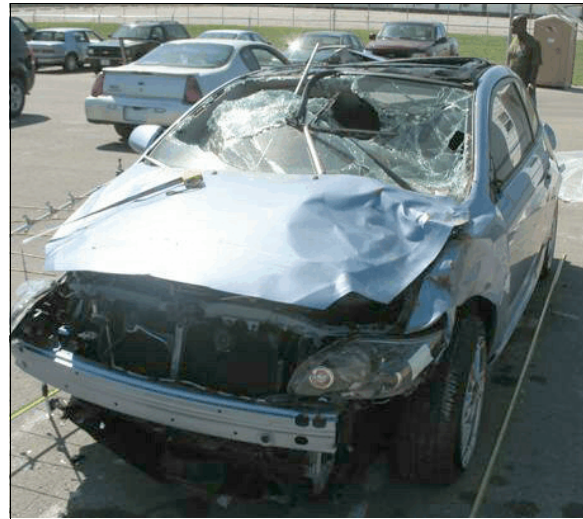
Figure 6: Damage to the Scion from the rollover

Exterior Damage Event 3: Both side planes and the top plane of the Scion were damaged during the rollover. The damage on the left side plane began 49 cm (19.3 in) forward of the left front axle and extended 110 cm (43.3 in) rearward along the left fender, hood, and A-pillar. The damage resumed 68 cm (26.8 in) forward of the left rear axle and extended 140 cm (55.1 in) rearward along the roof side rail, C-pillar, and quarter panel. The damage on the right side plane began 323 cm (127.2 in) forward of the right rear axle and extended 87 cm (34.3 in) rearward along the right fender. The damage resumed 70 cm (27.6 in) forward of the right rear axle and

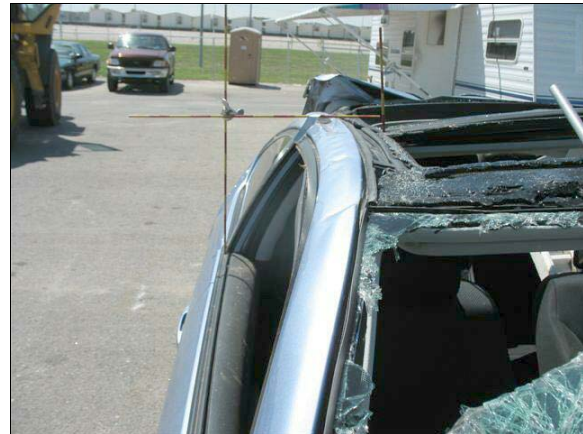
Figure 7: The maximum vertical crush to the roof of the Scion

extended 102 cm (40.2 in) rearward along the right roof side rail, C-pillar, and quarter panel. The damage on the top plane resided on the hood, the right roof side rail, the tops of the C-pillars, and the back hatch. The maximum vertical crush (**Figure 7**) was 5 cm (2 in). It was located at the right center portion of the roof, 99 cm (39 in) forward of the right rear axle. The maximum lateral crush was 5 cm (2 in) and was located on the right roof rail, 92 cm (36 in) forward of the right rear axle. The roof, hood, and both quarter panels sustained induced damage.

Damage Classification Event 3: The CDC for the rollover was 00TDDO2. The WinSMASH program could not be used to calculate a Delta V for this event since rollovers are out of scope for the program. Based on the extent of the roof crush, the severity of the damage was minor.
