CALSPAN ON-SITE MOTORCOACH FIRE INVESTIGATION

SCI CASE NO.: CA10028

VEHICLE: 1990 MCI MODEL 102-C3 MOTORCOACH

INCIDENT DATE: JUNE 2010

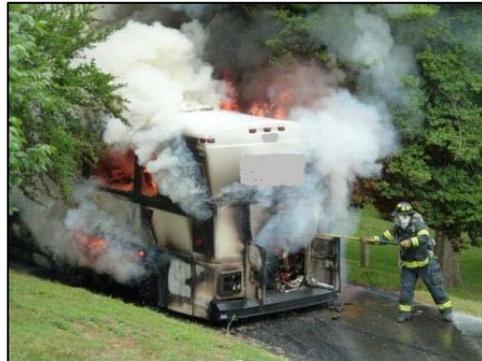
Figure 1. On-scene image of the MCI motorcoach fire. (Internet news image.)

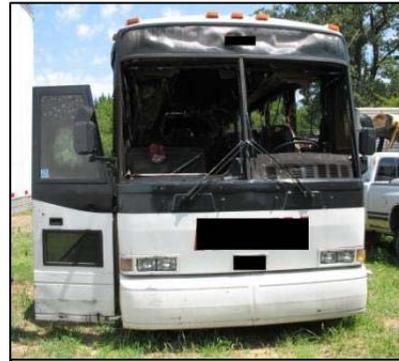
The front of the motorcoach (**Figure 3**) sustained minor severity damage that was associated with the fire. There was no damage below the base of the split windshields. Both laminated windshields were pierced by the firefighters with a pike pole and removed from the vehicle to vent the interior of the motorcoach. The windshield wiper blades appeared to have been recently replaced and remained undamaged, in the up and stowed positions. The perimeter gaskets for the windshields were intact with slight heat damage to the upper aspect of both gaskets. The Plexiglas panel above the windshields was in place, distorted by heat and stained by smoke and soot.

Figure 3. Frontal view of the MCI motorcoach.

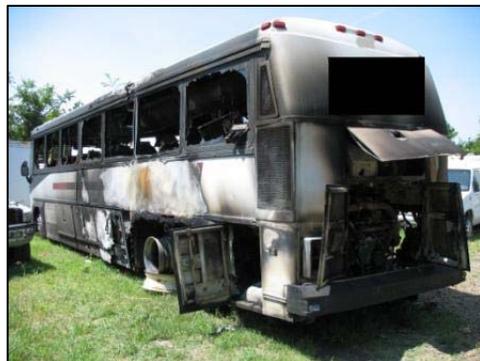
The painted body panels began to display evidence of heat and fire exposure immediately forward of the left E-pillar. The body panel aft of the left E-pillar displayed evidence of heat-induced buckling with blistering of the paint. The paint was burned from the body panel surfaces aft of the left F-pillar. The aluminum trim below the beltline was melted at the rear third of the F- to G-pillar location and continued to the midpoint of the G- to H-pillars. An aluminum trim strip above the luggage bay doors was melted at the midpoint of the left F- to G-pillars and extended aft of the H-pillar, to a point over the tag axle location. High heat was present in the sheet metal body panels at the F- to G-pillar locations over the rear axle positions. These panels were buckled with rust present on the steel. **Figure 4** is an oblique view of the damage to the left side of the motorcoach.

Figure 4. Left side view of the motorcoach.

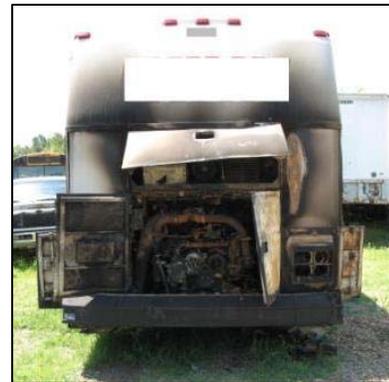
The back of the motorcoach (**Figure 5**) consisted of solid panels and three doors. Two center closing sheet metal doors provided access to the engine compartment. The firefighters opened these doors during the early phases of the fire suppression process. The paint was burned from the left engine compartment door, most notably at the upper third aspect. The door panel was warped by exposure to heat. This door also contained the aluminum license plate. The plate remained intact with the paint burned from the aluminum. The door was jammed in the open position by upward deflection of the bumper during the towing process. The right engine compartment door was opened by the firefighters. The painted surface was completely burned with warping of the steel skin. High heat oxidation was present to the upper inboard aspect of this door.

Figure 5. Back view of the motorcoach.

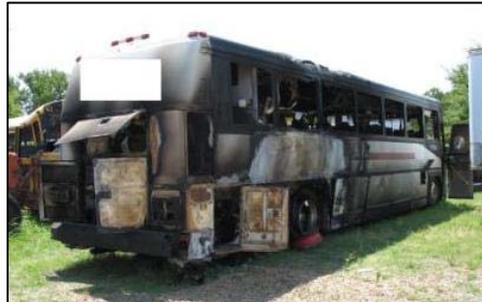
The right side of the motorcoach (**Figure 6**) was burned in a pattern similar to the left side. The right entry door was smoke stained with no fire or heat related damage noted to the door. The painted body panels were smoke and soot stained from the right B- to the E-pillar areas. The fuel filler cap access door was located at the aft edge of the C-pillar. This door was intact and free of fire or heat related damage. The battery compartment was located immediately aft of the filler cap/fuel tank location, between the C- and D-pillars. The door was closed and the batteries, associated wiring and cut-off switches were intact without damage.

Figure 6. Right oblique view of the motorcoach.

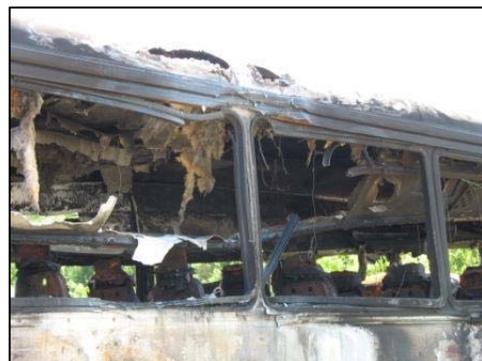
Figure 7. Burn-through of the right aluminum roof panels.

forward and aft of the right G-pillar, above the roof side rail (**Figure 7**). The roof panels were buckled and distorted by heat in the areas of the F- to H-pillars. A similar burn pattern was present on the left roof area over the G-pillar area with complete burning of the paint from the F- to the H-pillars.

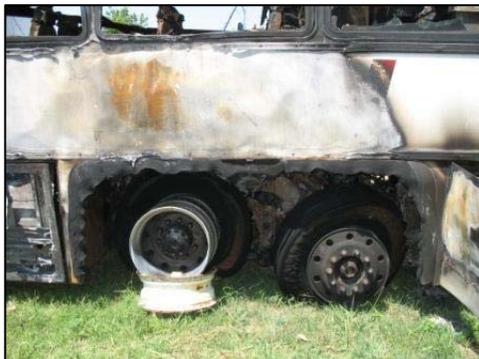
The left outboard drive axle tire was removed from the alloy wheel prior to the SCI inspection. There were no tire remnants (i.e., bead wire) present on the wheel. The wheel was intact, but was discolored due to heat. The outer sidewall of the left inboard drive axle tire was burned through at the 3-6 o'clock positions with the steel belts exposed. The tire was de-beaded from the wheel and the majority of the tread was burned. The tire retained its shape, but lost air pressure and remained on the wheel. The alloy wheel was intact, but displayed heat-related discoloration. **Figure 8** is a view of the left rear axle tires and wheels.

Figure 8. Fire damage to the left drive and tag axle tires and wheels.

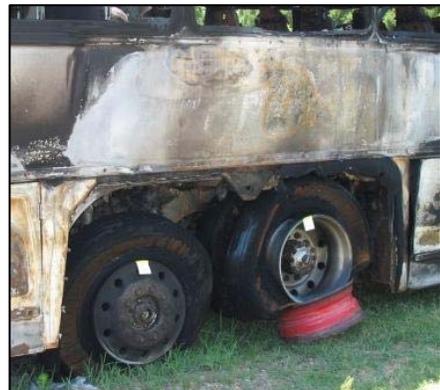
Figure 9. Right side drive and tag axle tires.

The outer sidewall of the right outer drive axle tire was burned full-thickness circumferentially with the steel belts exposed (**Figure 9**). The tread was burned with the exception of the tire patch that was in contact with the pavement at the time of the fire. The tire had rotated on the alloy wheel approximately 90 degrees during the tow process. The intact tire patch was located at the 9 o'clock position at the time of the SCI inspection which yielded 6 mm (8/32 in) of remaining tread depth. The alloy wheel was intact with heat-related discoloration and slight charring of the bottom aspect. The outer sidewall to the inner drive axle tire was burned full-thickness and the tread was burned smooth. The tire de-beaded from the wheel. The alloy wheel was not visible, but remained intact.

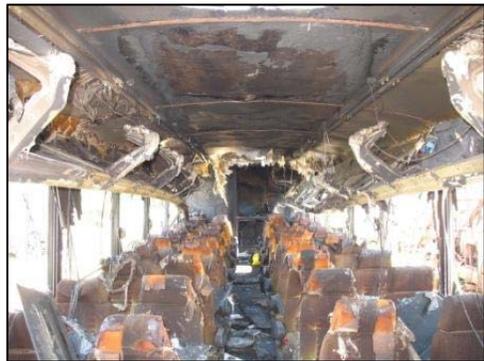
The interior of the motorcoach sustained extensive damage as the fire spread into the passenger compartment (**Figure 10**). The inside surface of the right front door was smoke and soot stained. The laminated lower door window was intact, but cracked due to heat. The upper glazing panel was intact with heat cracking and blistering of the plastic laminate in the upper third area of the window. The status of the door following the egress of the passengers is unknown (open or closed).

Figure 10. Rear interior view of the fire damage to the interior of the motorcoach.

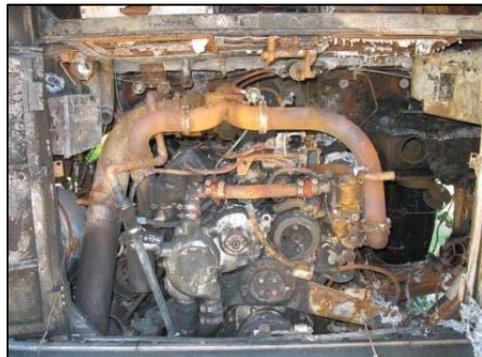
The fire appeared to have originated in the engine compartment area of the motorcoach based on driver statements and fire-related evidence. An assessment of the fire origin was conducted by an inspector for the FMCSA prior to the SCI investigation. This inspector's assessment was relayed back to the motorcoach company and he suspected the turbocharger as the likely origin of the fire. An overall view of the engine compartment is provided in **Figure 11**.

Figure 11. Overall view of the engine compartment.

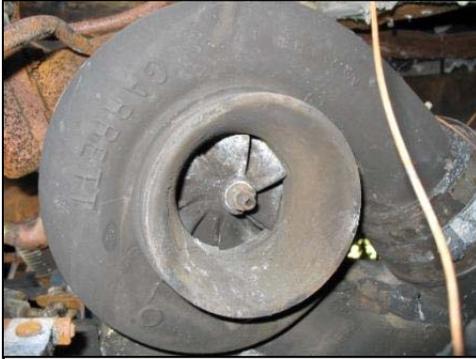
The aluminum duct from the air box to the cold air intake side of the turbocharger was consumed by the fire, thus exposing the intake impeller of the turbocharger. The high temperature silicone connector that joined the duct to the turbo was partially consumed by the fire. The steel band clamp remained in place on the outboard side of the turbocharger. The impeller and the cast aluminum housing were intact (**Figure 12**). The impeller was slightly blackened by soot and spun freely by hand. Without a complete disassembly, there was no notable binding or damage to the impeller shaft or bearings. The fins of the impeller were intact and free of damage. The surrounding casting was intact with minimal discoloration due to the fire.

Figure 12. Intake impeller and cast alloy housing of the turbocharger.

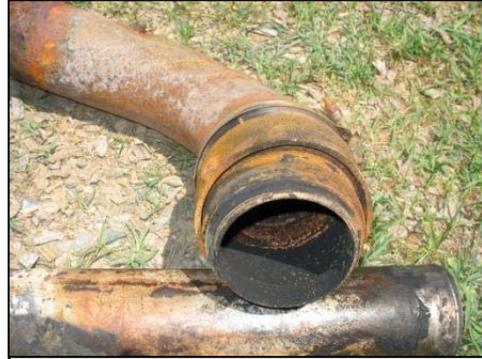
Figure 13. Exhaust pipe removed from turbocharger.

The exhaust side of the turbocharger was inspected. The 12 cm (4.75 in) diameter exhaust pipe that extended from the discharge side of the turbocharger to the muffler was loose, but intact at the turbocharger connection. The SCI investigator loosened the band clamp at the turbocharger and removed the exhaust pipe from the vehicle. The initial inspection of the exhaust pipe revealed carbon deposits on the upper aspect of the pipe with no trace of oil deposits (**Figure 13**). The lower aspect of this exhaust pipe and the adjoining pipe to the muffler were clean of carbon deposits.

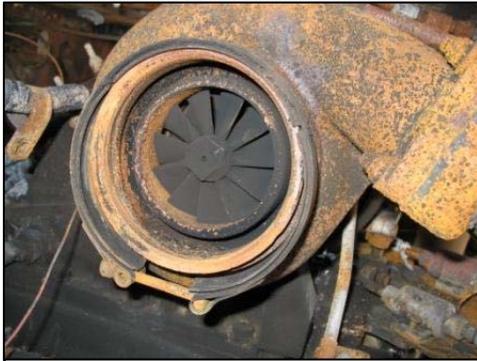
The hot (discharge) side of the turbocharger was inspected for signs of damage and oil deposits. The cast iron body of the turbocharger was intact with no visible cracks. The casting was clean and yielded a rusted surface. The exhaust side impeller was covered with a film of carbon and spun freely when turned by hand. Again, similar to the intake side, there was no damage to the fins or apparent internal damage with no deposits of oil present (**Figure 14**).

Figure 14. Exhaust impeller and cast iron housing of the turbocharger.

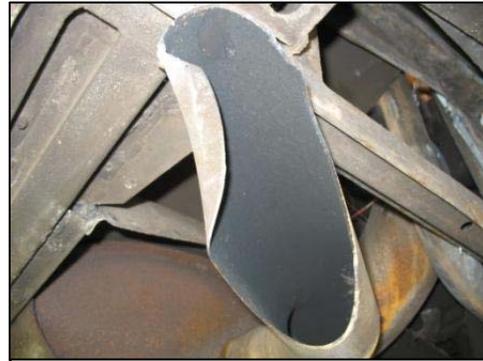
The exhaust tailpipe was inspected for evidence of oil with no traces of engine oil present in the tailpipe or the muffler. The tailpipe contained a thick layer of carbon on the full circumference of the tailpipe.

Figure 15. Carbon deposits in the tailpipe of the motorcoach.

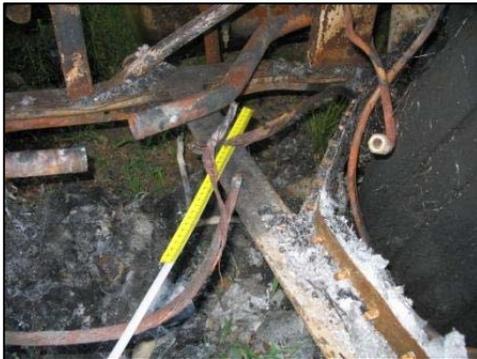
The least likely of the fire's electrical sources involved the possible arcing of a battery cable (**Figure 16**). This 6-gauge cable extended along the right side of the motorcoach aft of the tag axle tire and yielded evidence of severe arcing in two places with welding of the copper wire at the arced locations. Immediately rearward of the arced locations, the cable was burned through with complete separation of the braided cable (**Figure 17**). The area surrounding this cable damage did not exhibit the high heat oxidation commonly associated with fire origin.

Figure 16. Arced and separated battery cable.

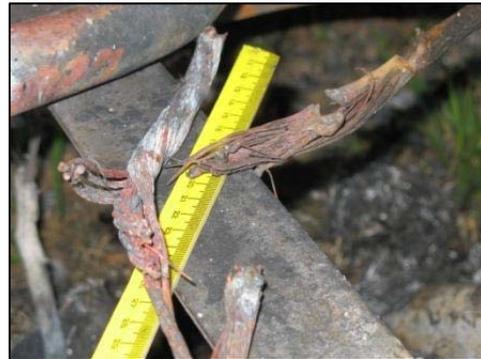
Figure 17. Close-up view of the arced cable.

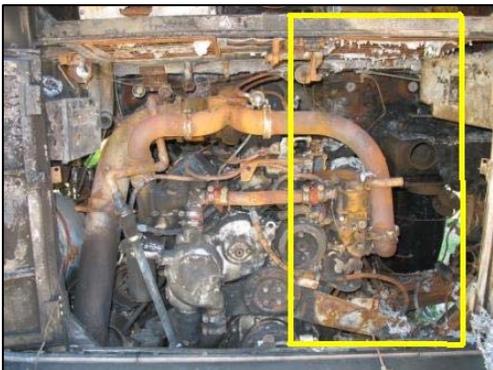
The lower right corner of the engine compartment displayed high heat oxidation with a distinct burn pattern that extended vertically upward into the cooling fan housing for the

The high heat burn pattern extended upward from this mounting point across the right side of the engine and into the squirrel cage cooling fan. The aluminum housing for this fan was melted by the fire. Evidence of high heat was present above the cooling fan on the right lower corner of the radiator reservoir, right of the vehicle's centerline. This high heat pattern was not present on the symmetrical- mounted left cooling fan. The right to left disparity in the heat pattern was indicative of the right biased fire origin.

Figure 18. High heat oxidation to the right side of the engine area.

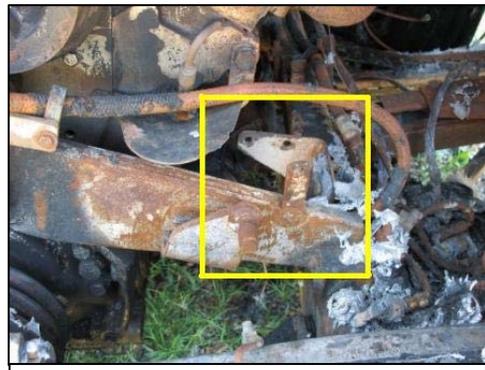
The most likely origin of this motorcoach fire involved the alternator that was mounted to the lower right side of the diesel engine. The alternator was belt driven off the engine's power-takeoff. The alternator was missing from the vehicle at the time of the SCI inspection. The alloy housing of the alternator was presumed to have been consumed by fire. Its contents probably fell to the pavement and were swept-up post-event by firefighters or maintenance personnel of the cemetery. The cemetery workers could not recall specifics regarding the clean-up of the debris at the fire site when interviewed by the SCI investigator.

radiator (**Figure 18**). This pattern originated on the transverse engine mount at the lower right corner of the engine. Two mounting plates were positioned in this area; one welded to the transverse mount and the second located forward of this mount. The mounting points did not contain bolts at the time of the inspection. Melted aluminum pooled immediately to the right of these mounts (**Figure 19**).

Figure 19. Presumed mounting points of the alternator.
