**CALSPAN ON-SITE SIDE IMPACT INFLATABLE OCCUPANT
PROTECTION SYSTEM CRASH INVESTIGATION
SCI CASE NO.: CA10029**

VEHICLE: 2010 HYUNDAI ACCENT GLS

LOCATION: NORTH CAROLINA

CRASH DATE: JUNE 2010

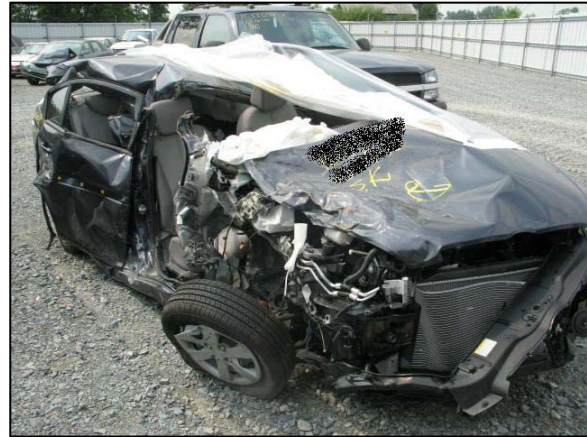
Figure 1: Front right oblique view of the Hyundai Accent.

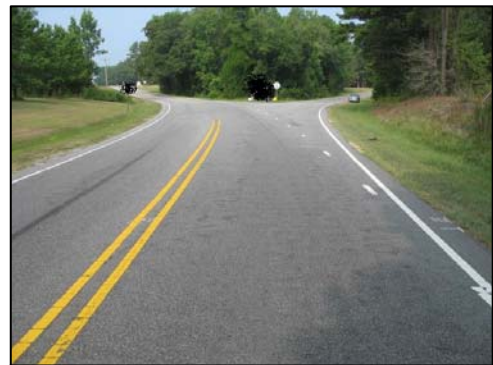
This crash occurred during daylight hours at the Y-intersection of two rural roadways. **Figure 2** depicts the Hyundai’s approach to the intersection. The environmental conditions were clear and dry at the time of the crash. The east/west primary roadway on which the Hyundai was traveling consisted of two asphalt-surfaced travel lanes that measured 3.3 m (10.8 ft) in width. The main roadway included a left curve for westbound traffic. The measured radius of curvature was 374 m (1263 ft). The road was bordered on both sides by narrow asphalt shoulders 70 cm (2.4 ft) in width. The north roadside consisted of grass terrain with a negative grade of two percent. The grade transitioned to a positive grade of 15 percent, 5 m (16.4 ft) north of the roadway. The south roadside was a grass-surfaced residential yard with a negative grade of two percent adjacent to the roadway that transitioned to a positive grade of two percent, 3.3 m (10.8 ft) south of the south road edge. In the pre-crash area for the Hyundai, the road grade was positive one percent. The intersecting roadway joined the main roadway at a 35 degree angle. This intersecting roadway consisted of two

Figure 2: Pre-crash trajectory of the Hyundai.

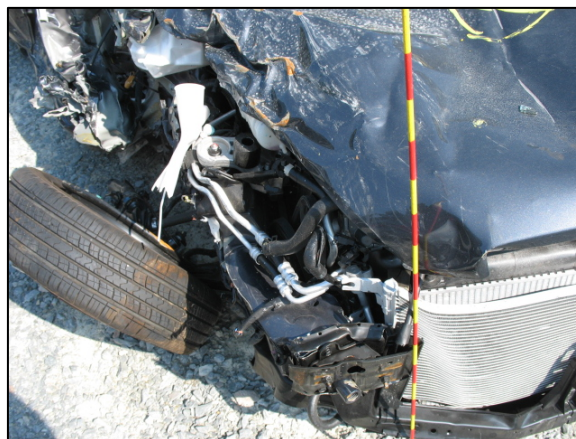
The front of the Hyundai sustained moderate damage in this offset frontal/side engagement crash (**Figure 3**). On the front plane, the direct contact damage began 40 cm (15.7 in) right of the centerline, and extended right 27 cm (10.6 in). The maximum crush was located at C5, 30 cm (11.8 in) right of center, and measured 22 cm (8.7 in). The combined direct and induced damage extended the full-width of the Hyundai's front plane. The bumper beam and front fascia separated from the vehicle during the impact. A residual crush profile was measured to the lower radiator support and was as follows: C1 = 0, C2 = 1 cm (0.4 in), C3 = 3 cm (1.2 in), C4 = 10 cm (3.9 in), C5 = 17 cm (6.7 in), C6 = 29 cm (11.4 in). Both right doors were jammed shut post-crash. The front of the Dodge traveled down the right plane of the Hyundai resulting in deformation and intrusion. The direct contact to the right

Figure 3: Frontal and right side damage to the Hyundai.

side of the Hyundai extended 280 cm (110 in) rearward from the right corner. The maximum crush along the right side was located 15 cm (5.9 in) forward of the A-pillar and measured 50 cm (19.7 in) laterally. The lateral crush to the right A-and B-pillars was 15 cm (5.9 in) and 16 cm (6.3 in), respectively. The right wheelbase was shortened by 27 cm (10.6 in) from contact with the front of the Dodge. The windshield was fractured and holed by the impact forces, and the right front, right rear and backlight were disintegrated due to impact forces. The windshield was cut from the vehicle by EMS during the extrication of the front right occupant. The left side windows and right rear quarter glass were undamaged in the impact. The Collision Deformation Classification (CDC) assigned for this impact was 12FRAE9.

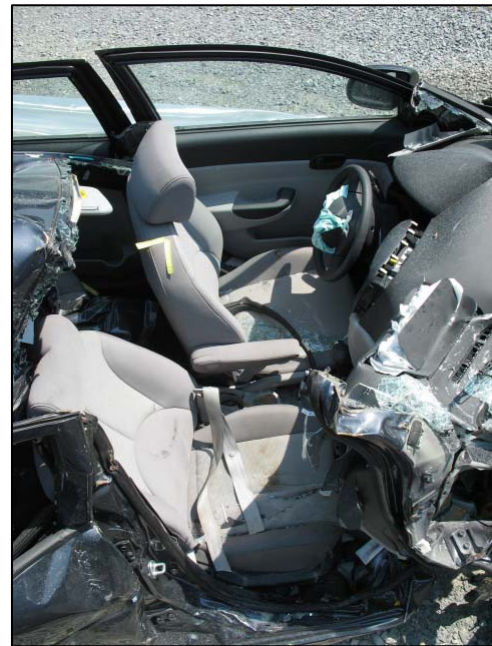
The Hyundai sustained moderate severity interior damage that was attributed to occupant compartment intrusion, occupant contact and air bag deployment. A 25 cm (10 in) scuff mark attributed to the driver’s right knee was located 28-38 cm (11-15 in) above the floor, beginning 5 cm (2 in) left of the mid-instrument panel seam and extending right 9 cm (3.5 in). The steering wheel was rotated 120 degrees counterclockwise (CCW) at the time of the SCI inspection. The fixed steering column/assembly was not damaged in this crash. In the front right seating position, the kick panel forward of the A-pillar, the A-pillar and the right door intruded laterally into the passenger compartment. There was a scuff mark with blood evidence on the inboard side of the front left seatback attributed to the front right passenger’s head. This 6 x 8 cm (2.4 x 3.1 in) contact was located on the upper inboard corner of the front left seat. The front right seat was compressed 12 cm (4.7 in).laterally by the intrusion of the front right door and B-pillar. **Figure 4** is a right lateral view of the Hyundai’s occupant compartment. The occupant compartment intrusion is listed on the following table:

Figure 4: Right lateral view of the interior damage to the Hyundai.

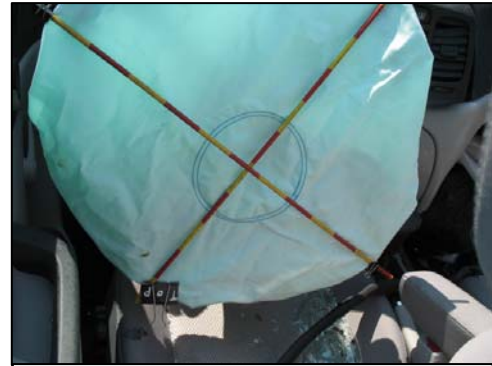
The driver's air bag was concealed within the center hub of the three-spoke steering wheel by a tri-flap design. The upper cover flap measured 14 cm (5.5 in) in width and 8 cm (3.1 in) in height. The lower flaps were triangular in shape and measured 7 cm (2.8 in) in width and 8 cm (3.1 in) in height. The air bag, (**Figure 5**), was 60 cm (23.6 in) in diameter. It contained a 15 cm (5.9 in) circular tether with two straps attached at the 12 and 6 o'clock positions. The driver's air bag was vented by two vent ports on the upper rear aspect of the air bag at the 11 and 1 o'clock positions. There was a 1 cm (0.4 in) drop of blood on the front of the air bag located 15 cm (5.9 in) above the center of the air bag and 3 cm (1.2 in) right of the center. The driver's air bag was unremarkable for further contact evidence.

Figure 5: Upper aspect of the front of the Hyundai's driver's air bag.

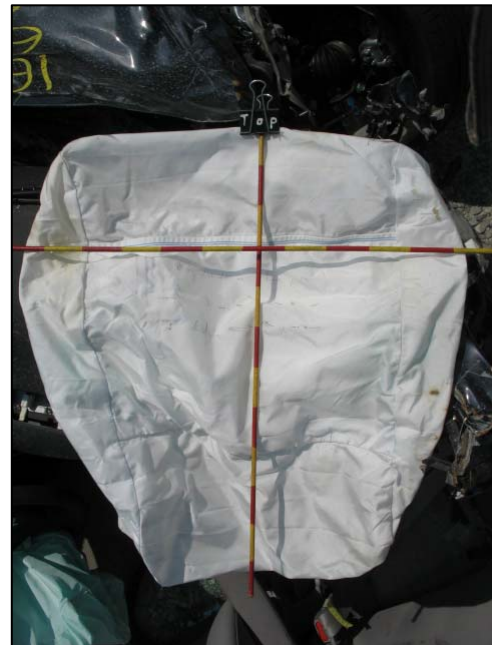
The front right air bag was mounted within the top aspect of the right instrument panel. The air bag was concealed under a single cover flap that measured 24 cm (9.4 in) in width and 10 cm (3.9 in) in height. The cover flap contained multiple scratches and gouge marks attributed to contact with the windshield that measured from 1 cm (0.4 in) to 4 cm (1.6 in) in length. This damage extended over the entire surface of the cover flap. The air bag (**Figure 6**) measured 52 cm (20.5 in) in width and 63 cm (24.8 in) in height. It was not tethered, but was vented by two ports on the left and right sides, at the 3 and 9 o'clock positions. There were numerous tear holes in the top of the air bag, in an area 24 cm (9.4 in) in width and 18 cm (7.1 in) in depth. These holes all measured less than 1 cm (0.4 in) in diameter and were attributed to the contact of the windshield by the deploying air bag. There was blood evidence present in several locations on the air bag. On the top aspect of the air bag, the blood evidence measured 20 cm (7.9 in) wide and 20 cm (7.9 in) in length. On the right side, there were two 10 cm (3.9 in) wide deposits of blood, located 6-10 cm (2.4-3.9 in) below and 32-56 cm (12.6-22 in) below the upper right corner.

Figure 6: View of the Hyundai's front right passenger's air bag.

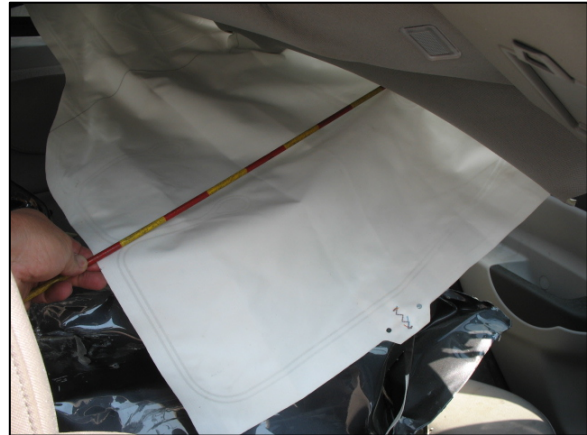
the left IC deployed during this crash. The right IC did not deploy and neither of the seat-mounted air bags deployed during this crash. The cause of the asymmetrical deployment could not be determined.

The deployed left IC measured 134 cm (52.7 in) in length. It measured 48 cm (18.9 in) in height at the front and rear seating positions and was tethered to the left A-pillar by a webbing strap 38 cm (15 in) in length. Vertically, the IC air bag extended below the belt line at the front and rear outboard positions. The left IC provided head protection from the left C-pillar forward to a location 48 cm (18.9 in) forward of the left B-pillar. The left IC was labeled with the identification “MC4DR PA66”, and was free from occupant contact points or damage. **Figure 7** depicts the inboard side of the front left IC.

Figure 7: View of the forward interior aspect of the Hyundai’s left IC air bag.

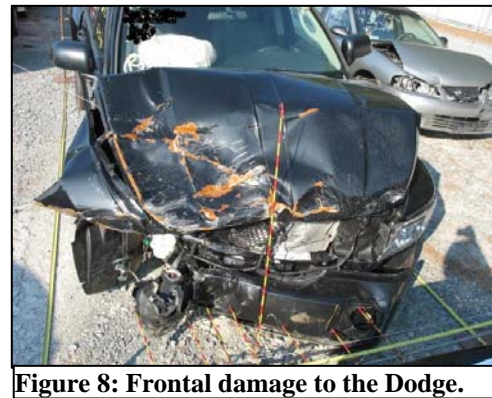
The front plane of the Dodge sustained moderate severity damage as a result of the impact with the Hyundai (**Figure 8**). The direct contact damage from the initial interaction between the vehicles began 3 cm (1.3 in) right of the vehicle centerline and extended right 78 cm (20.5 in) to the right corner. The combined width of the direct and induced damage extended the across full end-width of the vehicle. The forward aspects of the vehicle's frame rails were shifted to the right. The right frame rail shift measured 29 cm (11.4 in) and the left frame rail shift measured 18 cm (7.1 in). The bumper had also shifted downward 20 cm (7.9 in). The maximum crush was located 49 cm (19.3 in) right of the vehicle centerline and measured 43 cm (17 in). The residual crush profile was measured at the level of the bumper and was as follows: C1 = 21 cm (8.3 in), C2 = 28 cm (11 in), C3 = 33 cm (13 in), C4 = 41 cm (16.1 in), C5 = 40 cm (15.7 in), C6 = 35 cm (13.8 in). The CDC assigned for this impact was 71FZEW2.

Figure 8: Frontal damage to the Dodge.
