ON-SITE ROLLOVER INVESTIGATION

CASE NUMBER - IN10029
LOCATION - MISSOURI
VEHICLE - 2010 HYUNDAI ACCENT SE
CRASH DATE - July 2010

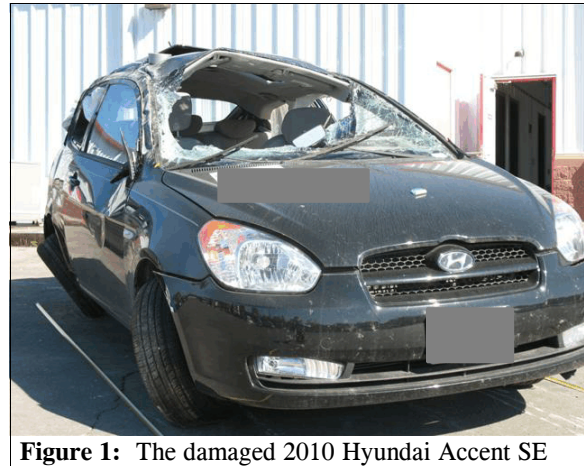
Figure 1: The damaged 2010 Hyundai Accent SE

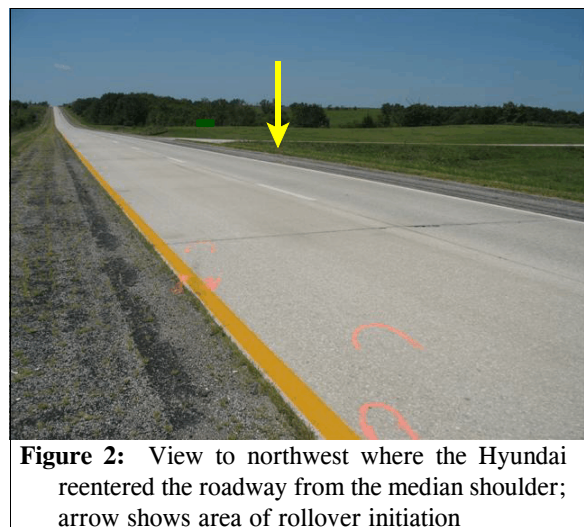
Figure 2: View to northwest where the Hyundai reentered the roadway from the median shoulder; arrow shows area of rollover initiation

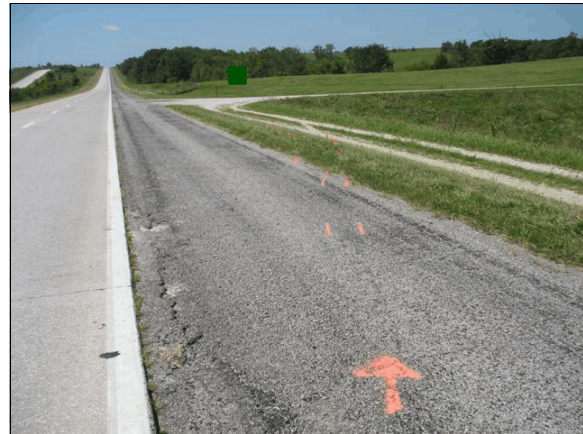
Figure 3: The Hyundai departed the road in a counterclockwise yaw and approached the area of rollover initiation

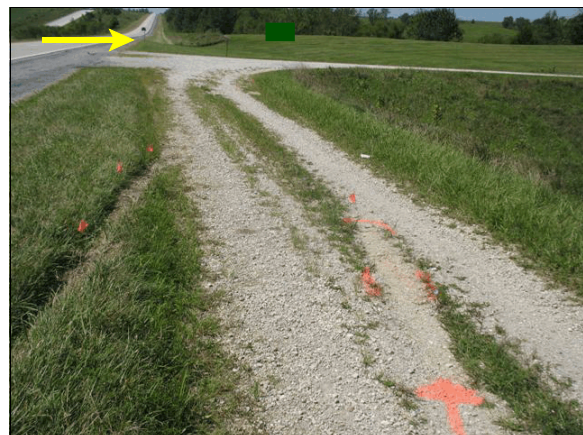
Figure 4: Area of rollover initiation; arrow shows area of final rest

The rollover of the Hyundai was initiated as the vehicle was in a counterclockwise yaw following the right roadside departure. As the right side tires produced furrows on the gravel driveway, the lateral force on the tires was sufficient to trip the vehicle and it rolled over right side leading 12 quarter turns across a distance of 53 m (173.8 ft). The calculated speed of the vehicle at the trip point was as 81 km/h (50.3 mph).

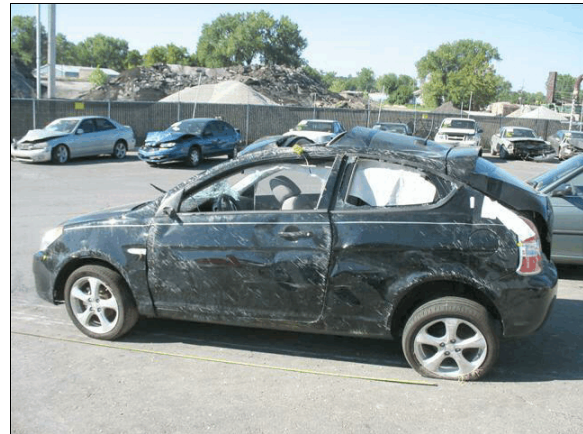
Exterior Damage: The Hyundai sustained damage on the top and both side planes (**Figures 5 and 6**) during the rollover. The direct damage on the left side plane began 48 cm (18.9 in) forward of the left front axle and extended 338 cm (133 in) rearward along the left side plane of the vehicle. Rocks and grass were embedded in the bead of the left front tire, which was still inflated. Grass was embedded in the bead of the left rear tire, which was deflated and positively cambered 20 degrees. The direct damage on the right side plane began on the top of the right fender located

Figure 5: Damage from the rollover on the left side and top planes of the Hyundai

Damage Classification: The Collision Deformation Classification (CDC) for the rollover was 00TZDO2. The WinSMASH program could not be used to calculate a Delta V since rollovers are out of scope for the program. Based on the extent of the roof crush, the severity of the damage was minor.

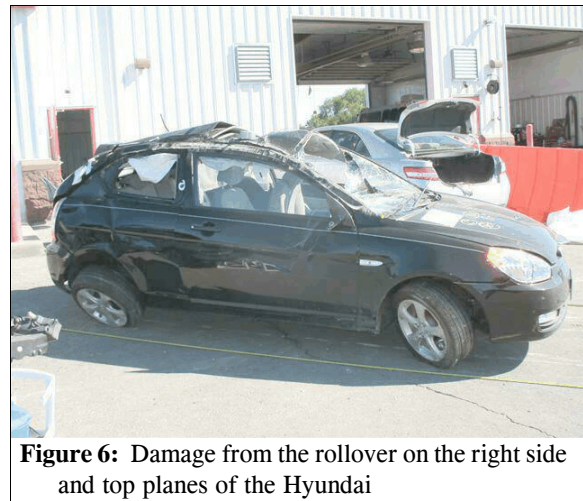
222 cm (87.4 in) forward of the right rear axle and extended rearward 220 cm (86.6 in) on the A-pillar and roof side rail. There was no direct damage on the right front door or quarter panel. Grass was embedded in the bead of the right front and right rear tires. The right rear tire was deflated and the wheel was positively cambered 40 degrees. The right front wheel was positively cambered approximately 20 degrees. The left side wheelbase was extended 5 cm (2 in), while the right side wheelbase was reduced 2 cm (0.8 in). The direct damage on the top plane resided primarily on both roof side rails with minor scratches located behind the sunroof. There was no direct damage on the hood. The maximum vertical crush was 8 cm (3.1 in), which occurred on the roof adjacent to the left rear window and 9 cm (3.5 in) inboard of the roof side rail. The maximum lateral crush was 9 cm (3.5 in), which occurred on the left roof side rail located 133 cm (52.4 in) rear of the left front axle.

Figure 6: Damage from the rollover on the right side and top planes of the Hyundai

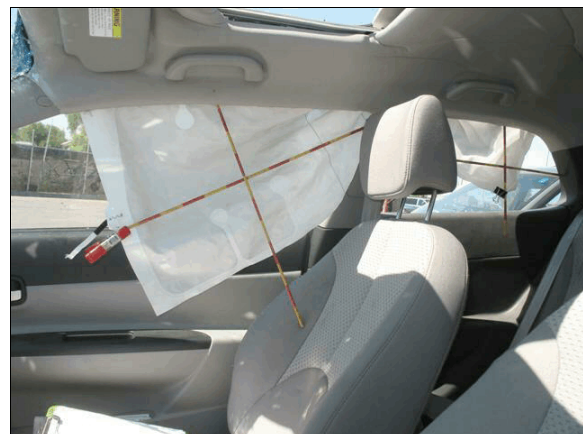
Figure 8: The partially deployed right IC air bag
