## ON-SITE OTHER INFLATABLE OCCUPANT PROTECTION INVESTIGATION

CASE NUMBER - IN10031

VEHICLE - 2008 FORD ESCAPE XLT

CRASH DATE - June 2010

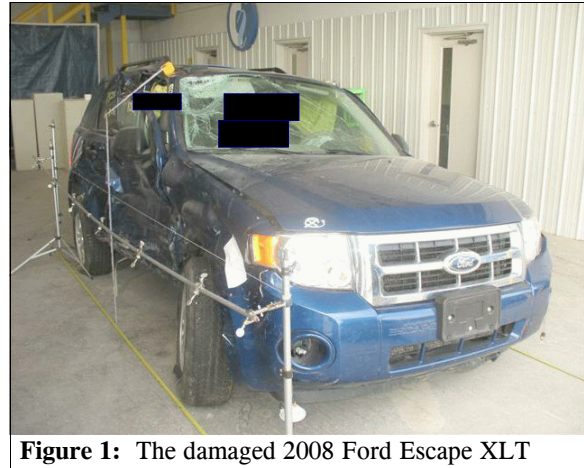
**Figure 1:** The damaged 2008 Ford Escape XLT

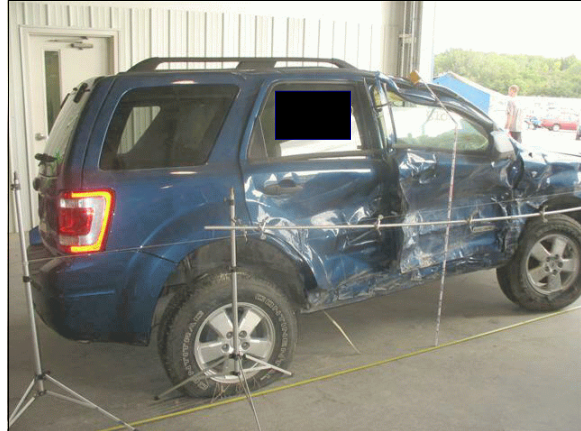
**Figure 3:** Damage on the right plane of the Ford from the impact by the front plane of the Dodge

**Exterior Damage Event 1:** The Ford sustained damage on the right plane during the impact with the front plane of the Dodge. The right fender, right front wheel, and both right side doors were directly damaged. The direct damage began 30 cm (11.8 in) forward of the right rear axle and extended 318 cm (125.2 in) forward along the right side. The crush measurements were taken at the mid-door level and the residual maximum crush was 19 cm (7.5 in) occurring at C<sub>3</sub>. The vehicle's sill height was 55 cm (21.7 in) and the height of the maximum crush was 83 cm (32.7

in). The Door Sill Differential was 0 cm. The right side wheelbase was reduced 20 cm (7.9 in), while the left side wheelbase was extended 1 cm (0.4 in). The induced damage involved the right fender and quarter panel. The table below presents the vehicle’s right side crush profile.

**Damage Classification Event 1.** The Collision Deformation Classification (CDC) for the right plane impact was 01RYEW3 (30 degrees). The missing vehicle algorithm of the WinSMASH program calculated the Delta V as 18 km/h (11.2 mph). The longitudinal and lateral velocity changes were -16 km/h (-9.9 mph) and -9 km/h (-5.5 mph), respectively. Based on the damage, the results appeared reasonable.

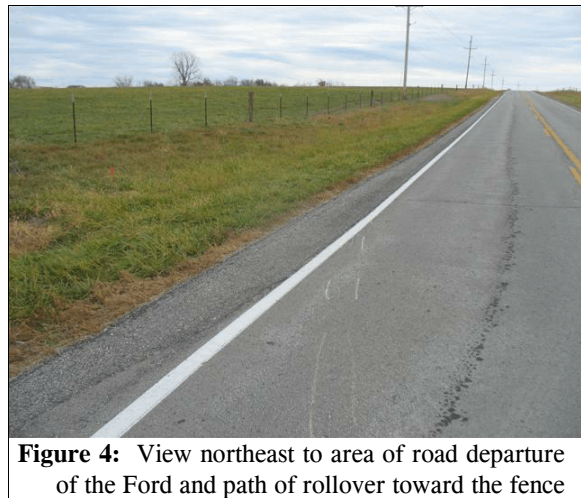
**Figure 4:** View northeast to area of road departure of the Ford and path of rollover toward the fence

The rollover of the Ford was initiated following the impact with the Dodge when the Ford departed the roadside in a clockwise rotation. As the vehicle traveled into the ditch, the left side tires furrowed into the ground. The lateral force on the left side wheels was sufficient to trip the vehicle and it rolled over left side leading, 4 quarter turns, across a distance of approximately 16 m (52.5 ft).

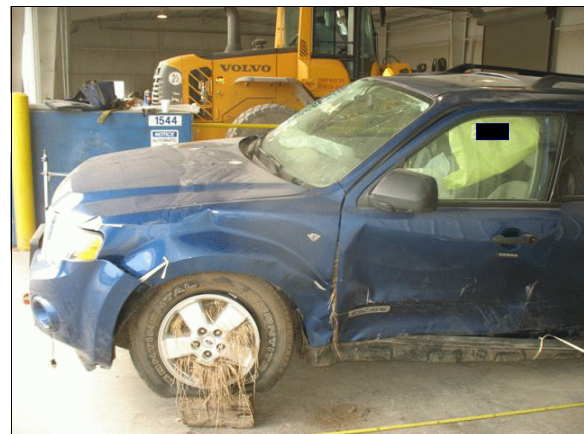
**Exterior Damage Event 2:** The Ford sustained damage on the both side planes and the top plane during the rollover. The direct damage on the left plane (Figures 5 and 6) began 15 cm (5.9 in) forward of the left front axle and extended 233 cm (91 in) along the fender, both doors, and the roof side rail. The direct damage on the right plane began 90 cm (35.4 in) forward of the right front axle and extended along the fender, onto the A-pillar, roof side rail, and overlapped the damage from the side impact. The direct damage on the top plane (Figure 7) resided on the roof and was intermittent involving the roof, luggage racks, and the roof side rails. There was no discernable damage from the rollover on the hood. The maximum vertical crush was 4 cm (1.6 in) and occurred at the right front corner of the sunroof 142 cm (55.9 in) forward of the right rear axle. The maximum lateral crush was 2 cm (0.8 in) and occurred at the top of the right C-pillar.

Figure 5: Damage from the rollover on the left plane of the Ford

**Damage Classification Event 2.** The CDC for the rollover was 00TPDO2. The WinSMASH program could not be used since rollovers are out of scope for the program. Based on the extent of the top plane crush, the severity of the rollover damage was minor.

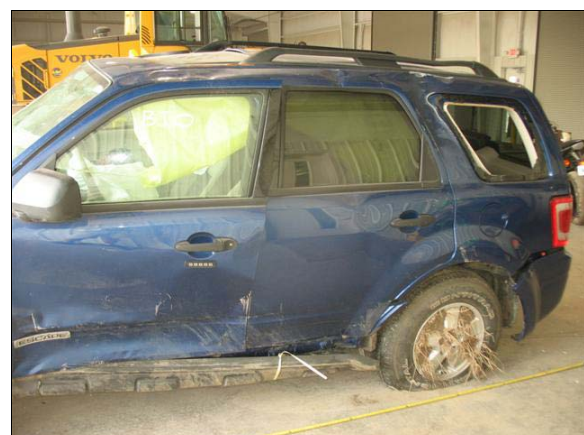
Figure 6: Damage from the rollover on the left plane of the Ford

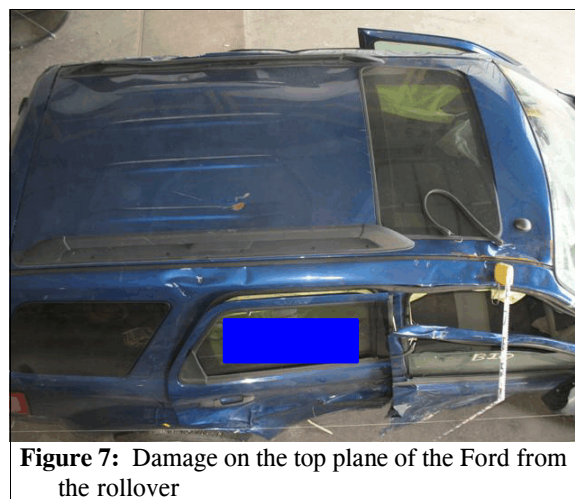
**Figure 7:** Damage on the top plane of the Ford from the rollover

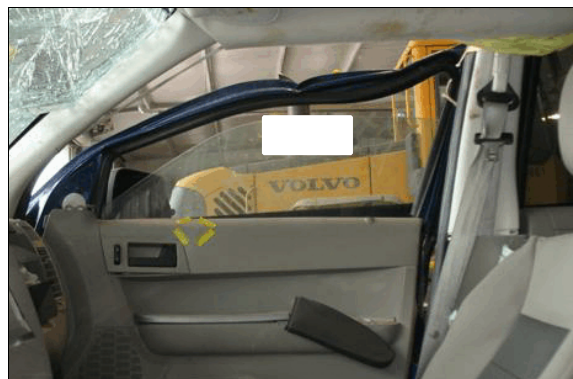
**Vehicle Interior:** The interior inspection of the Ford revealed a scuff mark on the forward upper quadrant of the right front door (**Figure 8**) at the beltline from contact by the front right passengers right forearm. The right front door armrest pad and center console were displaced from contact by the passenger’s right flank and left hip, respectively. The right instrument panel was scuffed from contact by the passenger’s knees. The turn signal lever was broken from contact by the driver’s left arm. There was no deformation of the steering wheel and no compression of the energy absorbing steering column.

**Figure 8:** Yellow tape and displaced armrest cushion shows area of occupant contact on the right front door

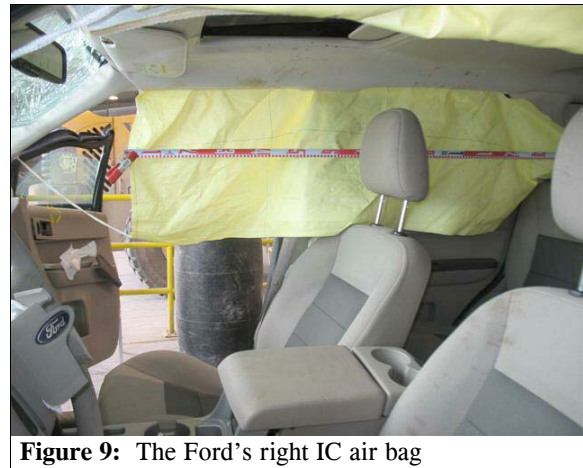
The IC air bags were located along the roof side rails inside the headliner and extended from the A-pillar to the C-pillar. There were no external vent ports. The deployed right IC air bag (**Figure 9**) was 140 cm (55.1 in) in width and 48 cm (18.9 in) in height. It was attached to the A-pillar by a 40 cm (15.7 in) nylon cord. The gap between the front of the IC air bag and the window frame was 30 cm (11.8 in) midway between the beltline and the top of the window. There was no gap between the back of the IC air bag and the C-pillar. The bottom of the air bag was attached to the C-pillar by a 9 cm (3.5 in) nylon cord. The distance the IC air bag extended vertically below the beltline was 13 cm (5.1 in).

**Figure 9:** The Ford's right IC air bag

The dimensions and features of the left IC air bag were the same as the right. There was no discernable evidence of occupant contact or damage on either IC air bag.

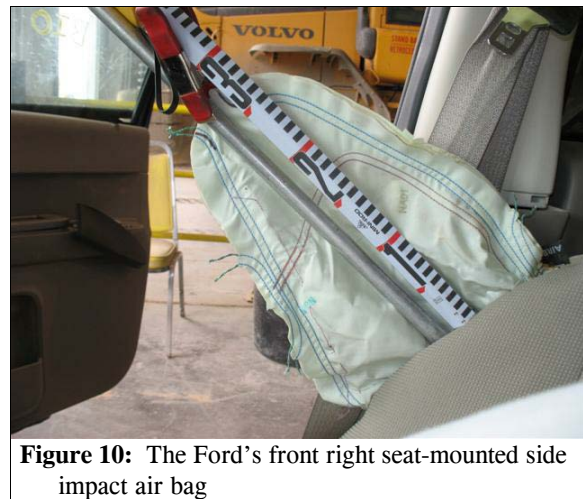
**Figure 10:** The Ford's front right seat-mounted side impact air bag

The front seat-mounted side impact air bags (**Figure 10**) were triangular in shape and measured 30 cm (11.8 in) in width and 25 cm (9.8 in) in height at the base. There was no discernable evidence of occupant contact or damage on either air bag.
