**CALSPAN ON-SITE ROLLOVER CRASH INVESTIGATION
SCI CASE NO.: CA10035**

VEHICLE: 2010 NISSAN SENTRA

LOCATION: NORTH CAROLINA

CRASH DATE: AUGUST 2010

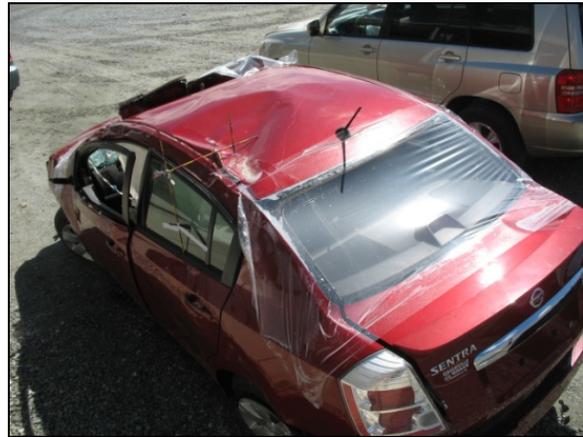
The 2010 Nissan's left, top and right planes sustained moderate damage as a result of this rollover (**Figure 3**). On the top plane, the direct contact damage began at the leading edge of the hood and extended rearward 423 cm (166.5 in) to the trailing edge of the trunk lid. Laterally, the direct damage extended across the full width of the Nissan, from the left roof side rail to the right roof side rail. The greatest vertical deformation was located on the roof over the rear left seating position, 46 cm (18.1 in) aft of the leading edge of the left rear door and 13 cm (5.1 in) inboard of the left roof side rail rubber trim strip. The residual vertical deformation measured 5 cm (2 in). The greatest lateral deformation was located on the left roof side rail adjacent to the rear left seating position 56 cm (22 in) aft of the leading edge of the left rear door. The residual lateral deformation measured 5 cm (2 in). The Collision Deformation Classification (CDC) assigned for the rollover event was 00TDDO2.

Figure 3: Rollover damage to the top plane of the Nissan.

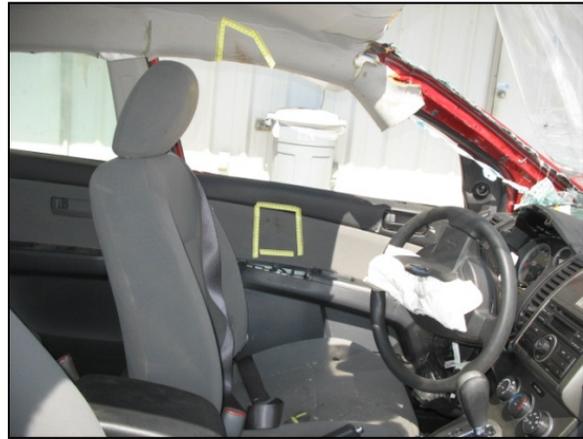
The Nissan sustained moderate severity interior damage that was attributed to passenger compartment intrusion, occupant contact and air bag deployment. There was a scuff mark that included body fluid and hair that measured 10 cm (3.9 in) wide and 8 cm (3.1 in) high on the left roof side rail. The contact scuff was located 17 cm (6.7 in) forward of the B-pillar. This contact was attributed to the left side of the driver's head. There was a scuff mark that included a small amount of body fluid on the upper rear quadrant of the left door panel, below the left IC and forward of the side impact air bag. This scuff mark measured 12 cm (4.7 in) in width and 11 cm (4.3 in) in height and was located 19 cm (7.5 in) forward of the rear edge of the door panel and 9 cm (3.5 in) below the window sill. This contact was attributed to the driver's left elbow. **Figure 4** depicts the occupant contact evidence observed during the SCI inspection. The passenger compartment intrusion is listed on the following table:

Figure 4: Left side occupant contact evidence in the Nissan.

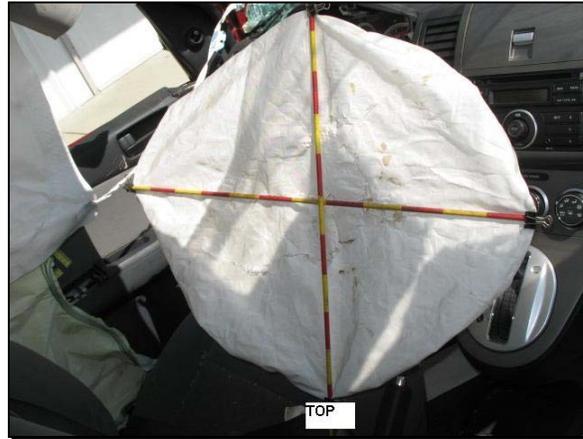
The driver's air bag was concealed within the center hub of the four-spoke steering wheel by a tri-flap design. The upper flaps were triangular in shape and measured 7 cm (2.8 in) in width and 4 cm (1.6 in) in height. The lower flap was 14 cm (5.5 in) in width at the upper tear seam, 9 cm (3.5 in) in width at the lower aspect and 9 cm (3.5 in) in height. The driver's air bag measured 60 cm (23.6 in) in diameter and was vented by two vent ports located on the back side of the air bag at the 10 and 2 o'clock positions. The air bag was not tethered. There were droplets of post-crash body fluid on the face of the air bag in the upper and lower left quadrants of the air bag. The driver's air bag was cut by the EMS during the windshield removal. The series of small cuts extended from the upper right quadrant near the 1 o'clock position to the left side of the air bag, near the 9 o'clock position. The face of the driver's air bag is depicted in **Figure 5**.

Figure 5: Face of the driver's air bag.

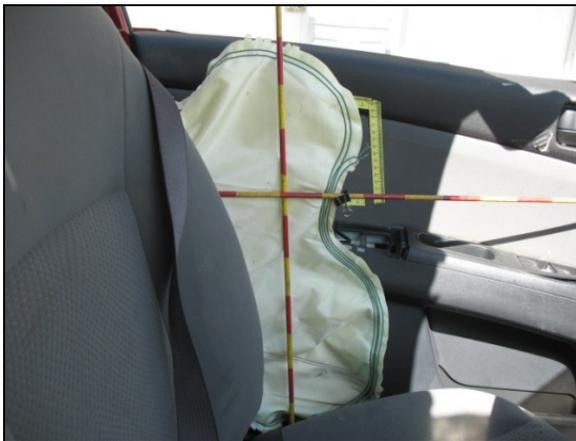
The side impact air bag deployed from a 34 cm (13.4 in) long seam in the outboard aspect of the front left seat back. The air bag measured 52 cm (20.5 in) in height and was “kidney-shaped”. The forward edge of the air bag had a double curve and measured 20 cm (7.9 in) forward of the seat back at the upper and lower aspects and 16 cm (6.3 in) forward at the center. The left side air bag (**Figure 6**) was free from contact evidence or damage.

Figure 6: Inboard aspect of left side air bag.

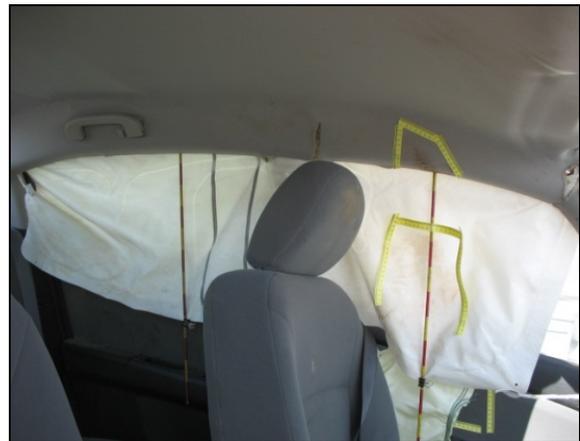
The left IC air bag deployed from the left roof side rail. The IC measured 138 cm (54.3 in) in length. It was 42 cm (16.5 in) in height at the front and rear seating positions. Vertically, the curtain air bags extended below the belt line at each outboard position. The left IC provided protection from the upper aspect of the A-pillar to the C-pillar area. The open triangular area located forward of the IC measured 29 cm (11.4 in) high and 43 cm (16.9 in) in length along the window sill. The left IC was tethered to the left A- and C-pillars by straps 55 cm (21.7 in) and 10 cm (3.9 in) in length, respectively. The left IC is depicted in **Figure 7**.

There was a scuff mark on the inboard side of the left IC attributed to the driver’s left shoulder, and a corresponding abrasion on the outboard side of the left IC from contact with the ground. These marks were 18 cm (7.1 in) in length and 19 cm (7.5 in) in height and were located 20 cm (7.9 in) aft of the forward edge of the IC and 9 cm (3.5 in) above the lower edge of the air bag. This contact resulted in the contusion to the driver’s left upper arm.

Figure 7: View of the left IC air bag.
