**CALSPAN ON-SITE SIDE IMPACT INFLATABLE OCCUPANT
PROTECTION SYSTEM CRASH INVESTIGATION
SCI CASE NO.: CA10036**

VEHICLE: 2009 NISSAN VERSA

LOCATION: NORTH CAROLINA

CRASH DATE: SEPTEMBER 2010

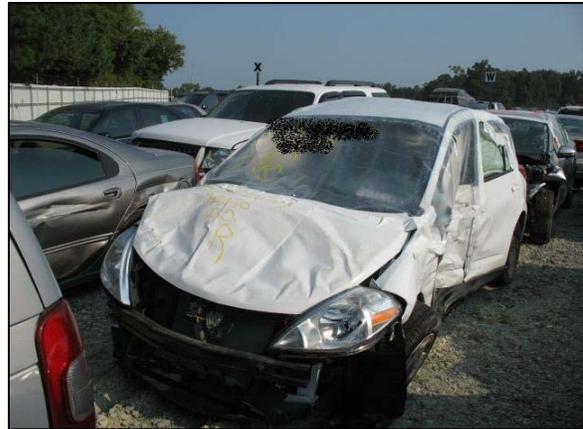
Figure 1: Left oblique view of the 2009 Nissan Versa.

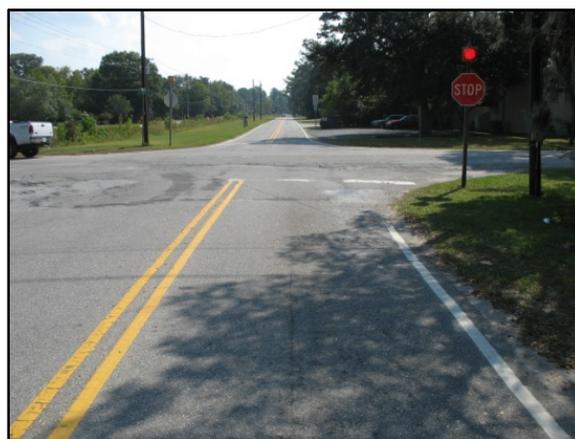
Figure 2: Eastbound pre-crash trajectory view of the Nissan.

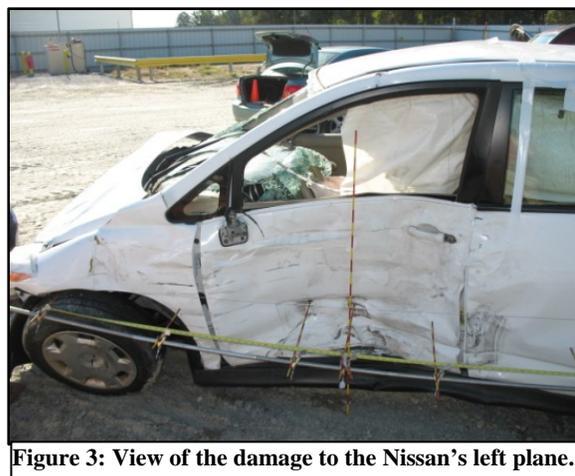
The left plane of the Nissan sustained moderate damage in the initial impact (Event 1). The direct contact damage began 88 cm (34.7 in) forward of the left rear axle, and extended forward 168 cm (66.1 in) to the left front wheel area. The combined direct and induced damage began 16 cm (6.3 in) forward of the left rear axle and extended forward 255 cm (100.4 in). The maximum crush was located 151 cm (59.4 in) forward of the left rear axle and measured 41 cm (16.1 in). A residual crush profile was measured at the lower door level and was as follows: C1 = 0 cm, C2 = 9 cm (3.5 in), C3 = 26 cm (10.2 in), C4 = 33 cm (13 in), C5 = 9 cm (3.5 in), C6 = 0 cm. The Door Sill Differential was 18 cm (7.1 in) with a max crush height of 41 cm (16.1 in). **Figure 3** depicts the initial impact damage to the Nissan. The left doors were both jammed closed as a result of the left side deformation. The Collision Deformation Classification (CDC) assigned for this impact was 10LYEW3.

Figure 3: View of the damage to the Nissan's left plane.

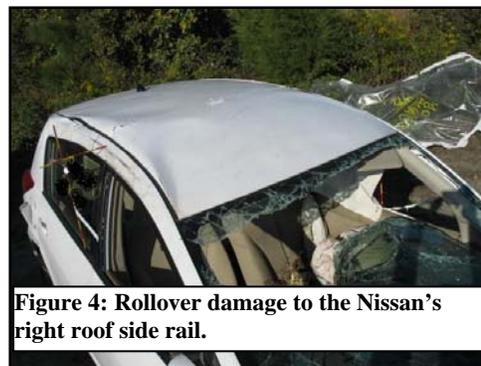
Subsequent to the initial impact, the Nissan was involved in a one-quarter turn rollover onto its right side (Event 2). The direct contact damage began at the forward edge of the right front fender and extended rearward 352 cm (138.6 in) to the right rear tail light area. Vertically, the direct damage extended the full height of the right side, 135 cm (53.2 in) from the door sill to the roof side rail. The maximum vertical and lateral deformation (**Figure 4**) were located on the right roof side rail 9 cm (3.5 in) rear of the junction between the closed right front and rear doors

The residual vertical deformation was 2 cm (0.8 in). The residual lateral deformation was 4 cm (1.6 in). The CDC of the rollover was 00RDAO2.

Figure 4: Rollover damage to the Nissan's right roof side rail.

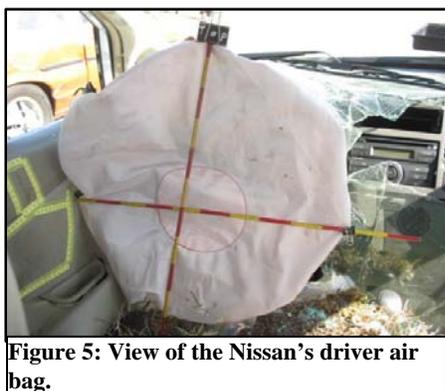
Figure 5: View of the Nissan's driver air bag.

The driver's frontal air bag (**Figure 5**) measured 52 cm (20.5 in) in diameter in its deflated state. It was tethered by two straps at the 12 and 6 o'clock positions of a circular tether sewn to the face of the air bag that measured 16 cm (6.3 in) in diameter. The driver's frontal air bag was vented by two vent ports on the upper rear of the air bag at the 10 and 2 o'clock positions. There were multiple droplets of blood measuring less than 1 cm (0.4 in) in diameter dispersed on the right hemisphere of the face of the air bag. The driver's frontal air bag was not damaged.

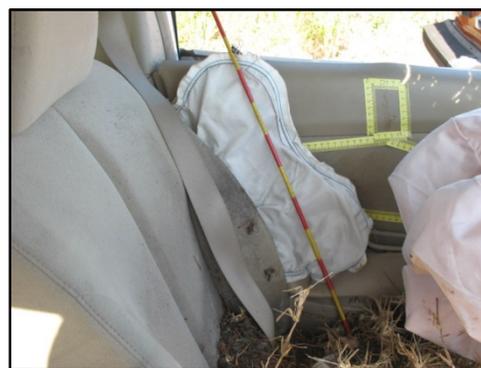
The deployed side impact air bag (**Figure 6**) measured 38 cm (15 in) in height. The kidney-shaped bag measured 14 cm (5.5 in) and 16 cm (6.3 in) in width at the upper and lower aspects, respectively, and 11 cm (4.3 in) in width at the center. The left side air bag deployed from a 32 cm (12.6 in) tear seam in seat back. There was no damage or occupant contact evidence present on this air bag.

Figure 6: Left side air bag in the Nissan.

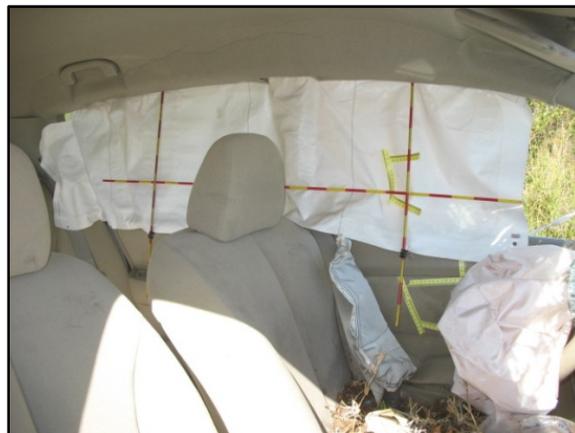
The deployed left IC measured 150 cm (59 in) in length. **Figure 7** depicts the inboard side of the left IC. It measured 40 cm (15.7 in) in height at the front and rear seating positions and was tethered to the left A-pillar by a webbing strap 40 cm (15.7 in) in length. Vertically, the IC air bag extended below the belt line at the front and rear outboard seating positions. The left IC provided head protection from the left C-pillar forward to a location 38 cm (15 in) aft of the left A-pillar. The IC was labeled with the identification “6105534C SI/PA 6.6”. There was a scuff mark attributed to the driver’s head on the inboard side of the left IC. This scuff mark was located 26-35 cm (10.2-13.8 in) rear of the front edge of the IC and 12-22 cm (4.7-8.7 in) above the lower edge of the IC.

Figure 7: View of the inboard side of the Nissan’s left IC.

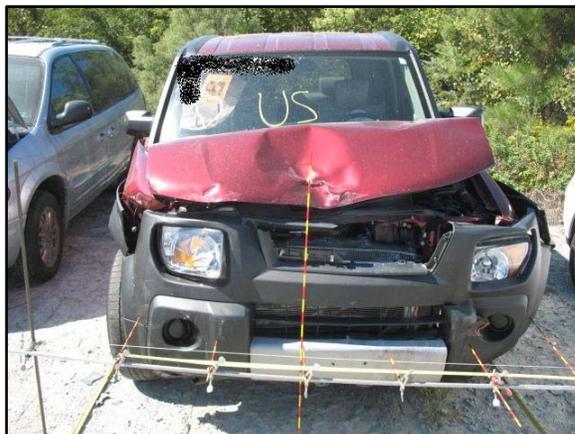
The front plane of the Honda sustained moderate severity damage as a result of the Event 1 impact with the Nissan (**Figure 8**). The direct contact damage extended across the entire 168 cm (66.1 in) end-width of the front bumper. The maximum crush was located at C2, 49 cm (19.3 in) left of the vehicle centerline. A residual crush profile was measured at the bumper level and was as follows: C1 = 23 cm (9.1 in), C2 = 25 cm (9.8 in), C3 = 11 cm (4.3 in), C4 = 10 cm (3.9 in), C5 = 15 cm (5.9 in), C6 = 8 cm (3.1 in). The front bumper height was 37 cm (14.6 in). The right and left wheelbases were shortened by 9 cm (3.5 in) and 5 cm (2 in), respectively. The forward aspects of the frame rails were shifted to the left by the lateral forces exerted during the

initial impact. The right frame rail shifted left 15 cm (5.9 in) and the left frame rail shifted left 22 cm (8.7 in). The left aspect of the windshield was fractured at the left A-pillar; the fracture extended laterally across to the midpoint of the windshield. All other windows were undamaged post-crash. All doors remained closed during the crash and were operational post-crash. The CDC assigned for this impact was 82FDEW2.

Figure 8: View of the frontal damage to the Honda.
