**CALSPAN ON-SITE SIDE IMPACT INFLATABLE OCCUPANT
PROTECTION SYSTEM CRASH INVESTIGATION
SCI CASE NO.: CA10038**

VEHICLE: 2010 NISSAN VERSA SEDAN

LOCATION: NORTH CAROLINA

CRASH DATE: OCTOBER 2010

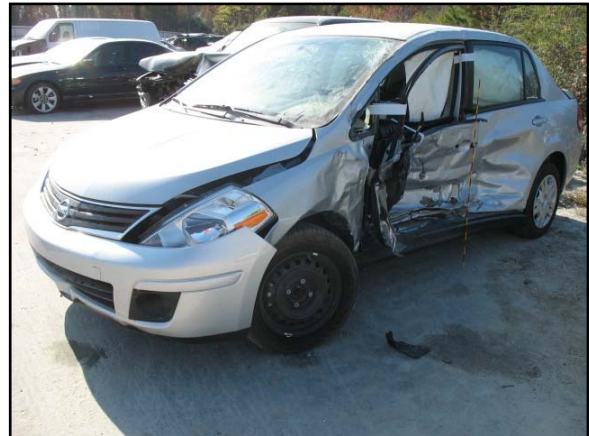
Figure 1: Left side view of the 2010 Nissan Versa.

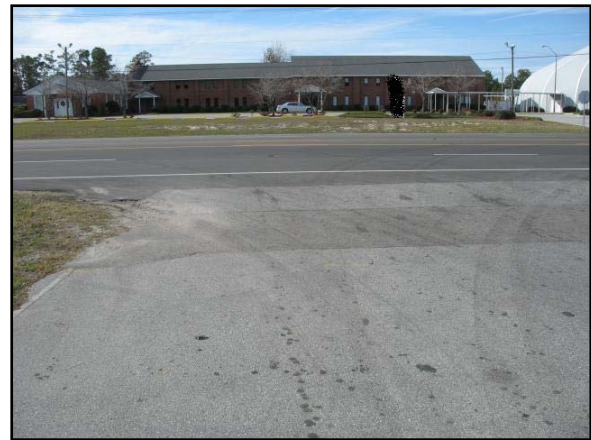
The driver of the Nissan was traveling westbound on the parking lot driveway, on a trajectory toward the roadway. Based on the EDR data, the Nissan was initially stopped. The driver then accelerated the vehicle forward for five seconds pre-crash. The throttle pedal position recorded one second (T-1) prior to Algorithm Enable (AE) was 44 percent. The brake pedal switch was recorded as “Off” for all 5 seconds of recorded pre-crash data. The Nissan had accelerated to a speed of 18 km/h (11 mph) at AE. The driver of the Toyota was operating his vehicle northbound in lane two of the five-lane roadway. The Toyota’s EDR was not supported with pre-crash data; therefore speed and pedal positions are unknown. **Figure 2** depicts the Nissan’s approach to the roadway. The driver of the Nissan entered the roadway and the initiated a left turn across the travel; path of the Toyota.

Figure 2: Pre-crash trajectory of the Nissan.

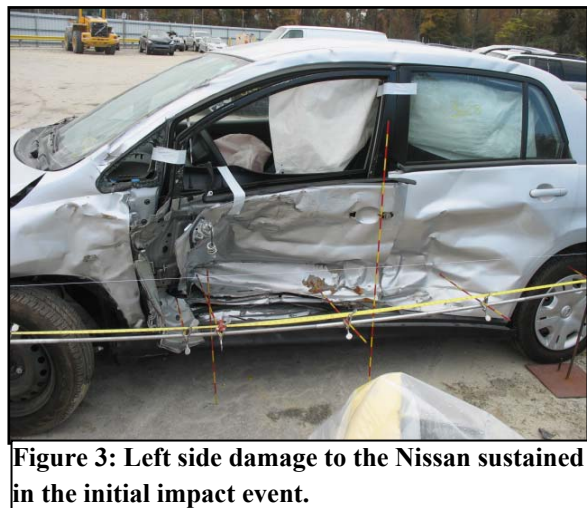
The left side of the Nissan sustained moderate severity damage from the initial impact with the Toyota (**Figure 3**). The left front door of the Nissan was repositioned to the vehicle for the damage measurements. The direct contact damage began 55 cm (21.7 in) forward of the left rear axle and extended forward 174 cm (68.5 in). The maximum crush was 40 cm (15.7 in), located at the forward aspect of the left front door, 182 cm (71.7 in) forward of the left rear axle. The combined direct and induced damage (Field L) began 7 cm (2.8 in) forward of the left rear axle and extended 312 cm (122.8 in) forward. The residual crush profile was measured at the lower door level and was as follows: C1 = 0 cm, C2 = 17 cm (6.7 in), C3 = 25 cm (9.8 in), C4 = 17 cm (6.7 in), C5 = 1 cm (0.4 in), C6 = 0 cm.

The sill height of the Nissan was 28 cm (11 in). The maximum crush height was 51 cm (20.1 in), and the Door Sill Differential (DSD) measured 33 cm (13 in). The damage algorithm of the WinSMASH program was used to calculate the severity of the crash (delta-V). The total delta-V for the Nissan was 35 km/h (21.8 mph). The Nissan's longitudinal and lateral components were -18 km/h (-11.2 mph) and 30 km/h (18.6 mph), respectively. The left front door deformed and intruded into the passenger compartment. Both left side doors were jammed shut post-crash. The windshield was fractured by the impact forces, with more significant damage extending vertically along the left A-pillar. The left front door glazing was disintegrated by the impact forces. The left rear window and quarter glazing were undamaged. Induced damage was also present on the left roof side rail, extending from the windshield header to the C-pillar area. The left wheelbase was not reduced in length. Direct damage attributed to the front plane of the Toyota was present on the left A-pillar of the Nissan which extended 26 cm (10.2 in)

above the belt line. The Collision Deformation Classification (CDC) assigned for this impact was 10LPAW3.

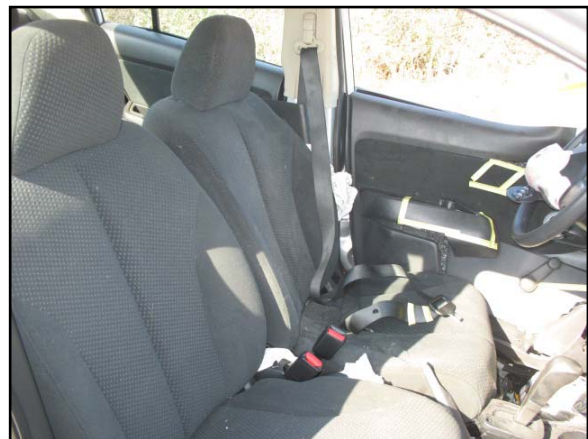
The driver's seat cushion was compressed laterally 4 cm (1.6 in) as a result of the intrusion of the front left door. The intrusion deformed the driver's seat track 6 cm (2.4 in) to the right. **Figure 4** depicts the damage to the front left seat and the intrusion into the driver's seating position.

Figure 4: Front left seat damage and passenger compartment intrusion in the Nissan.

The A-pillar of the Nissan intruded laterally 2 cm (0.8 in). The maximum crush to the Nissan was located aft of the A-pillar, and the greatest extent of interior lateral intrusion was to the forward lower quadrant of the front left door. This intrusion measured 30 cm (11.8 in). The lateral intrusion to the rear lower quadrant of the front left door measured 12 cm (4.7 in), and 15 cm (5.9 in) at the left front door sill. The driver's seat intruded 6 cm (2.4 in) to the right. The B-pillar intruded laterally 7 cm (2.8 in). In the second row, the forward lower quadrant of the left door intruded laterally by 6 cm.

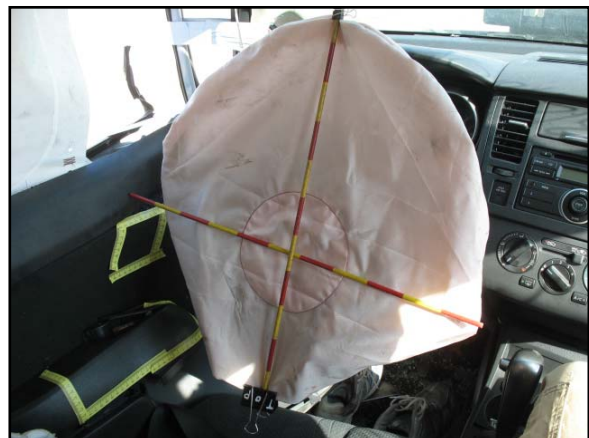
The driver's frontal air bag (**Figure 5**) was 60 cm (23.6 in) in diameter in its deflated state. It was tethered by two tethers at the 12 and 6 o'clock positions of a circular tether seam in the center of the face of the air bag that measured 16 cm (6.3 in) in diameter. The driver's frontal air bag was vented by two vent ports on the upper rear aspect of the air bag at the 10 and 2 o'clock positions. Due to the position of the steering wheel, the driver's frontal air bag was nearly inverted at the time of the inspection. The air bag was labeled with the nomenclature:

Figure 5: Driver's frontal air bag in the Nissan.

The face of the driver's air bag contained two scuff marks attributed to deployment transfers. One extended in a diagonal line from 6-10 cm (2.4-3.9 in) below the upper aspect of the air bag and 4-9 cm (1.6-3.5 in) right of the vertical centerline of the air bag. The second was located 19-23 cm (7.5-9.1 in) above the lower aspect of the air bag and 10-15 cm (3.9-5.9 in) right of the vertical centerline of the air bag. There were multiple droplets of blood concentrated in the upper left quadrant of the front of the air bag, 3-7 cm (1.2-2.8 in) below the upper aspect of the air bag and 6 cm (2.4 in) left of the vertical centerline of the air bag.

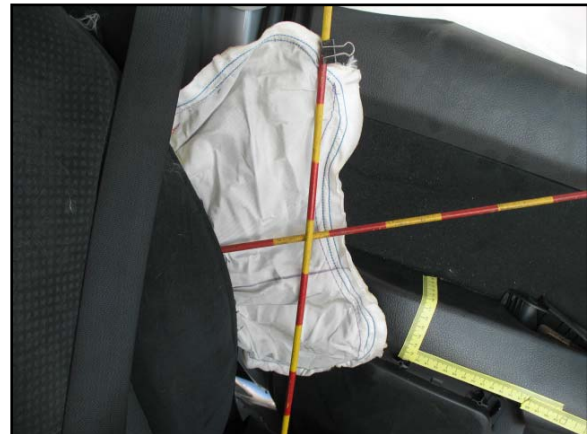
Figure 6: Driver's side impact air bag in the Nissan.

The deployed side impact air bag (**Figure 6**) measured 38 cm (15 in) in height. The forward edge of the bag had a curved shape and measured 16 cm (6.3 in) and 15 cm (5.9 in) in width at the upper and lower aspects, respectively, and 10 cm (3.9 in) in width at the center. The left side air bag deployed from a 32 cm (12.6 in) tear seam in the outboard aspect of the left seatback.

There was no damage or occupant contact evidence present on this air bag.

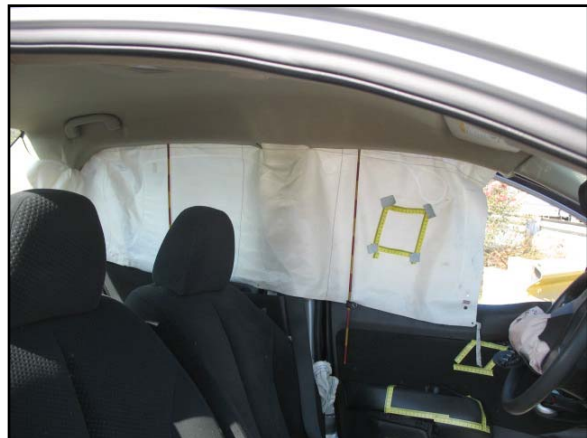
The deployed left IC measured 148 cm (58.3 in) in length. It measured 42 cm (16.5 in) in height at the front and rear seating positions and was tethered to the left A-pillar by a webbing strap that was 38 cm (15 in) in length. Vertically, the IC air bag extended below the belt line at the front and rear outboard seating positions. The left IC provided head protection from the left C-pillar forward to a location 38 cm (15 in) aft of the left A-pillar. The IC was labeled with the nomenclature "6105534D SI/PA 6.6". There was a scuff mark attributed to the driver's head on the inboard side of the left IC. This scuff mark was located 16-26 cm (6.3-10.2 in) rear of the front edge of the IC and 14-24 cm (5.5-9.4 in) above the lower edge of the IC. **Figure 7** depicts the inboard side of the left IC.

Figure 7: Inboard side of the left IC, including driver's head contact in the Nissan.

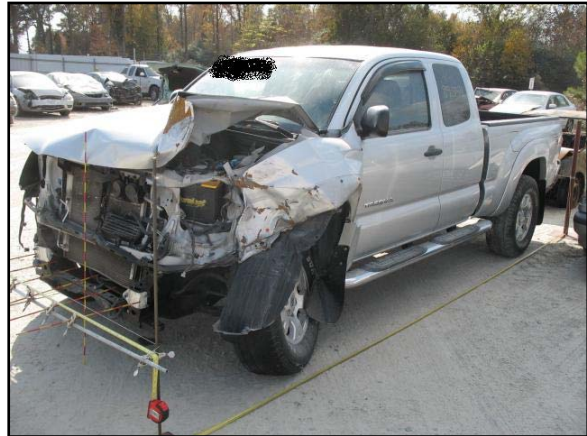
The front plane of the Toyota sustained moderate severity damage as a result of the impact with the Nissan (**Figure 8**). The bumper and front fascia separated from the vehicle during this crash. There was direct damage present on the lower radiator support, the leading edge of the hood and the left front fender. The direct contact damage and Field L were measured between the frame rail ends of the vehicle. The Field L width was 95 cm (37.4 in). The maximum crush was based on the deformation to the lower radiator support and was located at C3, 38 cm (15 in) right of the left frame rail end. The maximum crush measured 20 cm (7.9 in). A crush profile based on the positions of the frame rail ends and the deformation to the lower radiator support was documented and was as follows: C1 = 1 cm (0.4 in), C2 = 17 cm (6.7 in), C3 = 20 cm (7.9 in), C4 = 19 cm (7.5 in), C5 = 15 cm (5.9 in), C6 = 0 cm. The total delta V for the Toyota was 22 km/h (13.7 mph). The Toyota's longitudinal and lateral components were -21 km/h (-13.1 mph) and -8 km/h (-5 mph), respectively. The CDC assigned for this impact was 01FDEW1.

Figure 8: Frontal and left side damage to the
