# INDIANA UNIVERSITY

## ON-SITE OFFICE OF DEFECTS INVESTIGATION AIR BAG NON-DEPLOYMENT INVESTIGATION

CASE NUMBER - IN10041  
LOCATION - MARYLAND  
VEHICLE - 2007 FORD ESCAPE XLT  
CRASH DATE - October 2010

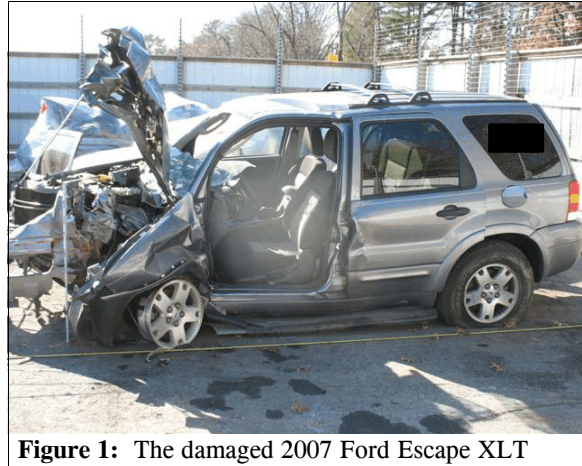
**Figure 1:** The damaged 2007 Ford Escape XLT

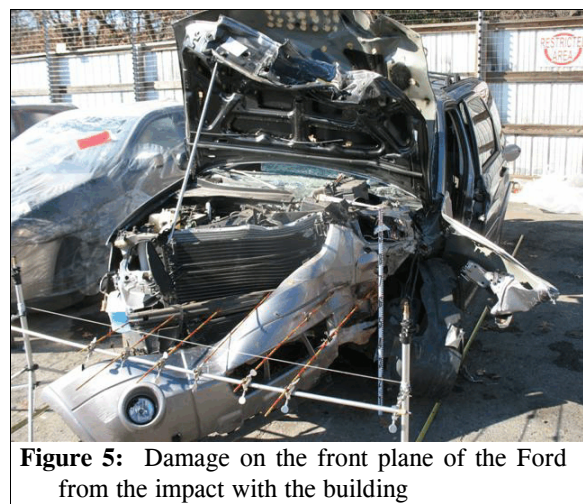
**Figure 5:** Damage on the front plane of the Ford from the impact with the building

**Exterior Damage Event 3:** The Ford sustained front plane damage during the impact with the building. The left portion of the front bumper, the left headlamp/turn signal, left front fender, and the hood were directly damaged. The direct damage began at the front left bumper corner and extended 50 cm (19.7 in) across the bumper. The crush measurements were taken at the bumper level and the maximum residual crush was 66 cm (26 in) occurring at  $C_1$  (**Figure 7**). The left wheelbase was reduced 42 cm (16.9 in). The right wheelbase was extended 5 cm (2 in). The induced damaged involved the left A-pillar, roof, left roof side rail, left front door, and the right front door.

**Damage Classification Event 3:** The CDC was 12FLEW3 (0 degrees). The WinSMASH program could not be used to calculate Delta V since the brick wall was displaced. However, the Barrier algorithm of WinSMASH was used to calculate an Barrier Equivalent Speed (BES) based on the front crush. The calculated BES was 57 km/h (35.4 mph).

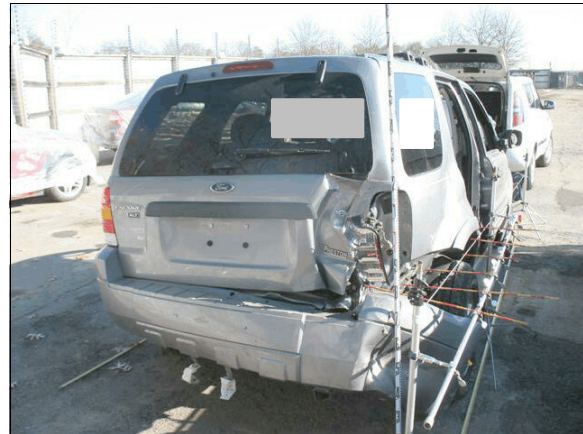
**Exterior Damage Event 4:** The right quarter panel was damaged during the impact with the trash can. The direct damage from this impact was masked by the damage from the impact with the brick support column. No crush measurements could be determined.

**Figure 6:** Damage on the right quarter panel from the impacts with the trash can and brick support column

**Damage Classification Event 4:** The CDC was 03RBE999 (90 degrees). Since there was overlapping damage, columns 6 and 7 of the CDC were coded unknown. The severity of the damage was minor.

**Exterior Damage Event 5:** The Ford sustained damage on the right quarter panel during the impact with the brick support column. The quarter panel and right rear corner of the back bumper fascia were directly damaged. The direct damage began 38 cm (15 in) rear of the right rear axle and extended 40 cm (15.7 in) rearward on the right plane. The crush measurements were taken at the mid-quarter panel level and the maximum residual crush was 7 cm (2.8 in) occurring at C<sub>2</sub>. The induced damage involved the quarter panel and the back bumper fascia.

**Damage Classification Event 5:** The CDC was 03RBEE1 (90 degrees). Since the support column was displaced by the impact, the Barrier algorithm of the WinSMASH program was used to calculate and Barrier Equivalent Speed (BES) based on the right plane crush. The calculated BES was 5 km/h (3.1 mph).

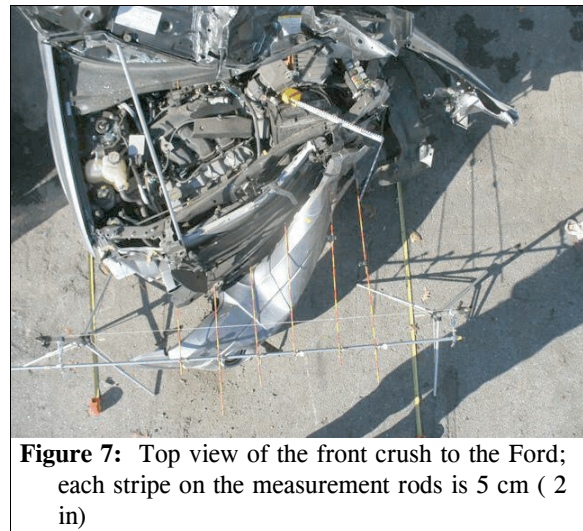
**Figure 7:** Top view of the front crush to the Ford; each stripe on the measurement rods is 5 cm ( 2 in)

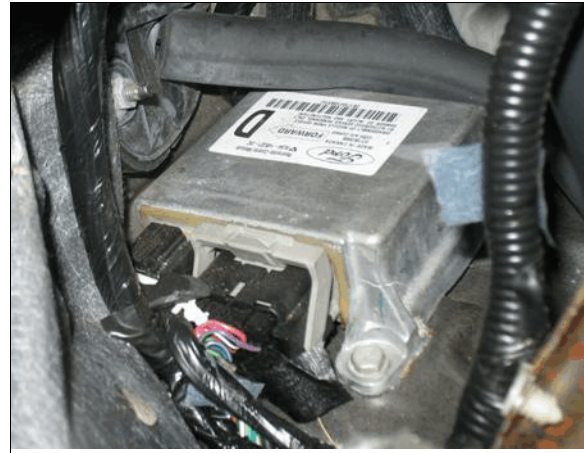
**Air Bag Related Components:** The Ford's Restraint Control Module (RCM), which contains the EDR was harvested from the vehicle and sent to NHTSA headquarters for imaging by the manufacturer. The RCM and the electrical connections (**Figure 8**) were examined prior to removal. There was no damage to the RCM and the electrical wires and connectors that were visible were intact and undamaged. The frontal air bag satellite sensor (**Figure 9**) was also examined. The component numbers on the sensor were E7934HKG844Y and 61-14-14B006-AB. The sensor was located on the upper center radiator support. Its location placed it inboard of the area of the direct frontal damage. There was no visible damage to the sensor. The electrical connections and wires that were visible were intact and undamaged. The Ford's battery and power distribution box (**Figure 10**) were located within the engine compartment on the driver's side front corner. The power distribution box contains the high current fuses for the vehicle's main electrical systems. The battery and power distribution box were in the area of the direct frontal damage. The

**Figure 8:** The condition of the Ford's ACM prior to removal from the vehicle

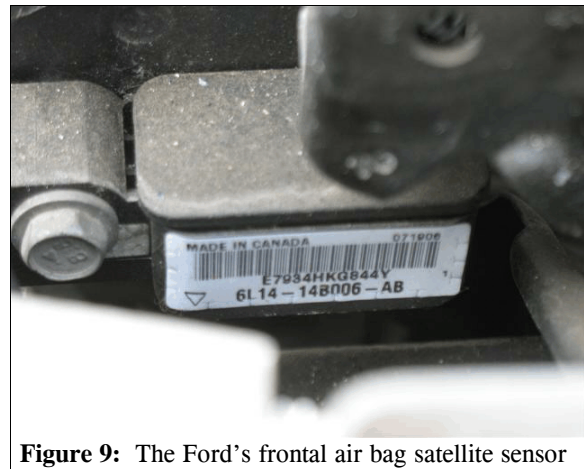
**Figure 9:** The Ford's frontal air bag satellite sensor

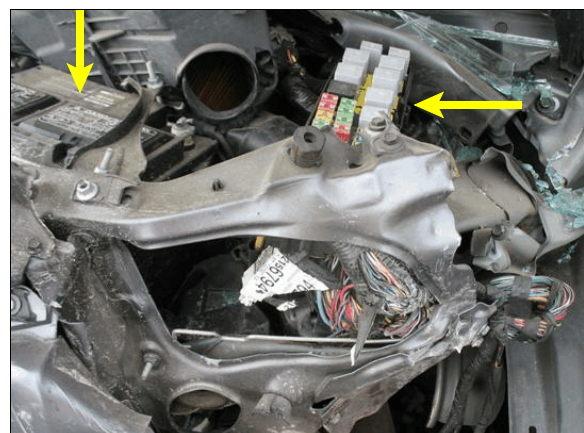
**Figure 10:** The battery and power distribution box were located in the front left corner of the Ford's engine compartment in the area of the direct damage

battery was displaced but it was not fractured. The power distribution box and electrical wiring were damaged.

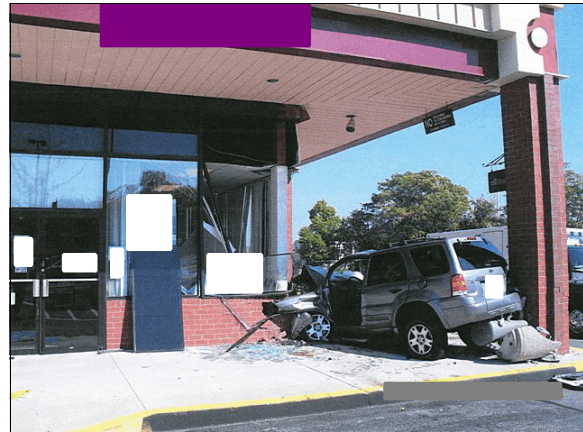
**Driver's Frontal Air Bag Non-Deployment Discussion:** Photographs of the damaged building (Figures 11 and 12) showed that the brick wall was partially displaced producing a small hole in the wall. There was a steel support column at the corner of the building behind the brick wall, which was indirectly engaged by the vehicle as the brick wall was displaced. It is possible that the yielding of the brick wall was a factor in the non-deployment of the driver's frontal air bag. It is this contractor's understanding that the RCM must make the decision to deploy the frontal air bags within approximately 40-50 ms following Algorithm Enable (AE). It's possible that due to the yielding of the brick wall the vehicle's acceleration did not reach the deployment threshold within this time frame. Additional factors were that the driver's seat was in the forward track position and the driver was restrained by the lap-and-shoulder belt.

**Figure 11:** View northeast to final rest position of the Ford and the damage to the building from the impact

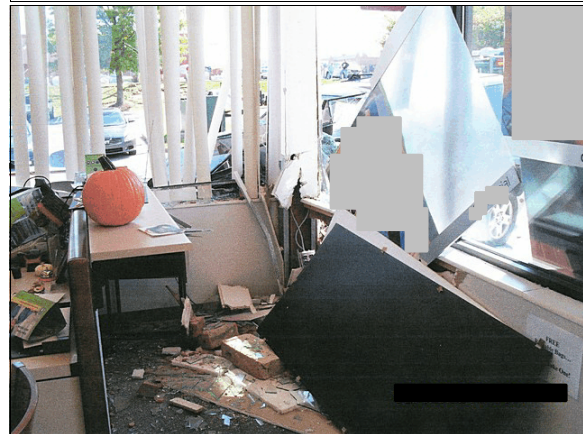
**Figure 12:** On-scene photo of the interior damage to the building from the impact by the Ford; view to southeast
