CALSPAN ON-SITE CHILD RESTRAINT SYSTEM CRASH INVESTIGATION

SCI CASE NO.: CA11001

VEHICLE: 2007 HONDA ODYSSEY EX-L

CRASH DATE: DECEMBER 2010

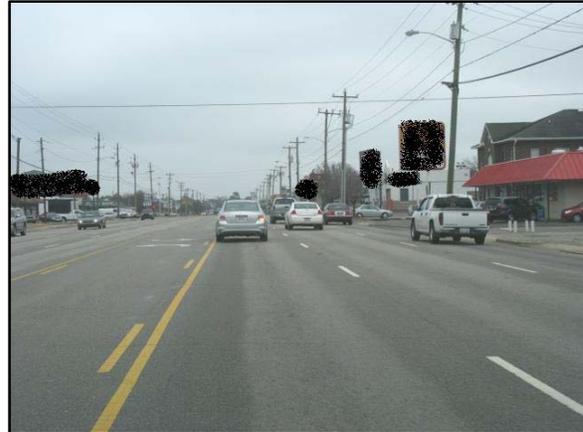
Figure 2: Eastbound pre-crash trajectory view of the Honda.

(12.5 ft). **Figure 2** depicts the eastbound trajectory view of the Honda. Concrete curbs bordered both sides of the road and measured 16 cm (6.3 in) in height. These barrier curbs transitioned to and from mountable curbs for parking lot access. Asphalt and concrete parking lots extended outboard of the curb line in this urban area. A three-lane, undivided, north/south roadway intersected the main roadway from the south. The southbound lane was 4.4 m (14.4 ft) in width. The two northbound lanes were designated as a left-turn lane and a right-turn lane, respectively. The left turn lane measured 3 m (9.8 ft) in width and the right turn lane measured 3.7 m (12.1 ft) in width. Consistent with the main roadway, the intersecting roadway was bordered by 16 cm (6.3 in) concrete curbs that transitioned to mountable curbs where necessary to accommodate the parking lot access. The intersecting roadway had a level grade. Access to the main roadway was controlled by a stop sign for the northbound traffic. The speed limit on both roadways was 72 km/h (45 mph). A Scene Diagram is included at the end of this technical report.

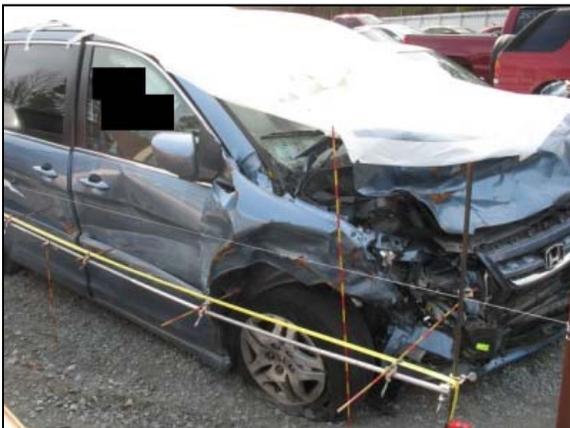
Figure 3: Right plane damage to the Honda resulting from Events 1.

Figure 3 is a side view depicting the damage to the right plane of the Honda. The impact resulted in deformation of the fender with continuous engagement across the right doors to the rear axle area. The direct and induced damage began 54 cm (21.3 in) aft of the right rear axle and extended forward 402 cm (158.3 in) to the front right corner. A residual crush profile measured at mid-door level produced the following results: C1 = 0 cm, C2 = 6 cm (2.4 in), C3 = 3 cm (1.2 in), C4 = 8 cm (3.1 in), C5 = 0 cm, C6 = 36 cm (14.2 in). The C5 crush measurement was located within the front wheel opening and thus was zero. The maximum crush was located at C6, the right front bumper corner. The Classification Deformation Classification (CDC) assigned to this damage pattern was 01RDEW3. The Damage Algorithm of the WinSMASH program was used to calculate the severity of the initial impact (delta-V). The total calculated delta-V for the Honda was 16 km/h (9.9 mph). Corresponding longitudinal and lateral delta-V components were -14 km/h (-8.7 mph) and -8 km/h (-5.0 mph), respectively.

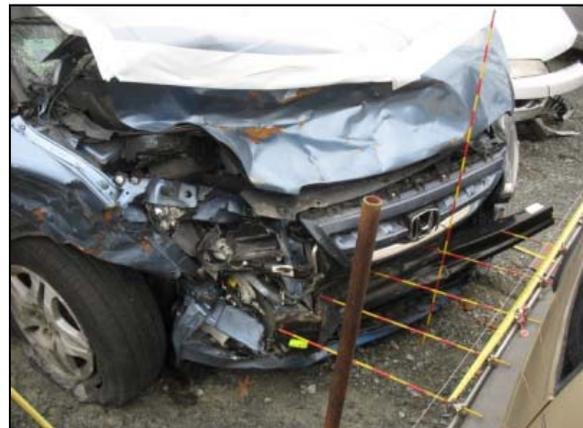
Figure 4: Right front oblique view of the Honda's frontal plane.

Figure 4 is an oblique view of the damage to the Honda's frontal plane resultant to the impact with the Pontiac (Event 2). The bumper fascia separated during the impact, exposing the reinforcement bar. The direct contact damage began 25 cm (10.0 in) left of center and extended 114 cm (44.9 in) laterally to the right corner. The damage pattern spanned the entire 178 cm (70.0 in) front end width.

A residual crush profile was documented at mid-level across the bumper reinforcement with a Field L of 105 cm (41.3 in), which produced the following measurements: C1 = 0 cm, C2 = 2 cm (0.8 in), C3 = 32 cm (12.6 in), C4 = 37 cm (14.6 in), C5 = 35 cm (13.8 in), C6 = 29 cm (11.4 in). The maximum crush on the front plane was located at C4, 11 cm (4.3 in) right of the vehicle centerline. The right wheelbase was shortened 23 cm (9.1 in). The CDC assigned to this damage pattern was 01FZEW2. The total delta-V of the Honda calculated by the WinSMASH program was 41 km/h (25.4 mph). The longitudinal and lateral delta-V components were -39 km/h (-24.2 mph) and -14 km/h (-8.7 mph), respectively.

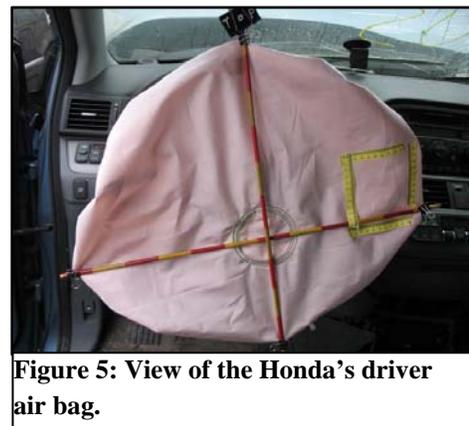
Figure 5: View of the Honda's driver air bag.

The driver reported that the Honda's frontal air bag had been replaced due to a previous frontal deployment crash. The driver's air bag was concealed within an H-configuration module mounted to the center hub of the four-spoke steering wheel. The upper flap was 15 cm (5.9 in) in width at the tear seam and 8 cm (3.1 in) in height. The lower flap tapered from 15 cm (5.9 in) in width at the tear seam to 10 cm (3.9 in) in width at the lower aspect, and was 9 cm (3.5 in) in height. The driver's air bag measured 56 cm (22 in) in diameter in its deflated state. It was vented by two vent ports on the upper rear aspect of the air bag at the 10 and 2 o'clock positions. There were two internal tethers that attached to a 9 cm (3.5 in) circular tether seam at the center of the face of the air bag. The front view of the driver's air bag is depicted in **Figure 5**.

There was a scuff mark on the face of the air bag attributed to the driver's chest. This scuff mark extended vertically 8 cm (3.1 in) above the horizontal centerline of the air bag to a point 1 cm (0.4 in) below the horizontal centerline. It extended laterally 16-22 cm (6.3-8.7 in) right of the vertical centerline of the air bag. There was an imprint from contact with the lower aspect of the steering wheel rim on the lower rear aspect of the air bag. This imprint was attributed to the driver's abdominal loading of the steering wheel rim through the air bag. It was located 5 cm (2 in) above the lower edge of the air bag and measured 4 cm (1.6 in) in height and 16 cm (6.3 in) in width, following the curvature of the steering wheel rim.

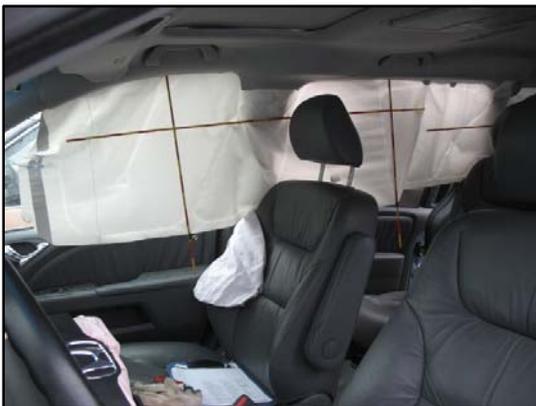
Figure 6: View of the Honda's right IC at front and second row seating positions.

The Honda was also equipped with roof side rail-mounted side impact Inflatable Curtain (IC) air bags. The right IC air bag deployed from the right roof side rail. It measured 246 cm (96.9 in) in length and 48 cm (18.9 in), 42 cm (16.5 in) and 39 cm (15.4 in) in height at the front, second, and third rows respectively. Vertically, the IC extended below the belt line at each outboard seating position. The right IC provided protection from the D-pillar forward to a location 20 cm (7.9 in) aft of the A-pillar. The open area between the right IC and A-pillar measured 20 cm (7.9 in) in length, 18 cm (7.1 in) in height at the A-pillar and 33 cm (13 in) in height at the forward edge of the IC. The right IC was tethered to the A-pillar by a webbing strap 14 cm (5.5 in) in length. The IC was labeled with the identifying nomenclature: *ID-6082110C SI/PA 6.6*. The right IC is depicted in **Figures 6 and 7**. It was free from damage or occupant contact evidence. The left IC did not deploy in this crash sequence.

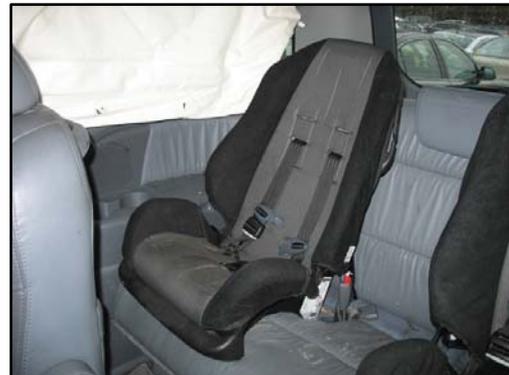
Figure 8: Rear right CRS, as found installed in the Honda.

Figure 8 depicts the third row right CRS as it was found installed in the vehicle. This CRS was installed using the lap and shoulder portion of the Honda's safety belt. The belt was routed through the forward facing belt path slots on the rear of the CRS. Prior to the crash during the CRS installation, the belt had been fully extended to place the retractor in the ALR mode. The webbing was then back-fed into the retractor to install the CRS. This seat position was not equipped with LATCH lower anchors; however, the inboard LATCH hook of the CRS was attached to the right

lower anchor of the center seating position. The LATCH belt was then tightened against the small strap that was used to retain the LATCH belt with the CRS. The outboard CRS LATCH hook was left unattached. The top tether was routed over the head restraint and down to the attachment point on the rear aspect of the seat. During the SCI inspection, it was observed that the longitudinal and lateral movement of the CRS (measured at the belt path) was 6 cm (2.4 in) and 9 cm (3.5 in), respectively. The internal 5-point harness was installed in the middle slot of three vertical options.

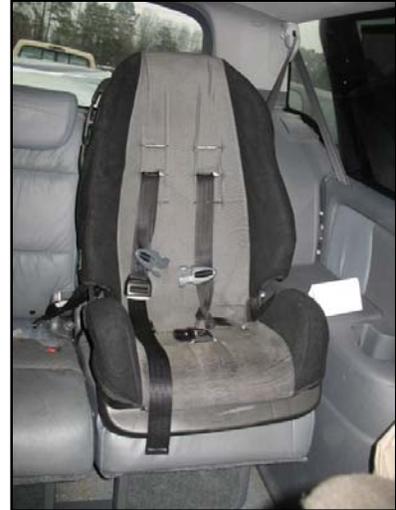
Figure 9: Rear left CRS, as found installed in the Honda.

Figure 9 depicts the rear left CRS as it was found installed in the vehicle. The third row left CRS was also installed using the vehicle's lap and shoulder belt with its retractor switched to the ALR mode. The safety belt was routed through the forward facing belt path on the rear of the CRS. In a manner similar to that of the right CRS, the inboard LATCH hook of this CRS was connected to the left lower anchor of the center seating position and tightened. The top tether was routed over the head restraint and attached to the top tether anchor point of the rear left seat. The longitudinal and lateral movement of the CRS measured 8 cm (3.1 in) in each direction.

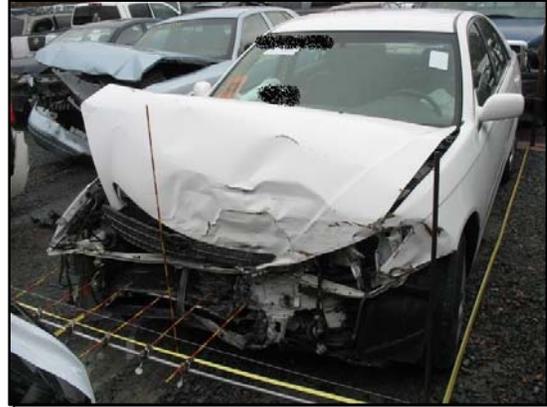
Figure 10: Frontal damage to the Toyota.

The front plane of the Toyota sustained moderate damage as a result of the Event 1 impact with the Honda. The combined width of the direct and induced damage extended across the full 148 cm (58.2 in) width of the front plane. The frame rail ends were shifted laterally to the right as a result of the impact force that was located within the 10 o'clock sector. The left and right frame shift measured 34 cm (13.4 in) and 33 cm (13 in), respectively. The front fascia and bumper support bar separated during the impact.

A residual crush profile was documented between the frame rail ends and across the lower radiator support (**Figure 10**). The profile produced the following measurements: C1 = 28 cm (11.0 in), C2 = 17 cm (6.7 in), C3 = 16 cm (6.3 in), C4 = 11 cm (4.3 in), C5 = 8 cm (3.1 in), C6 = 13 cm (5.1 in). The maximum crush was located at C1. The Damage Algorithm of the WinSMASH program was used to calculate the severity of the crash. The total calculated delta-V of the Toyota was 24 km/h (14.9 mph). The Toyota's longitudinal and lateral delta-V components were -15 km/h (-9.3 mph) and 18 km/h (11.2 mph), respectively. The CDC assigned for the Event 1 impact was 70FDEW1, incremented by 60 to denote the lateral end shift of the frame rails.

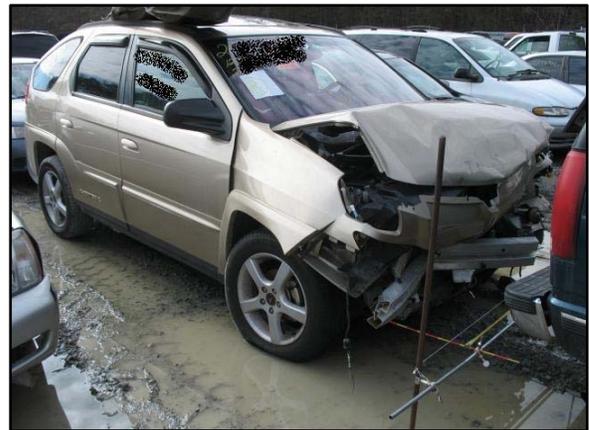
Figure 11: Front right oblique view of the Pontiac.

The front plane of the Pontiac (**Figure 11**) sustained moderate severity damage as a result of the impact with the front of the Honda. The front fascia of the Pontiac had separated from the vehicle during the crash sequence. The combined width of the direct and induced damage extended the full 156 cm (61.4 in) width of the frontal plane. A residual crush profile was documented along the bumper reinforcement bar and was as follows: C1 = 16 cm (6.3 in), C2 = 26 cm (10.2 in), C3 = 37 cm (14.6 in), C4 = 55 cm (21.7 in), C5 = 19 cm (7.5 in), C6 = 0 cm. The maximum crush was located at C4.

The Damage Algorithm of the WinSMASH program was used to calculate the crash severity. The total calculated delta-V of the Pontiac was 55 km/h (34.2 mph). Longitudinal and lateral components of the calculated delta-V were -54 km/h (-33.6 mph) and 10 km/h (6.2 mph), respectively. The CDC assigned for the Event 2 impact was 12FDEW4.
